Tidal Wetland Plants Distribution and Primary Control Factors in Commencement Bay

Ronald M. Thom Amy B. Borde Dana L. Woodruff

Battelle Marine Sciences Laboratory
1529 West Sequim Bay Road
Sequim, Washington 98382

April, 2000

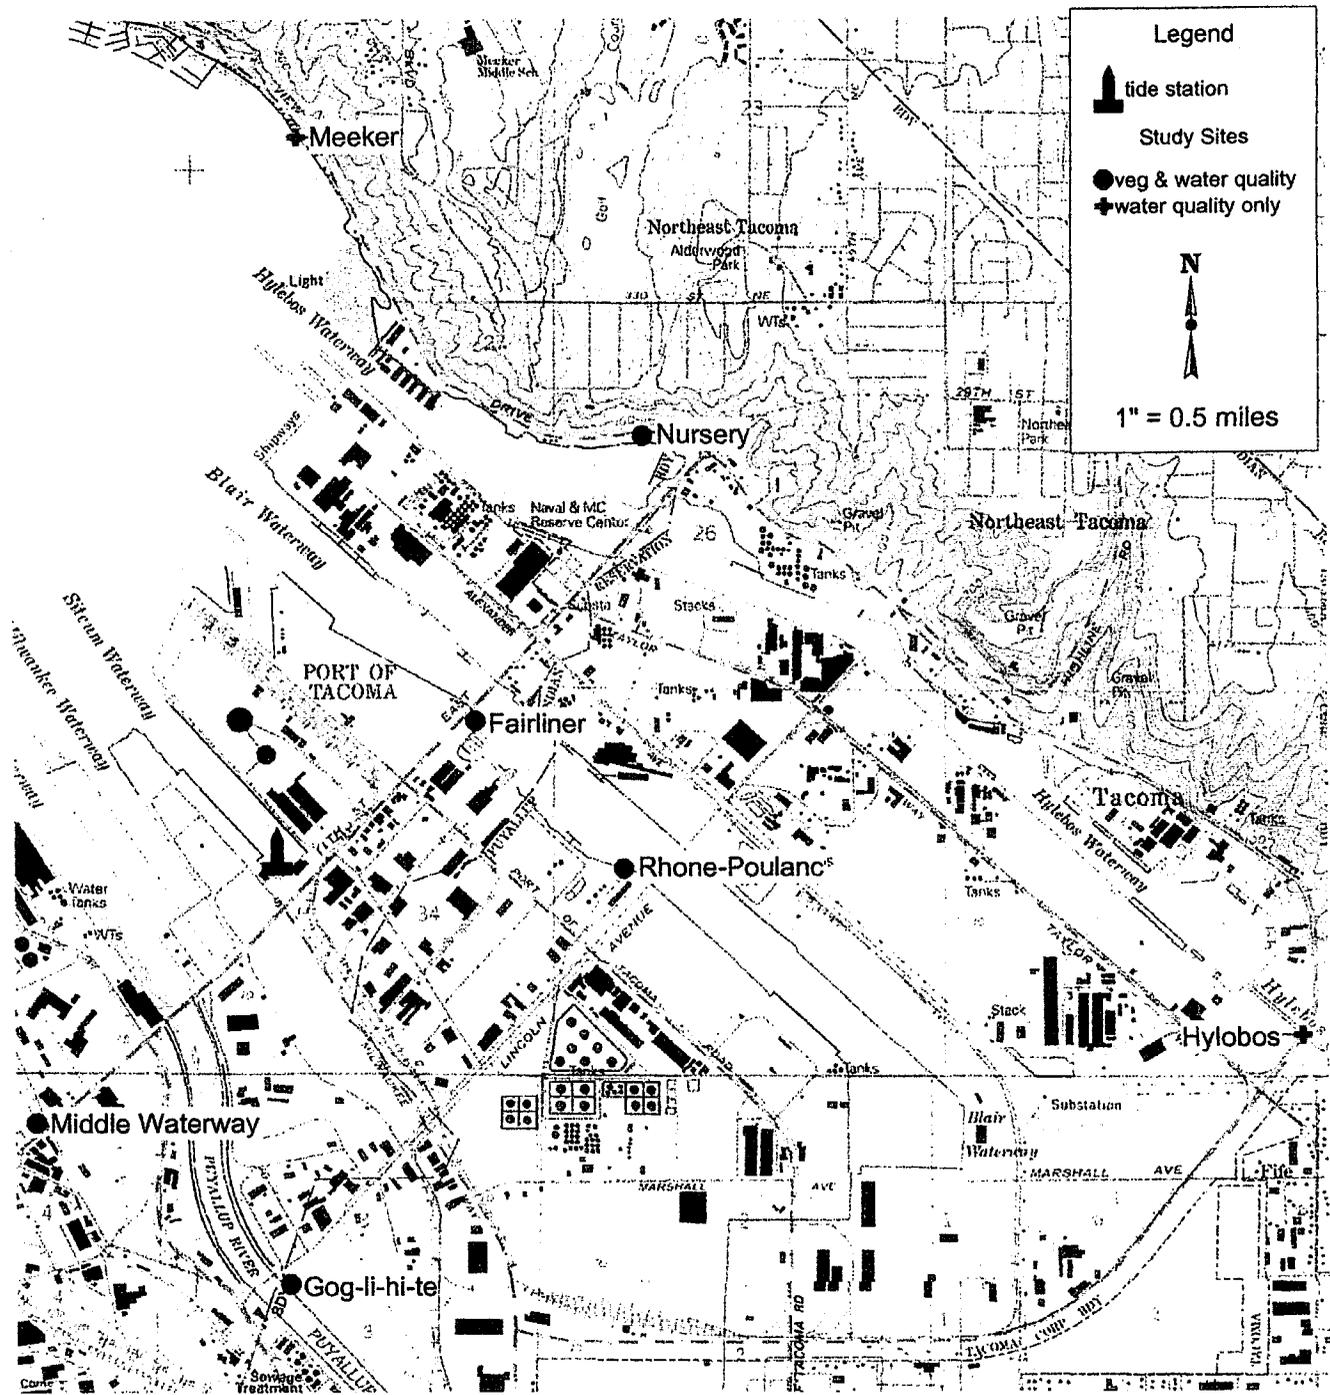
Figure 1. Location of study sites and tide station in Commencement Bay, Washington

Sites. We conducted surveys of vegetation and soils at five sites representative of the habitat focus areas in Commencement Bay (Figure 1). The sites were selected based on discussions and recommendations of NOAA, and were designed to include the range of tidal marsh species that would normally be expected in Commencement Bay. Because of the highly altered state of the bay ecosystem and general lack of natural marshes, all but one of the sites (Nursery) were restored marshes. We also examined other sites of interest to NOAA, including the Meeker site and the Wasser Winter site. Neither of these sites contained marsh vegetation, and hence were not sampled for vegetation. We did, however, collect water properties data at these sites (see below).

Vegetation and Soils. At each of the sites, we delineated the portion of the site containing emergent wetland vegetation patches that we sampled using a Trimble Global Positioning System with a listed accuracy of <1 m. There were other patches of vegetation at most sites, but these were not delineated. In most cases, we collected position data at several points along the edge of the vegetation distribution. In some cases, the vegetation was so sparse that only points where vegetation occurred were surveyed. Elevations relative to a base point on the shore were collected using a Criterion 400 Laser Range Finder. This instrument has a manufacturer's-stated accuracy of ± 0.2 degrees. The elevations were referenced to MLLW by recording the elevation of the water's edge along with the time, and correcting this elevation to data from that date at the NOAA tide gauge station located in Sitcum Waterway (Figure 1).

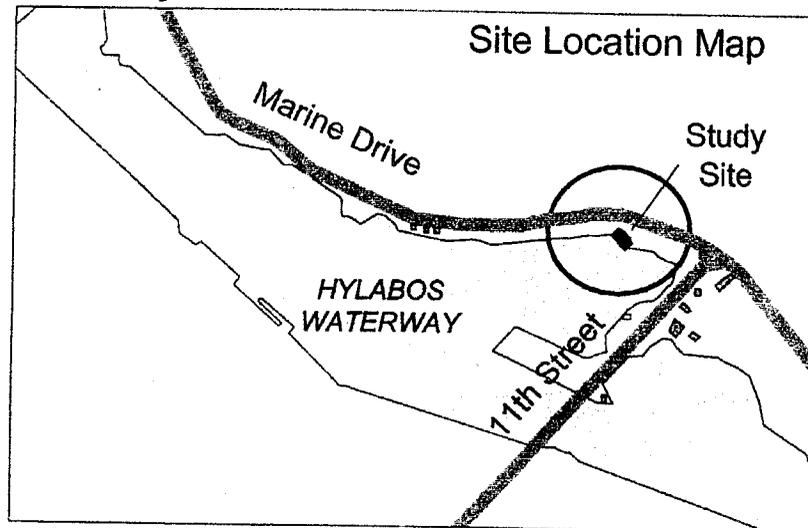
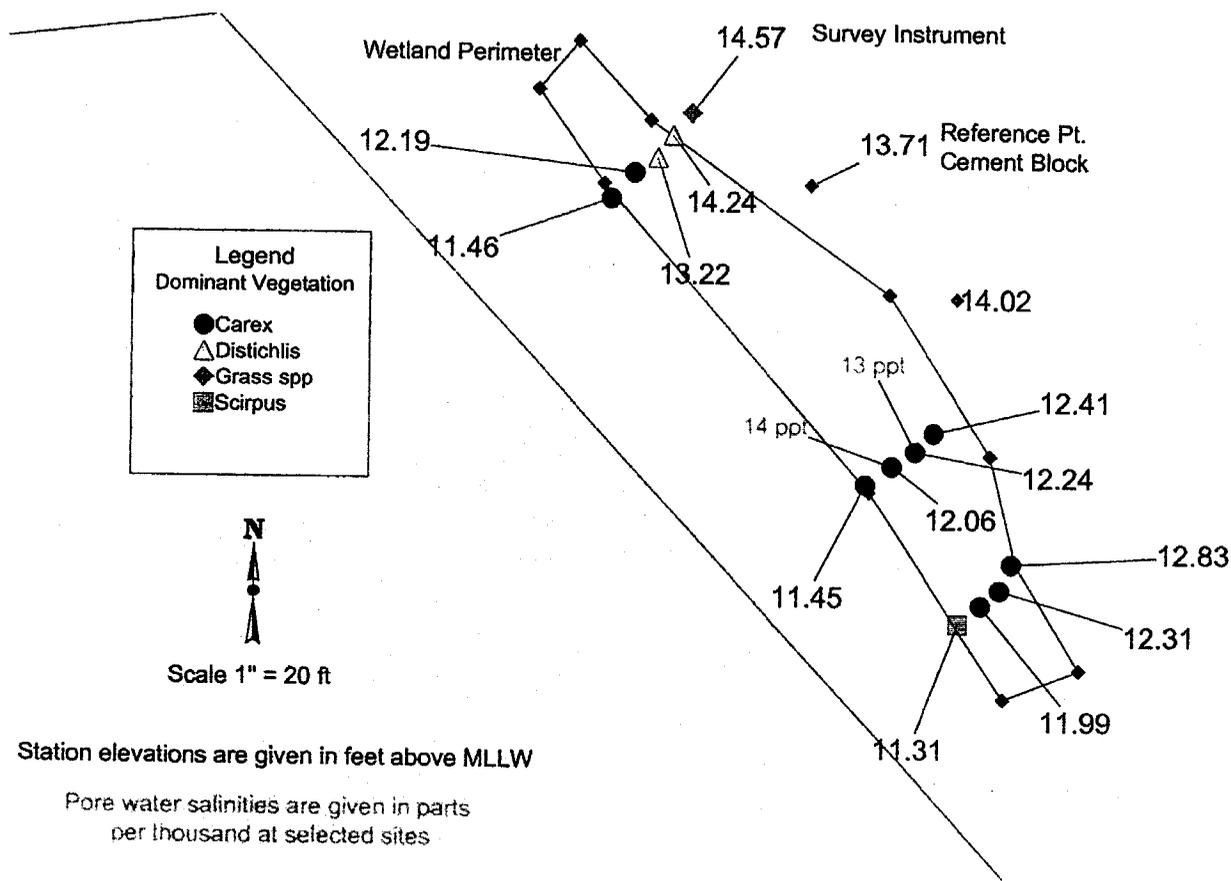
Station elevations are given in feet above MLLW

Pore water salinities are given in parts per thousand at selected sites

Figure 2. Delineation of the Nursery study site showing elevations, major species, and soil salinities

Nursery Site. At the Nursery site, a relatively lush natural marsh is distributed between about +11 and +14 ft MLLW (Figure 2, Appendix B). *Carex* dominated most of the site, and *Distichlis* occurring at higher elevations. Soil salinities were 13-14 ppt. We recorded freshwater inflow through a culvert located near the north end of the site, and we suspect that there is subsurface freshwater source at this site. Soils were relatively high in moisture content, organic carbon content, and gravels and sand (Table 2). Nitrogen and phosphate concentrations were relatively great at this site. The slope of the site was approximately 1.0 v:10.0 h (vertical to horizontal), which is steep for marshes in the region. The site has a maximum fetch of about 560 m, and it is open to wind driven waves from the southwest. A broad mudflat seaward from the marsh likely attenuates waves from this direction.

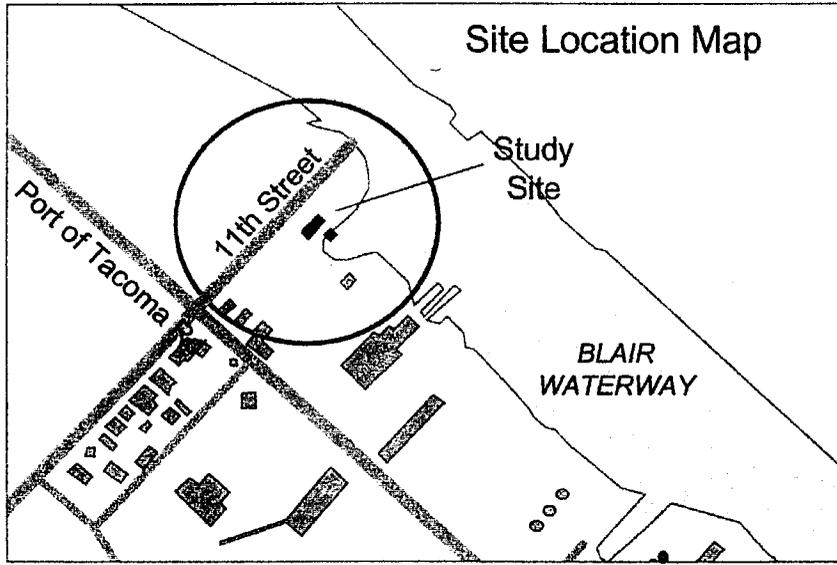
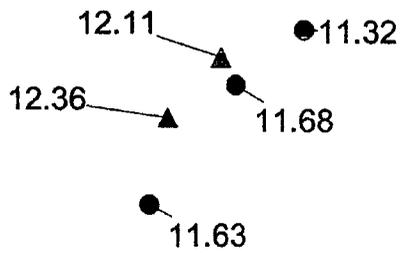
◆ 11.24
Survey Instrument

◆ 0.02
Reference Pt
Water level @
3:00 pm

Station elevations are given in feet above MLLW

Figure 3. Delineation of the Fairliner study site showing elevations, major species, and soil salinities

Fairliner Site. The Fairliner site was characterized as almost devoid of vegetation. Most of the few patches of extant vegetation were included in our samples and were found between elevations between +11.32 and +12.36 ft MLLW (Figure 3, Appendix C). The specimens of *Scirpus* and *Jaumea* that were present were sparse (Table 1) and appeared to be wilted and unhealthy. The sediment at the site is hard-packed, relatively low in moisture content, and dominated by silt and clay (Table 2). We were unable to obtain samples for salinity and nutrient analysis because of the dry and hard-packed nature of the soil. The slope is steep (1.1 v:10.0 h). Because it is located very near the shipping channel in Blair Waterway, the site likely receives substantial wakes from passing ships.

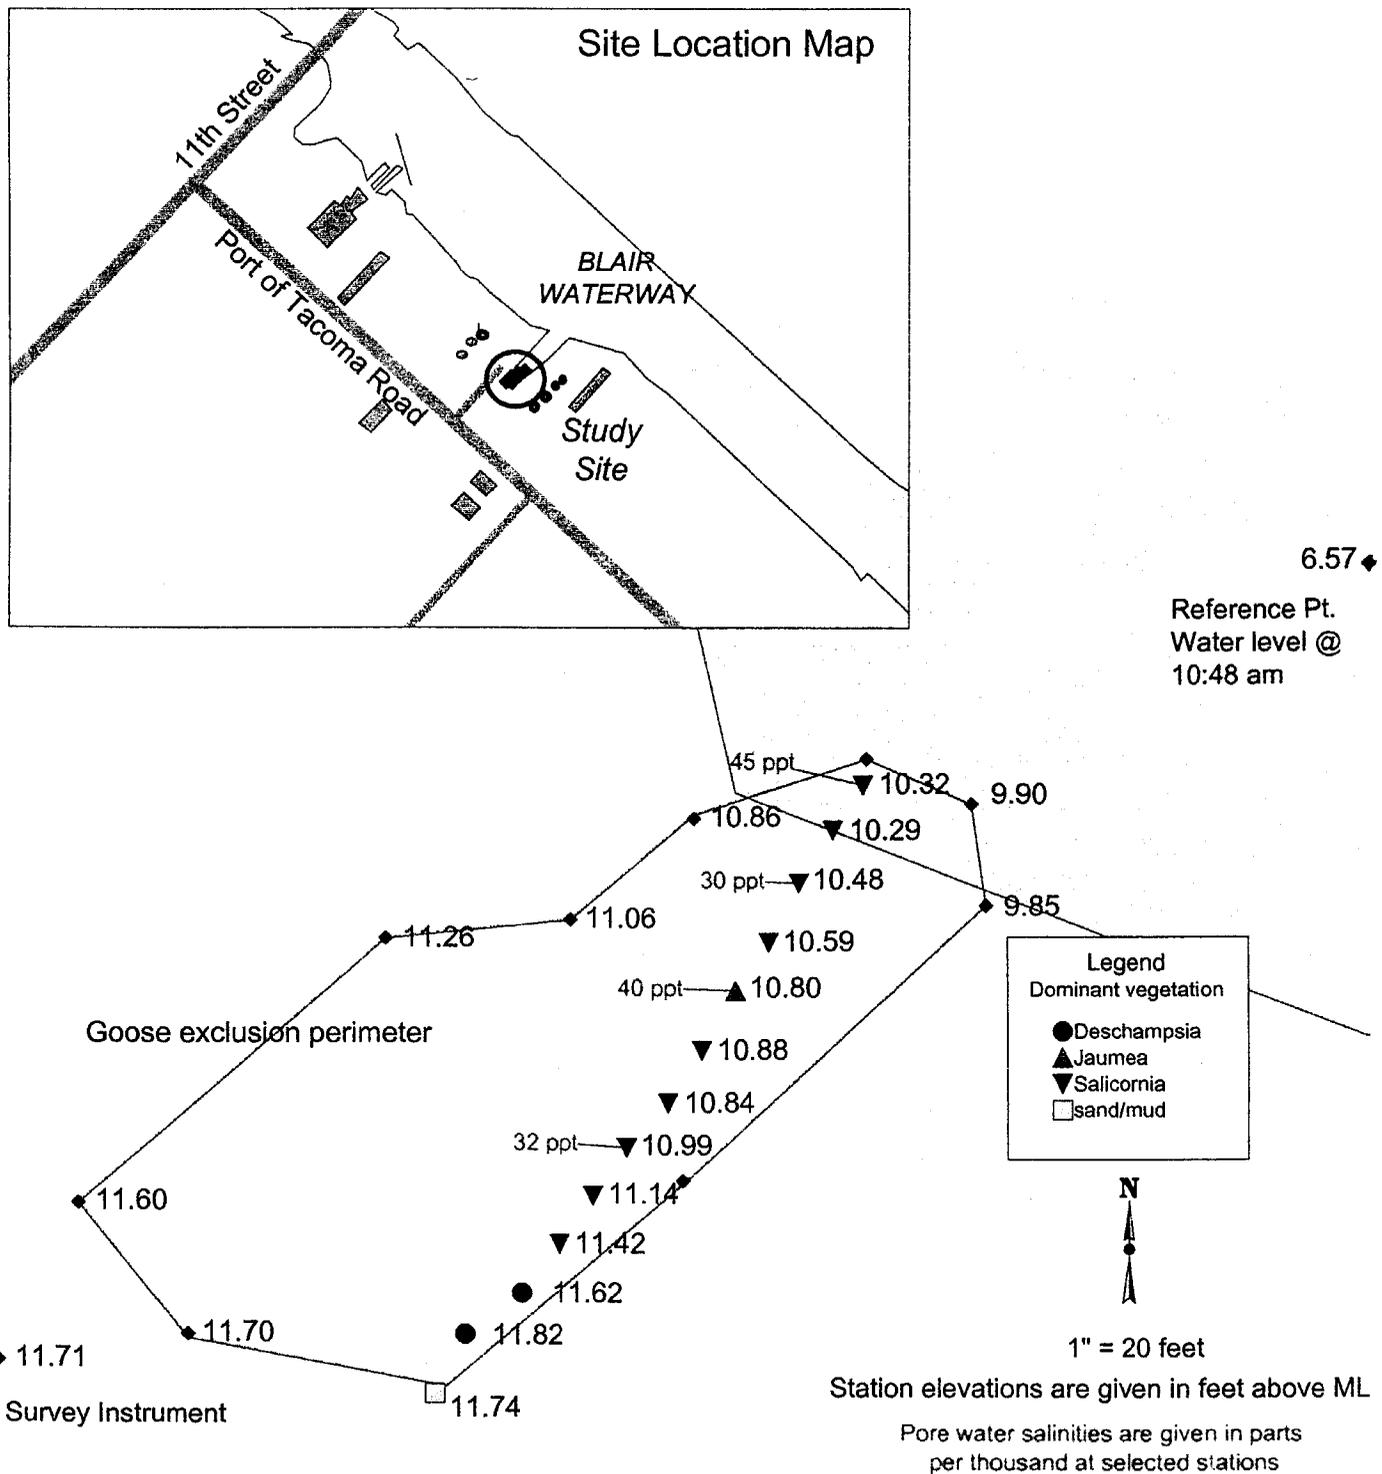
Figure 4. Delineation of the Rhone-Poulanc study site showing elevations, major species, and soil salinities. Boundary shown is the perimeter of the goose-exclusion area. Vegetation does not cover the entire area

Rhone-Poulanc Site. This site is relatively newly restored with a developing marsh system. We surveyed the main marsh patch at the western portion of this site. A goose-exclusion fence surrounded the patch. According to the site manager, geese have removed a large portion of the marsh plantings from this site. The marsh vegetation is dominated at the lower elevations by relatively lush *Salicornia*, and at the higher elevations by clumps of *Deschampsia*. *Jaumea* is abundant in patches throughout the site. The vegetation extends from +11.74 ft MLLW down to +10.32 ft MLLW (Figure 4, Appendix D). Soil salinities were elevated, and ranged from 30 to 45 ppt. The soils were moderate in moisture content, and were dominated (>87%) by sand (Table 2). Nitrogen ranged widely from 0.4 to 10 mgN/kg. Phosphate was relatively low compared with the other sites. The site has a gentle slope of 0.2 v:10.0 h. This site is protected from wind-generated waves from the southwest. Ship wakes can reach the site, but they are probably minor factor affecting the vegetation because of the relatively narrow shape of the embayment in which the site is located.

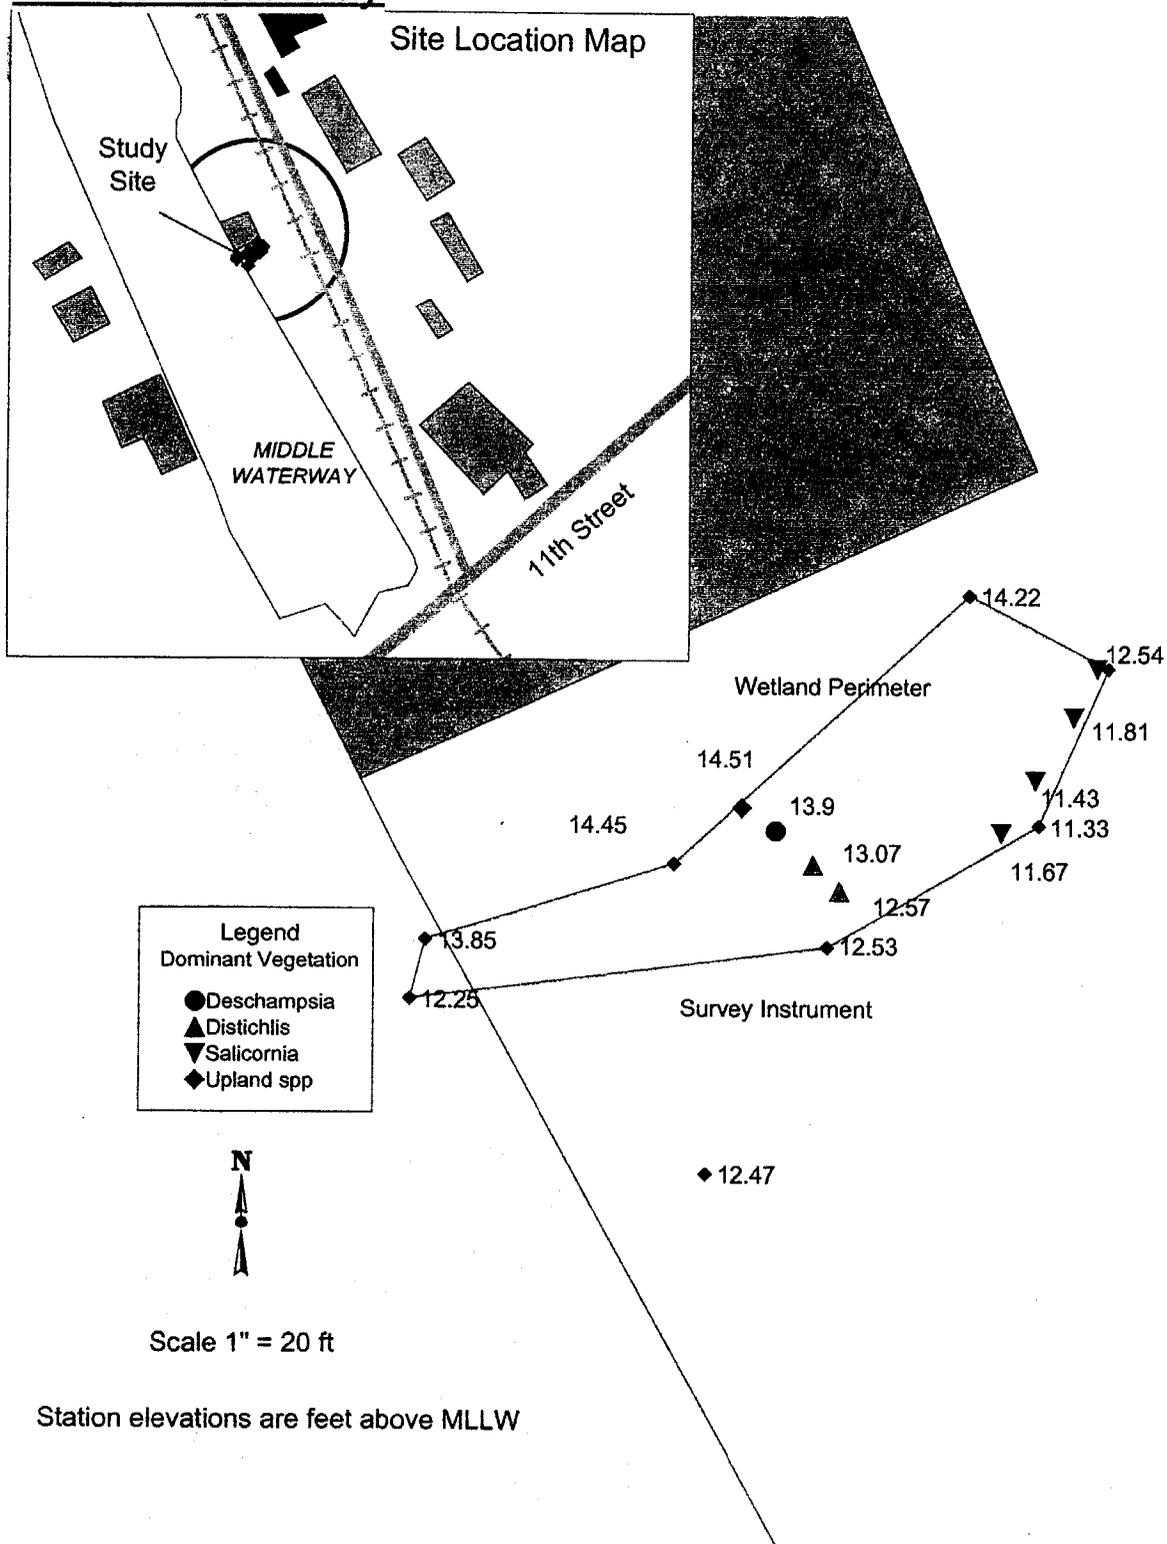
Figure 5. Delineation of the Middle Waterway study site showing elevations, major species, and soil salinities

Middle Waterway Site. The Middle Waterway site sits in a protected back bay portion of the waterway. A broad mudflat extends from the lower edge of the marsh to a narrow channel that forms at low tides in the middle of the waterway. Vegetation at the site is dominated by *Salicornia* and *Distichlis*, and is patchy but lush where it occurs. Vegetation occurs between +11.7 and +13.9 ft MLLW, and *Distichlis* occupies somewhat higher elevations than does *Salicornia* (Figure 5, Appendix E). The site is the remaining portion of a larger transplanted area in the general vicinity. Marsh vegetation also occurs as a narrow (ca. 5m wide) fringe to the west and south of the area we surveyed. The soils were dominated by hard-packed sand (96%) that contained very low moisture. We were unable to extract enough water at this site to make soil salinity measurements. Soil carbon, nitrogen, and phosphate values were among the lowest recorded during our study. The slope varies from moderate (0.4 v:10.0 h) in the *Salicornia* zone to steep (1.3 v:10.0 h) in the *Distichlis-Deschampsia* zone (Figure 5). Although the site is open across the waterway to winds and waves from the southwest, the presence of the mudflat and the probable lack of major ship traffic nearby, means that this site likely does not receive substantial wave disturbance.

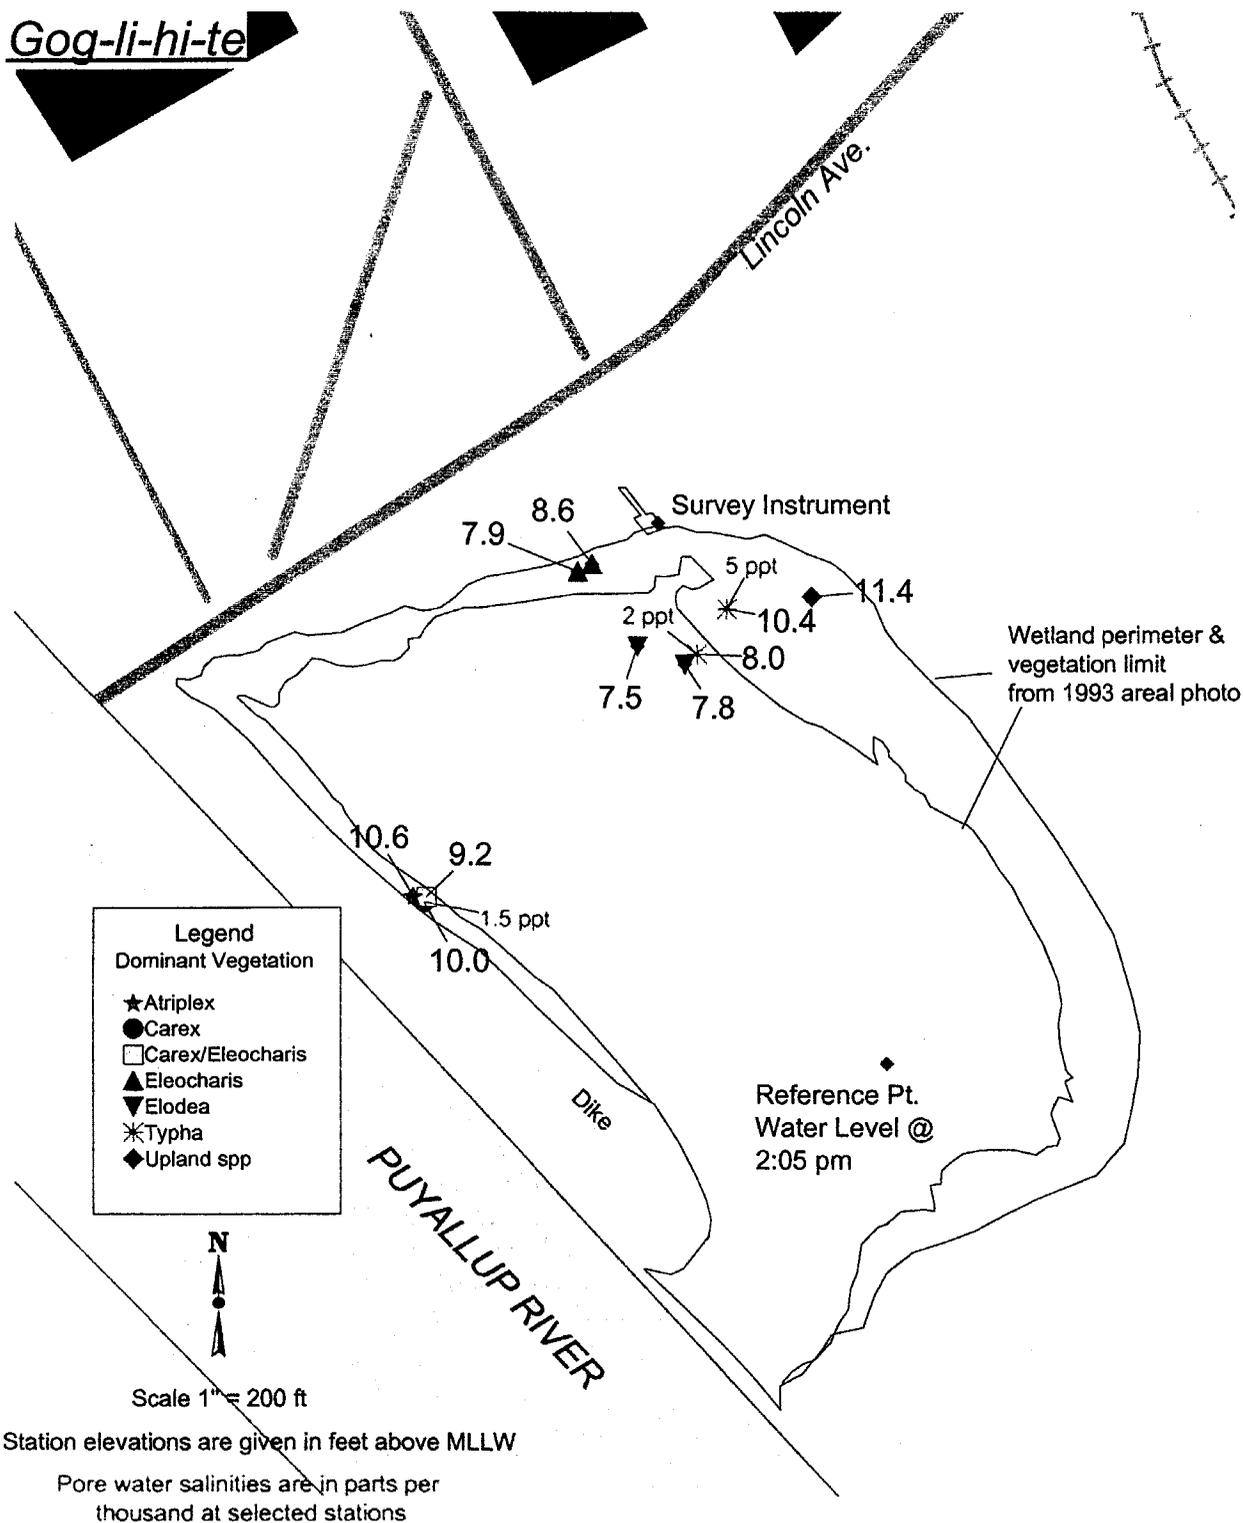
Figure 6. Delineation of the Gog-le-hi-te study site showing elevations, major species, and soil salinities

Gog-Le-Hi-Te Site. This restored wetland lies in the tidal portion of the Puyallup River. *Typha* dominates the lush vegetation, with small patches of *Carex* and *Eleocharis* (Figure 6, Appendix F). Very low-growing aquatic vegetation consisting of *Elodea* and *Juncus bufonius* occurs on the mudflats seaward of the emergent marsh. *Typha* occurs at an elevation range of +7.9 to +11.4 ft MLLW, and *Carex* occurs between about +9.2 and +10.6 ft MLLW. Moisture content in the soils is great, and organic carbon is moderate. The soils are predominately silts and clays (Table 2). Soil nitrogen is moderate, and soil phosphate are relatively high. Soil salinity ranged from 2 to 5 ppt in the dense *Typha* stand. Soil salinity was lower (1.5 ppt) in the *Carex* stand, which was on a steeper slopes and closer to the mouth of the system. The site is protected from any significant wind waves and boat wakes by the river levee, which has a small (ca. 30 m-wide) connection to the river. The slope in the primary portion of the *Typha* marsh is a gentle 0.2 v:10.0 h.

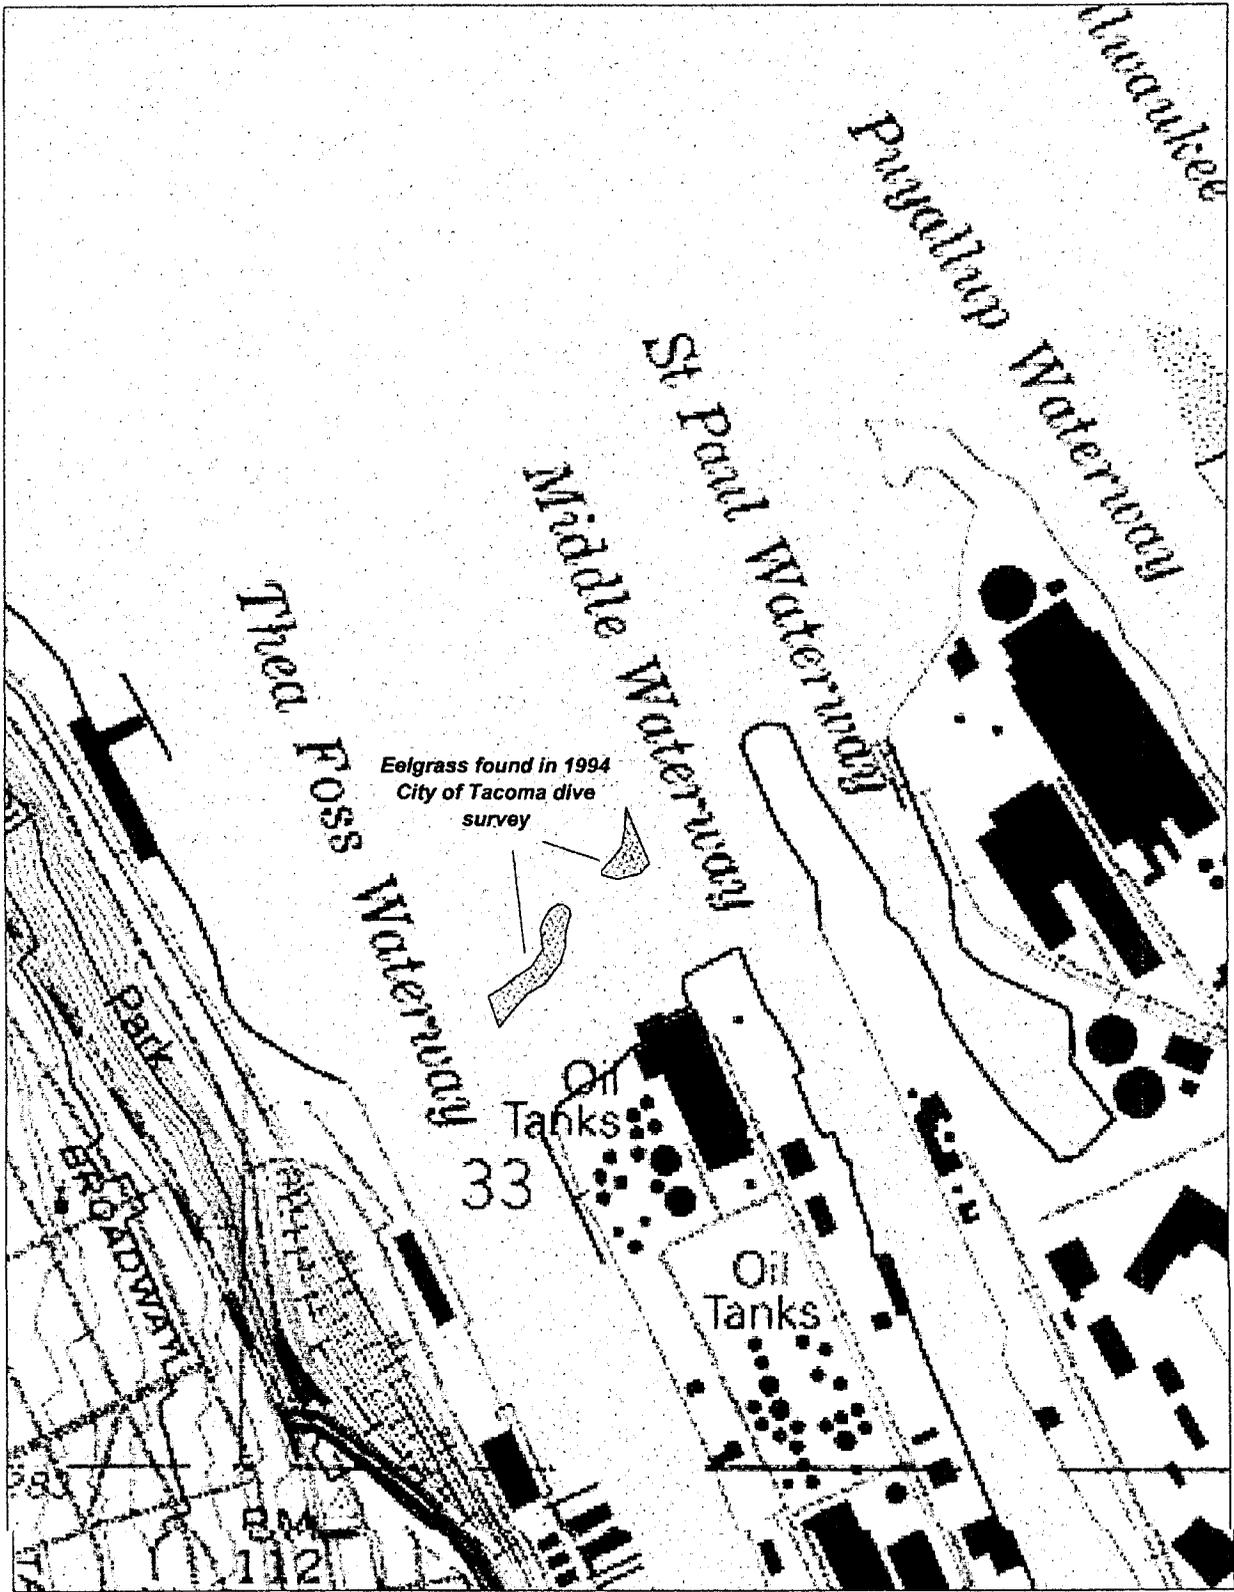
Figure 7. Eelgrass distribution in Commencement Bay

According to the data available, eelgrass occurs on the seaward end of the peninsula between the Puyallup River and the Middle Waterway (Figure 7). We have also observed eelgrass in small patches along the northern and southern shorelines of the bay.

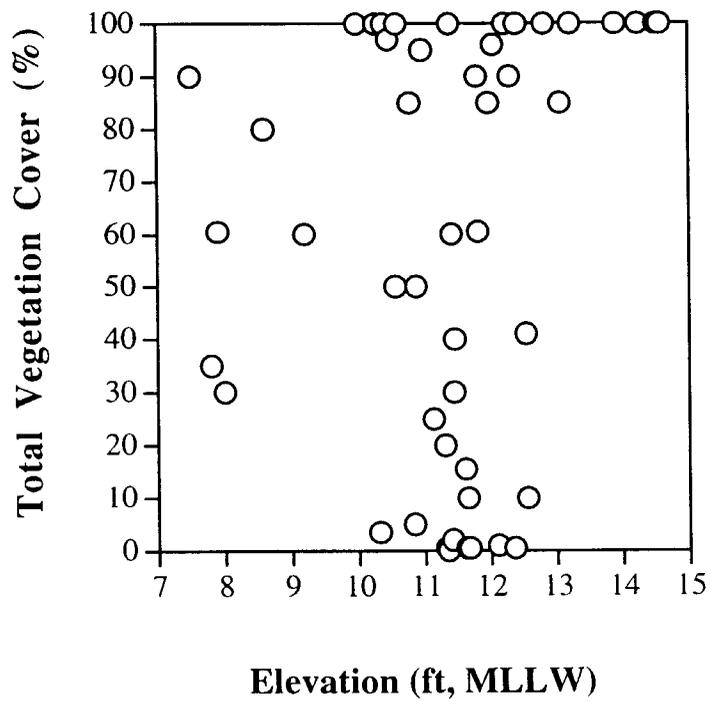
Figure 8. Total vegetation cover versus elevation at all sites

Elevation. Marsh vegetation was found between about +7 and +14.5 ft MLLW (Figure 8). The elevation range and elevation of peak cover varied among the five main species (Figure 9, Table 4). For example, *Distichlis* ranged from about +11.5 to +14.5 ft MLLW, with a peak at 13.2 ft MLLW. *Salicornia* occurred between 10.2 and 13.2 ft MLLW and peaked at about 10.5 ft MLLW. *Carex* cover was greatest at about +10.0 to +12.8 ft MLLW.

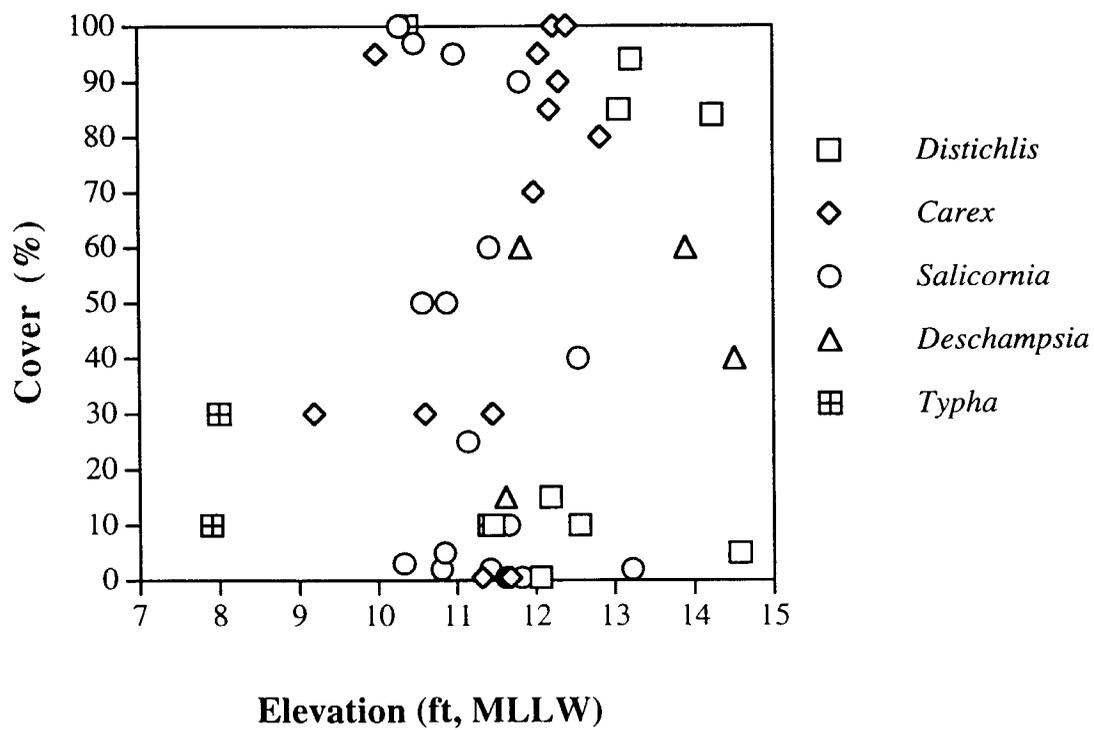
Figure 9. Cover of five major species versus elevation

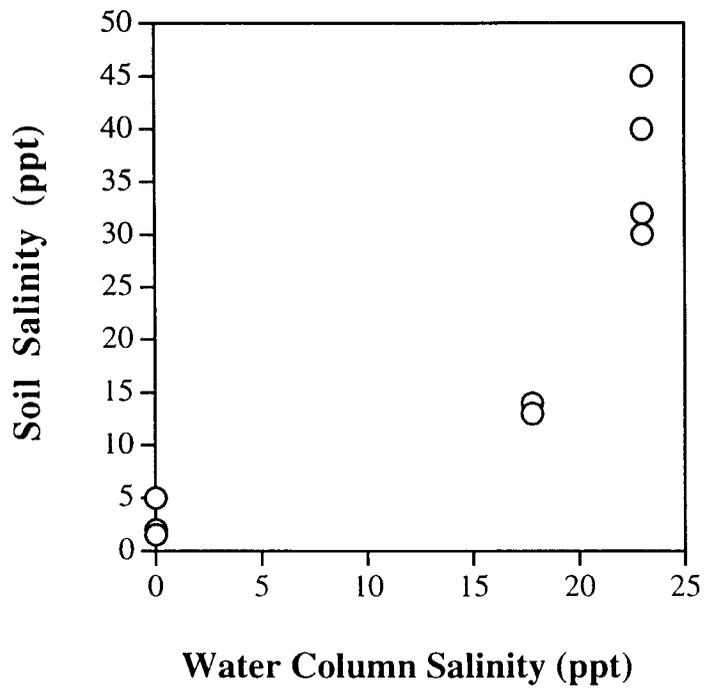
Figure 10. Soil salinity versus water column salinity

Salinity. For the three sites where we were able to collect soil salinity samples, there was a strong relationship between salinity in surface waters in samples and soil salinity in June (Figure 10). Soils tended to accumulate salts, likely largely because of evaporation, at sites where water salinities were above about 20 ppt and below about 1 ppt. The Nursery site had intermediate soil salinities (Figure 2, Figure 10). As mentioned above, we noted a freshwater seepage very near the site that may have diluted salinities in the soils through a persistent flow both above and below ground.

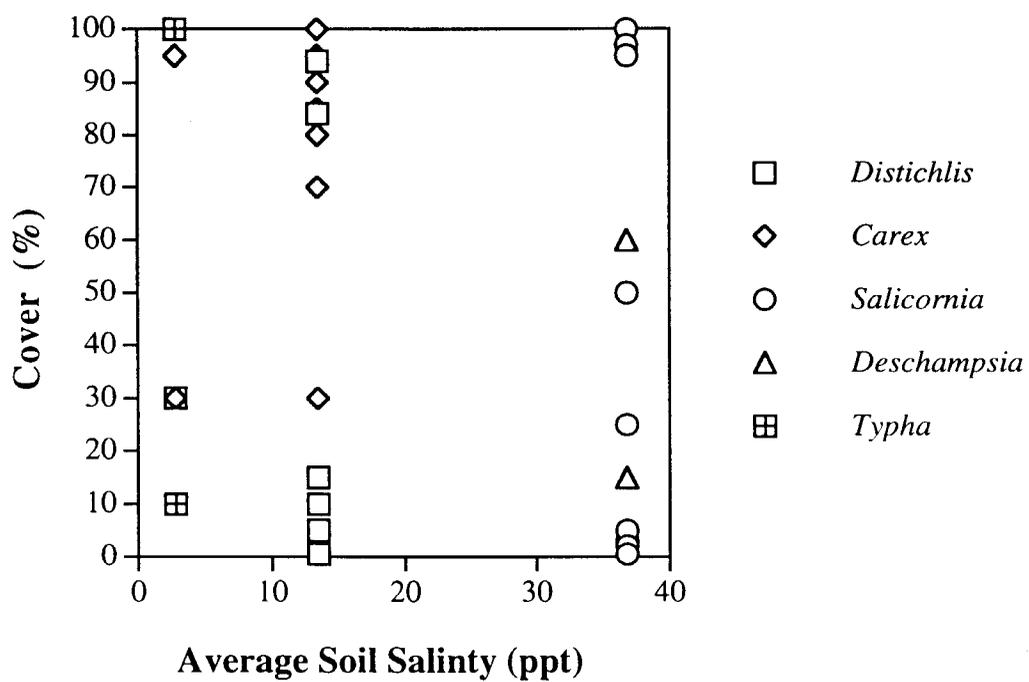
Figure 11. Soil salinity versus cover of five major species

The plants must deal with soil salinities through mechanisms that reduce internal salt concentrations. Cover of the five major plant species varied with soil salinity (Figure 11) and water column salinity (Figure 12). As evidenced by both water column and soil salinity data, *Salicornia* was the most salt tolerant, followed by *Distichlis* and *Deschampsia*. *Carex*, known to be a euryhaline species, exhibited the widest range of salinity tolerance.

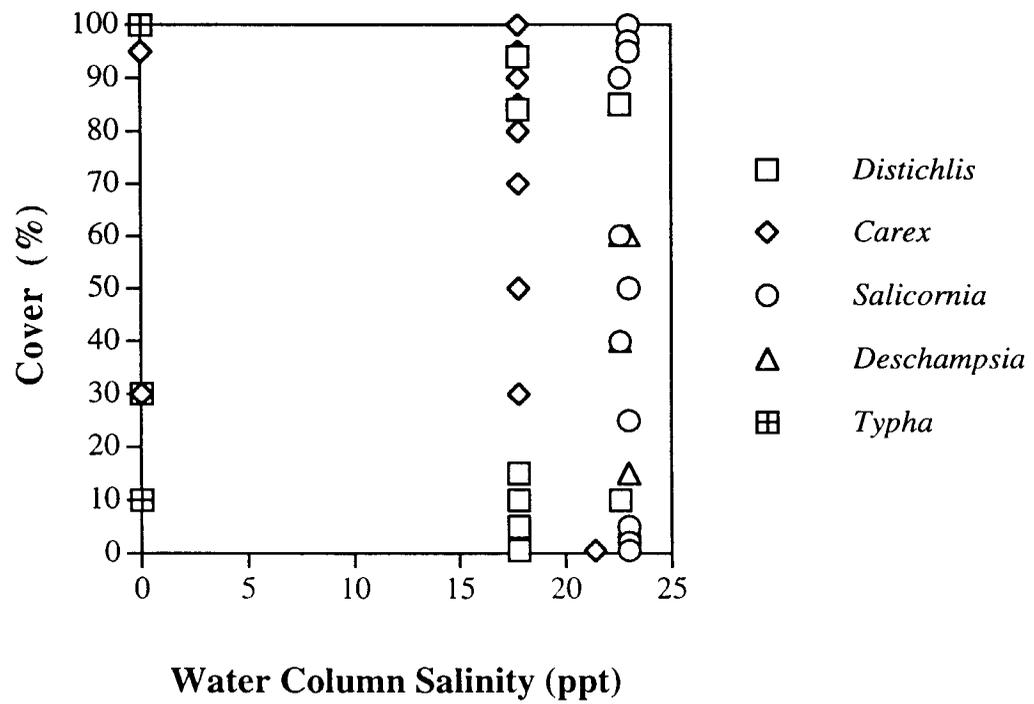
Figure 12. Water column salinity versus cover of five major species

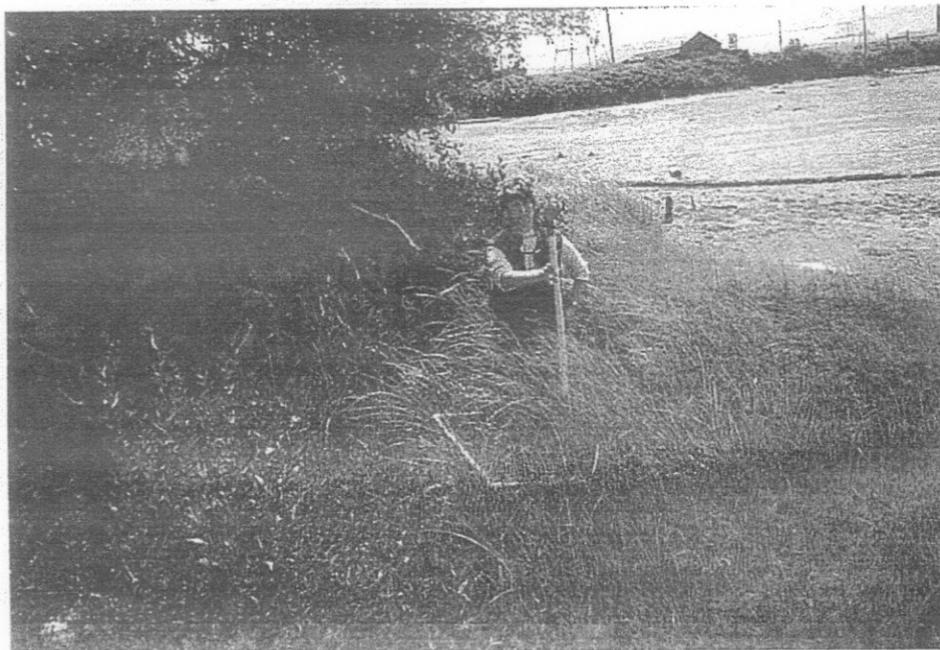
Appendix B. Nursery site showing quadrat in *Carex lyngbyei*

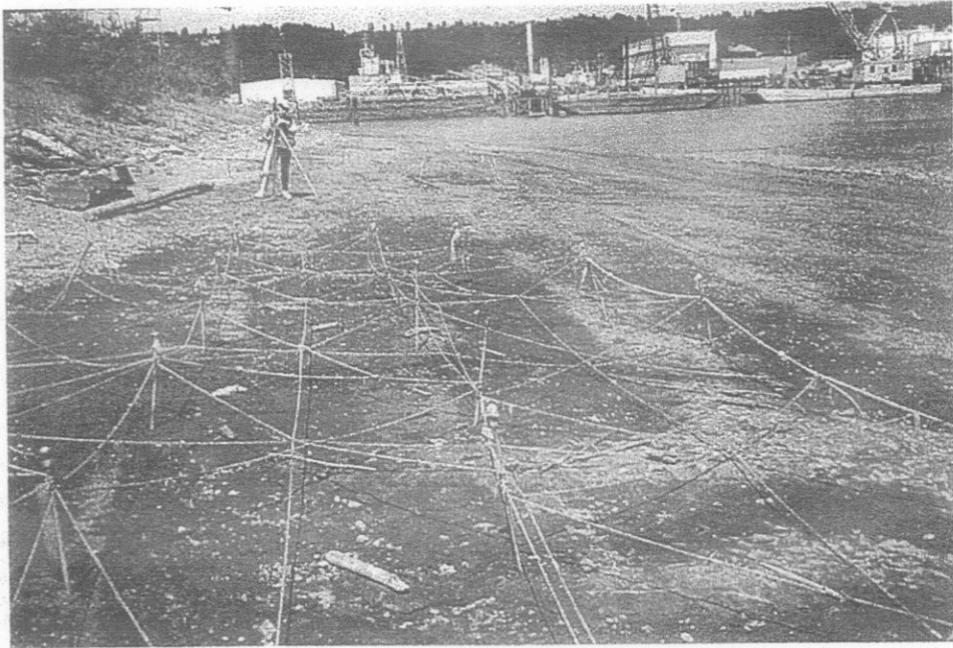
Appendix C. Fairliner site showing goose exclusion ropes and lack of vegetation

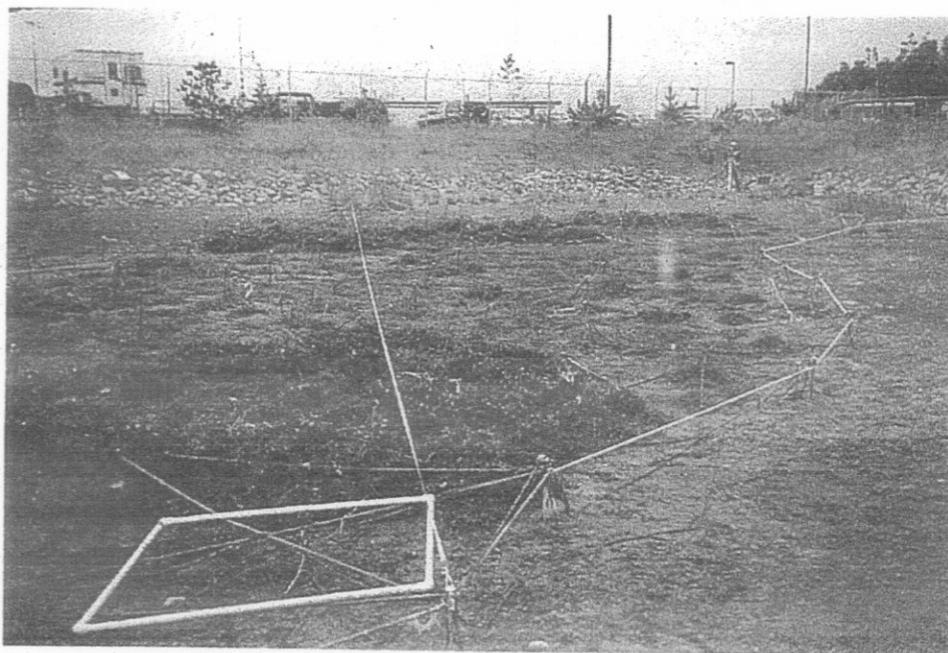
Appendix D. Rhone-Poulanc site from lower end of transect showing *Salicornia virginica* clump in foreground and *Deschampsia cespitosa* in background

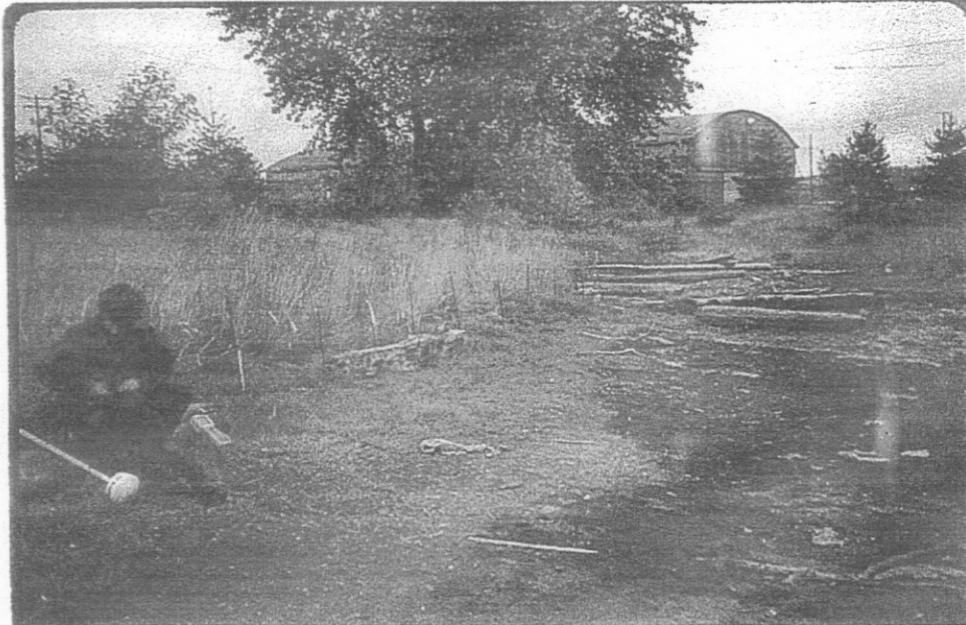
Appendix E. Middle Waterway site showing *Distichlis spicata* at lower elevation near mud interface and *Dechampsia cespitosa* at higher elevation

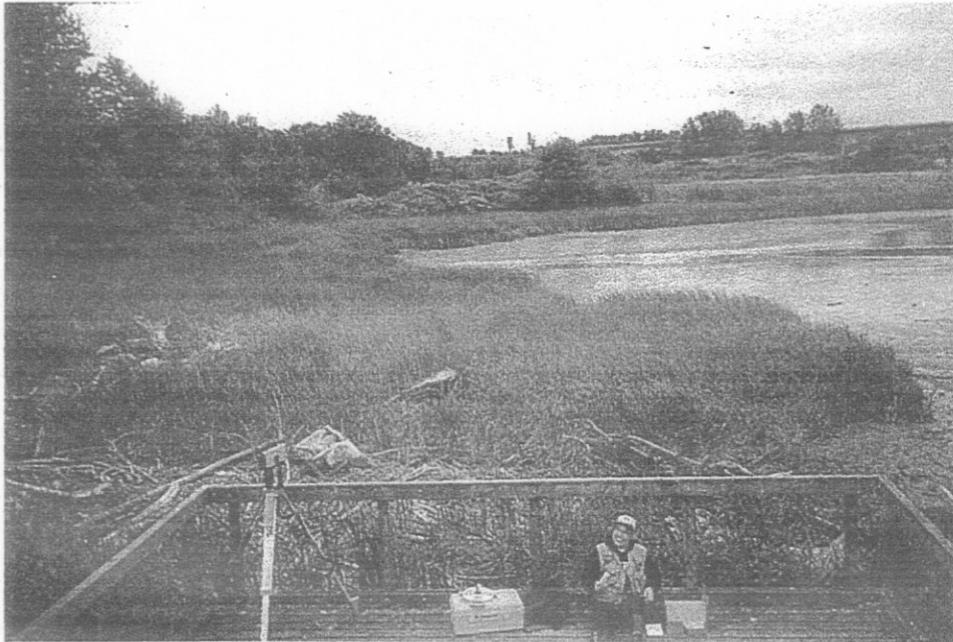
Appendix F. Gog-le-hi-te site showing *Typha* spp. stand
