**Habitat Monitoring Report: Year 0**  
**City of Tacoma Middle Waterway**  
**Restoration Project**  
*AND PICKLEWEED RANCH*

October 2001

# **Habitat Monitoring Report: Year 0**

## **City of Tacoma Middle Waterway Restoration Project**

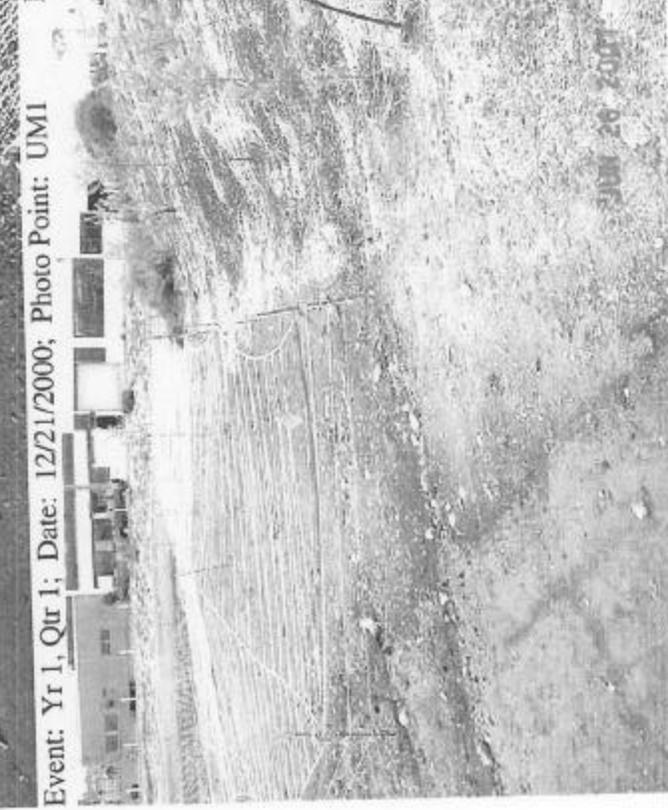
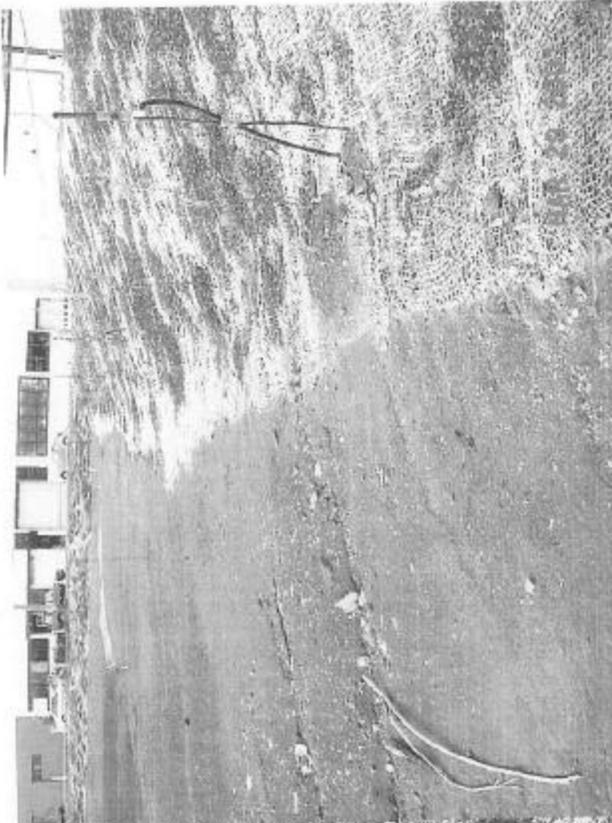
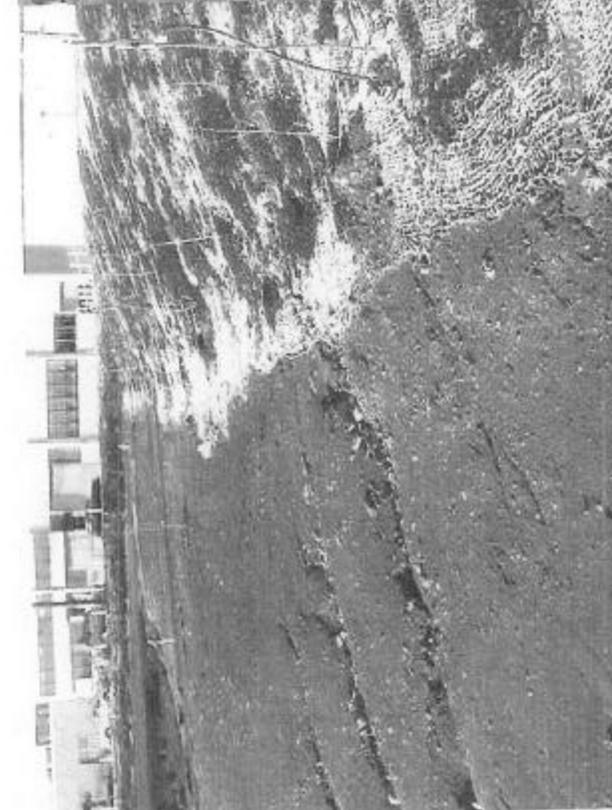
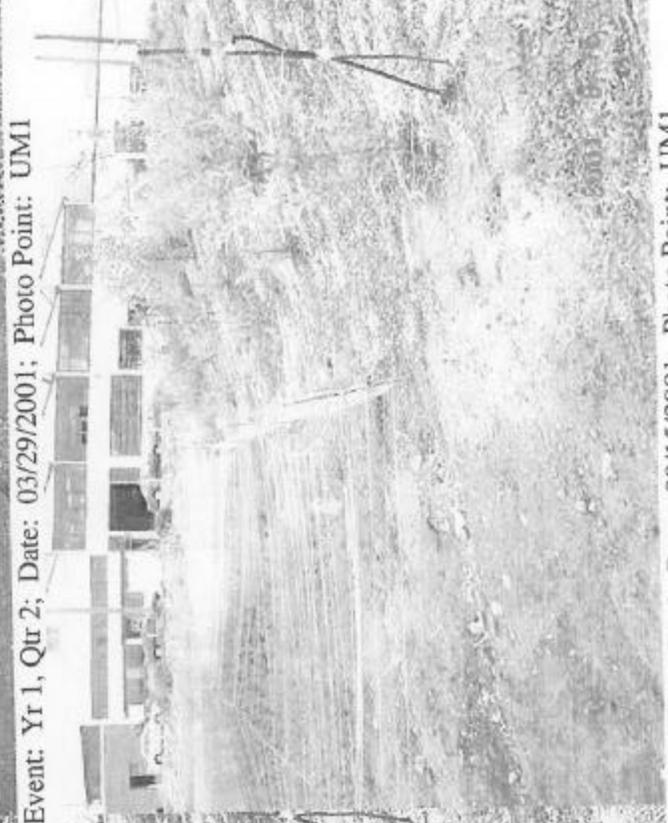
Event: Yr 1, Qtr 1; Date: 12/21/2000; Photo Point: UMI

Certain areas of the restoration site have experienced limited sediment loss since construction was completed. The salt marsh area developed small rills after construction (see Appendix A, photo points UM1, UM5, LM1A and B.) This erosion has not caused a problem and it appears to have been mitigated with the establishment of root mass from the plantings and the volunteer vegetation. In the area near the pedestrian walkway (Photo point LM1A) some stone was added to prevent the possibility of exposing any of the capped materials.

Soon after construction a couple of rills formed on the slopes adjacent to the public access walkway and at the ends of the constructed channels on the City parcel. Stone was placed near the access walkway and jute mat was placed at the ends of the constructed channels. These activities appear to have controlled the situation and additional sediment loss has not been apparent.
