Habitat Monitoring Report: Year 2

City of Tacoma Middle Waterway Restoration Project

August 2004

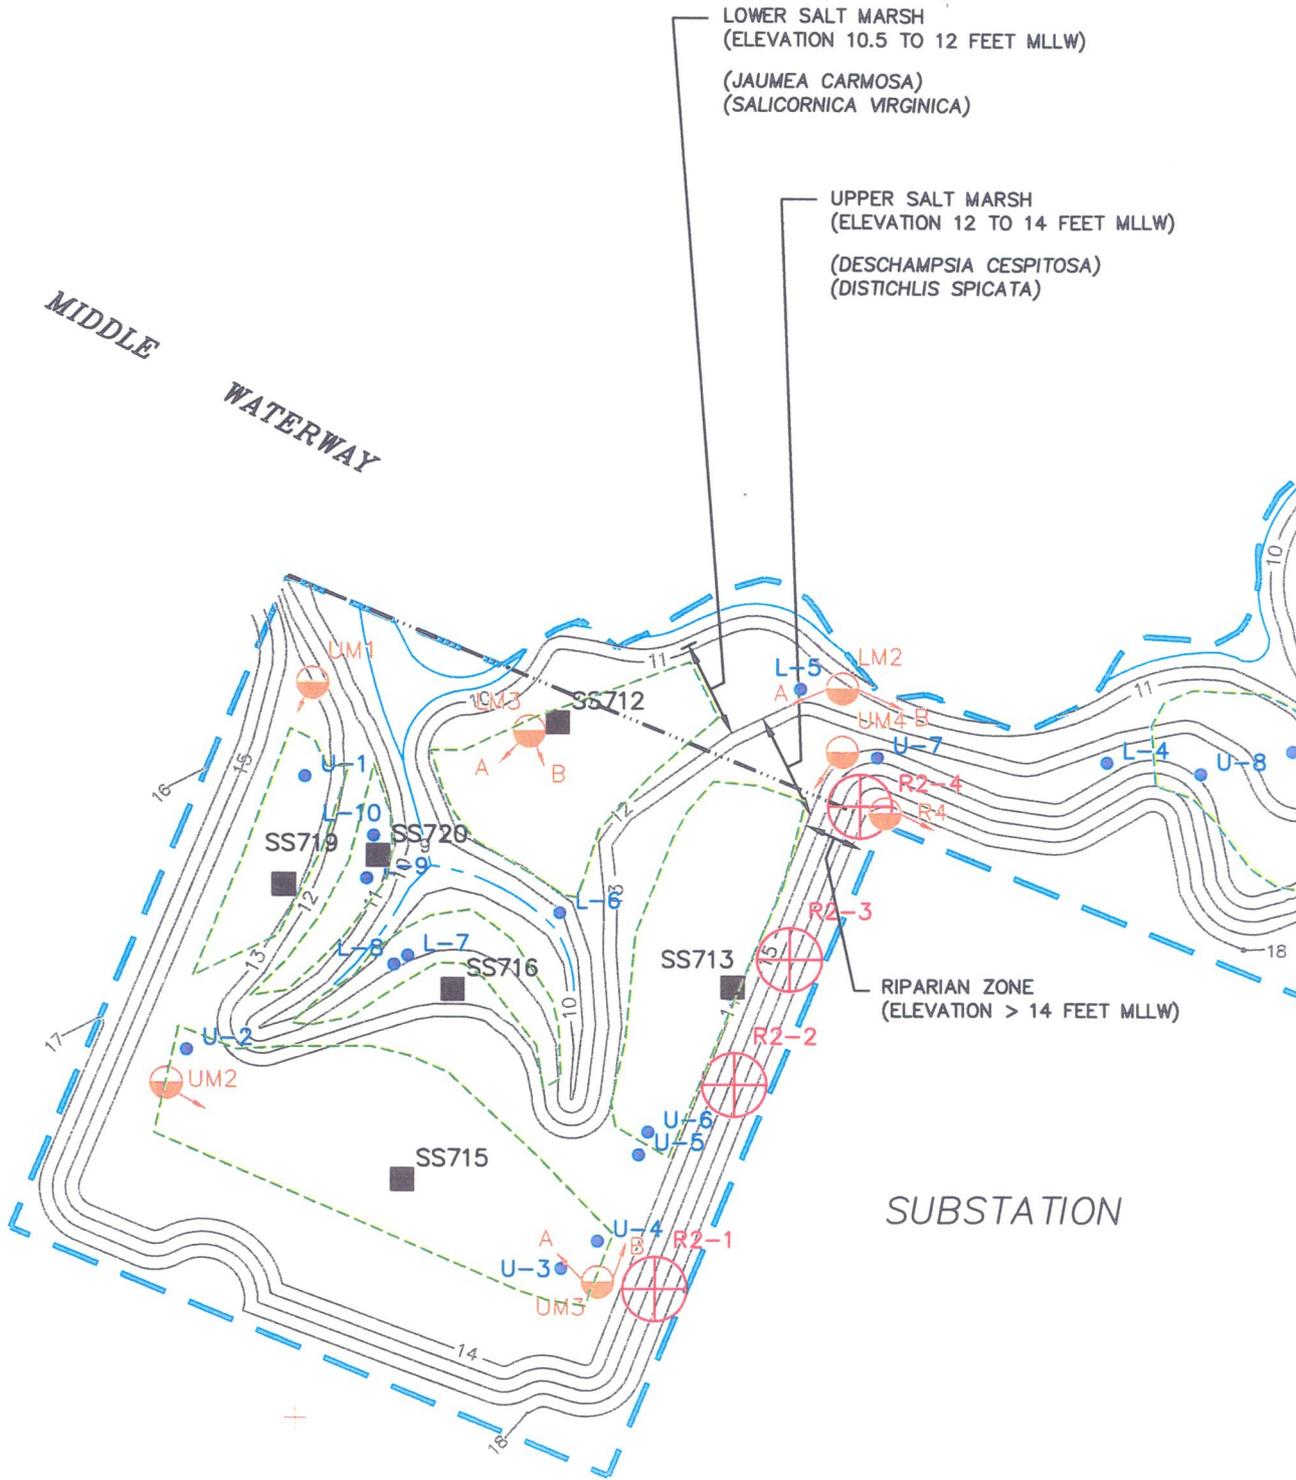
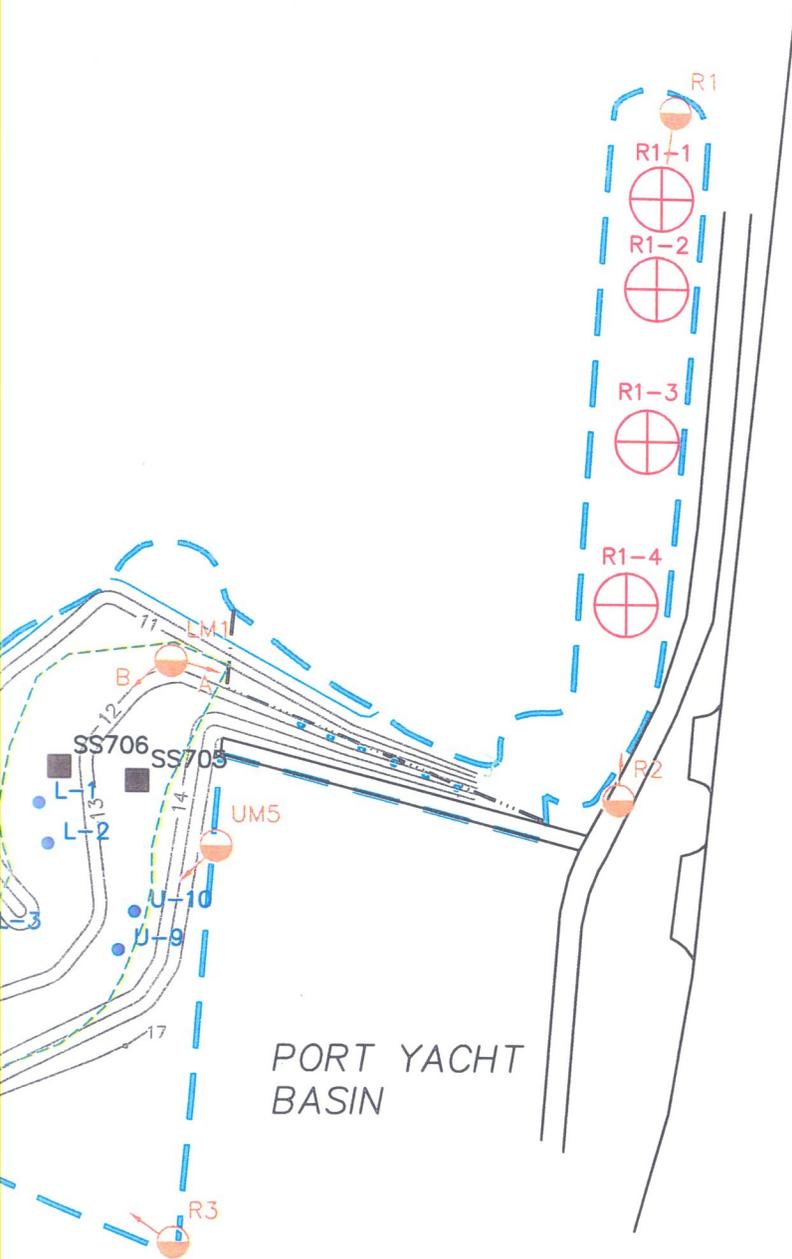
FIGURE 1

Photo points were established as described in the MAMP and depicted in Figure 1. The location of each point was marked by a stake and surveyed. A digital photo was taken from each photo point during each monitoring event. Year 2 photos are presented in Appendix A by photo point location.

Quantitative vegetation monitoring for Year 2 was conducted on September 9, 2003. Transects and quadrats established during Year 0 (illustrated in Figure 1) were again monitored.

Quantitative sediment monitoring consisted of recording the sediment elevation at each of 8 sediment stakes. The stakes were installed on October 30, 2000 in the areas shown on Figure 1 and initial readings recorded. Because these stakes were installed shortly after the end of construction it is appropriate to address this reading as Year 3. Each stake was marked in centimeters starting at the top of the stake, however, over time the marks have worn off. During Year 3 monitoring all stakes were read with a tape measure in centimeters from the bottom up.

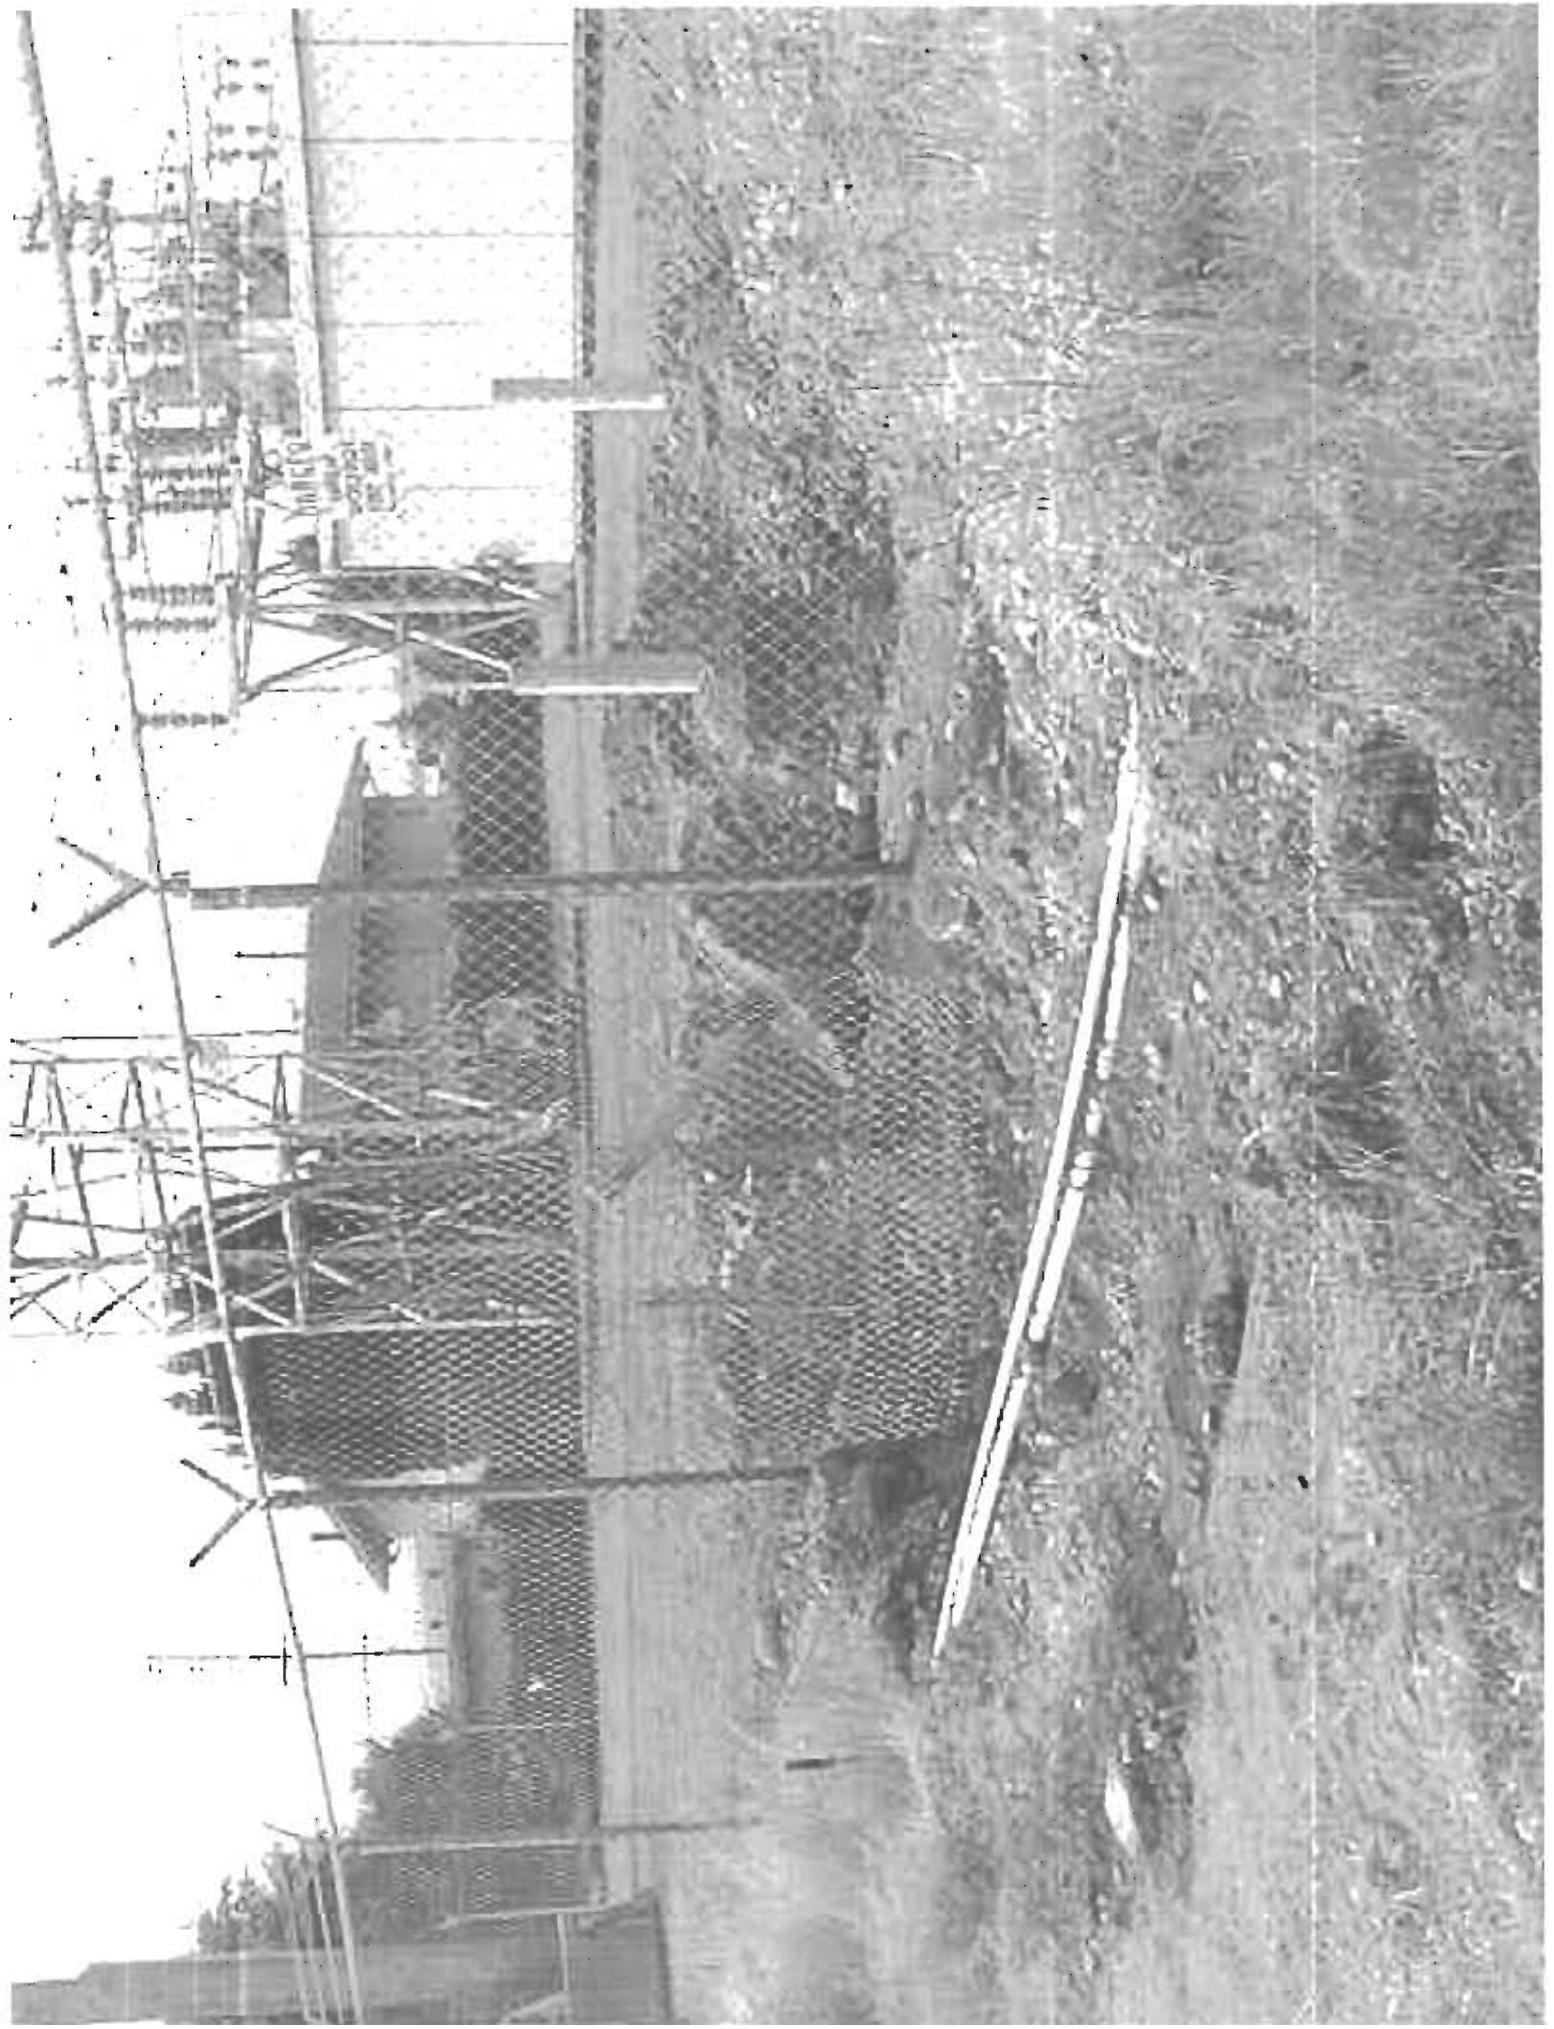
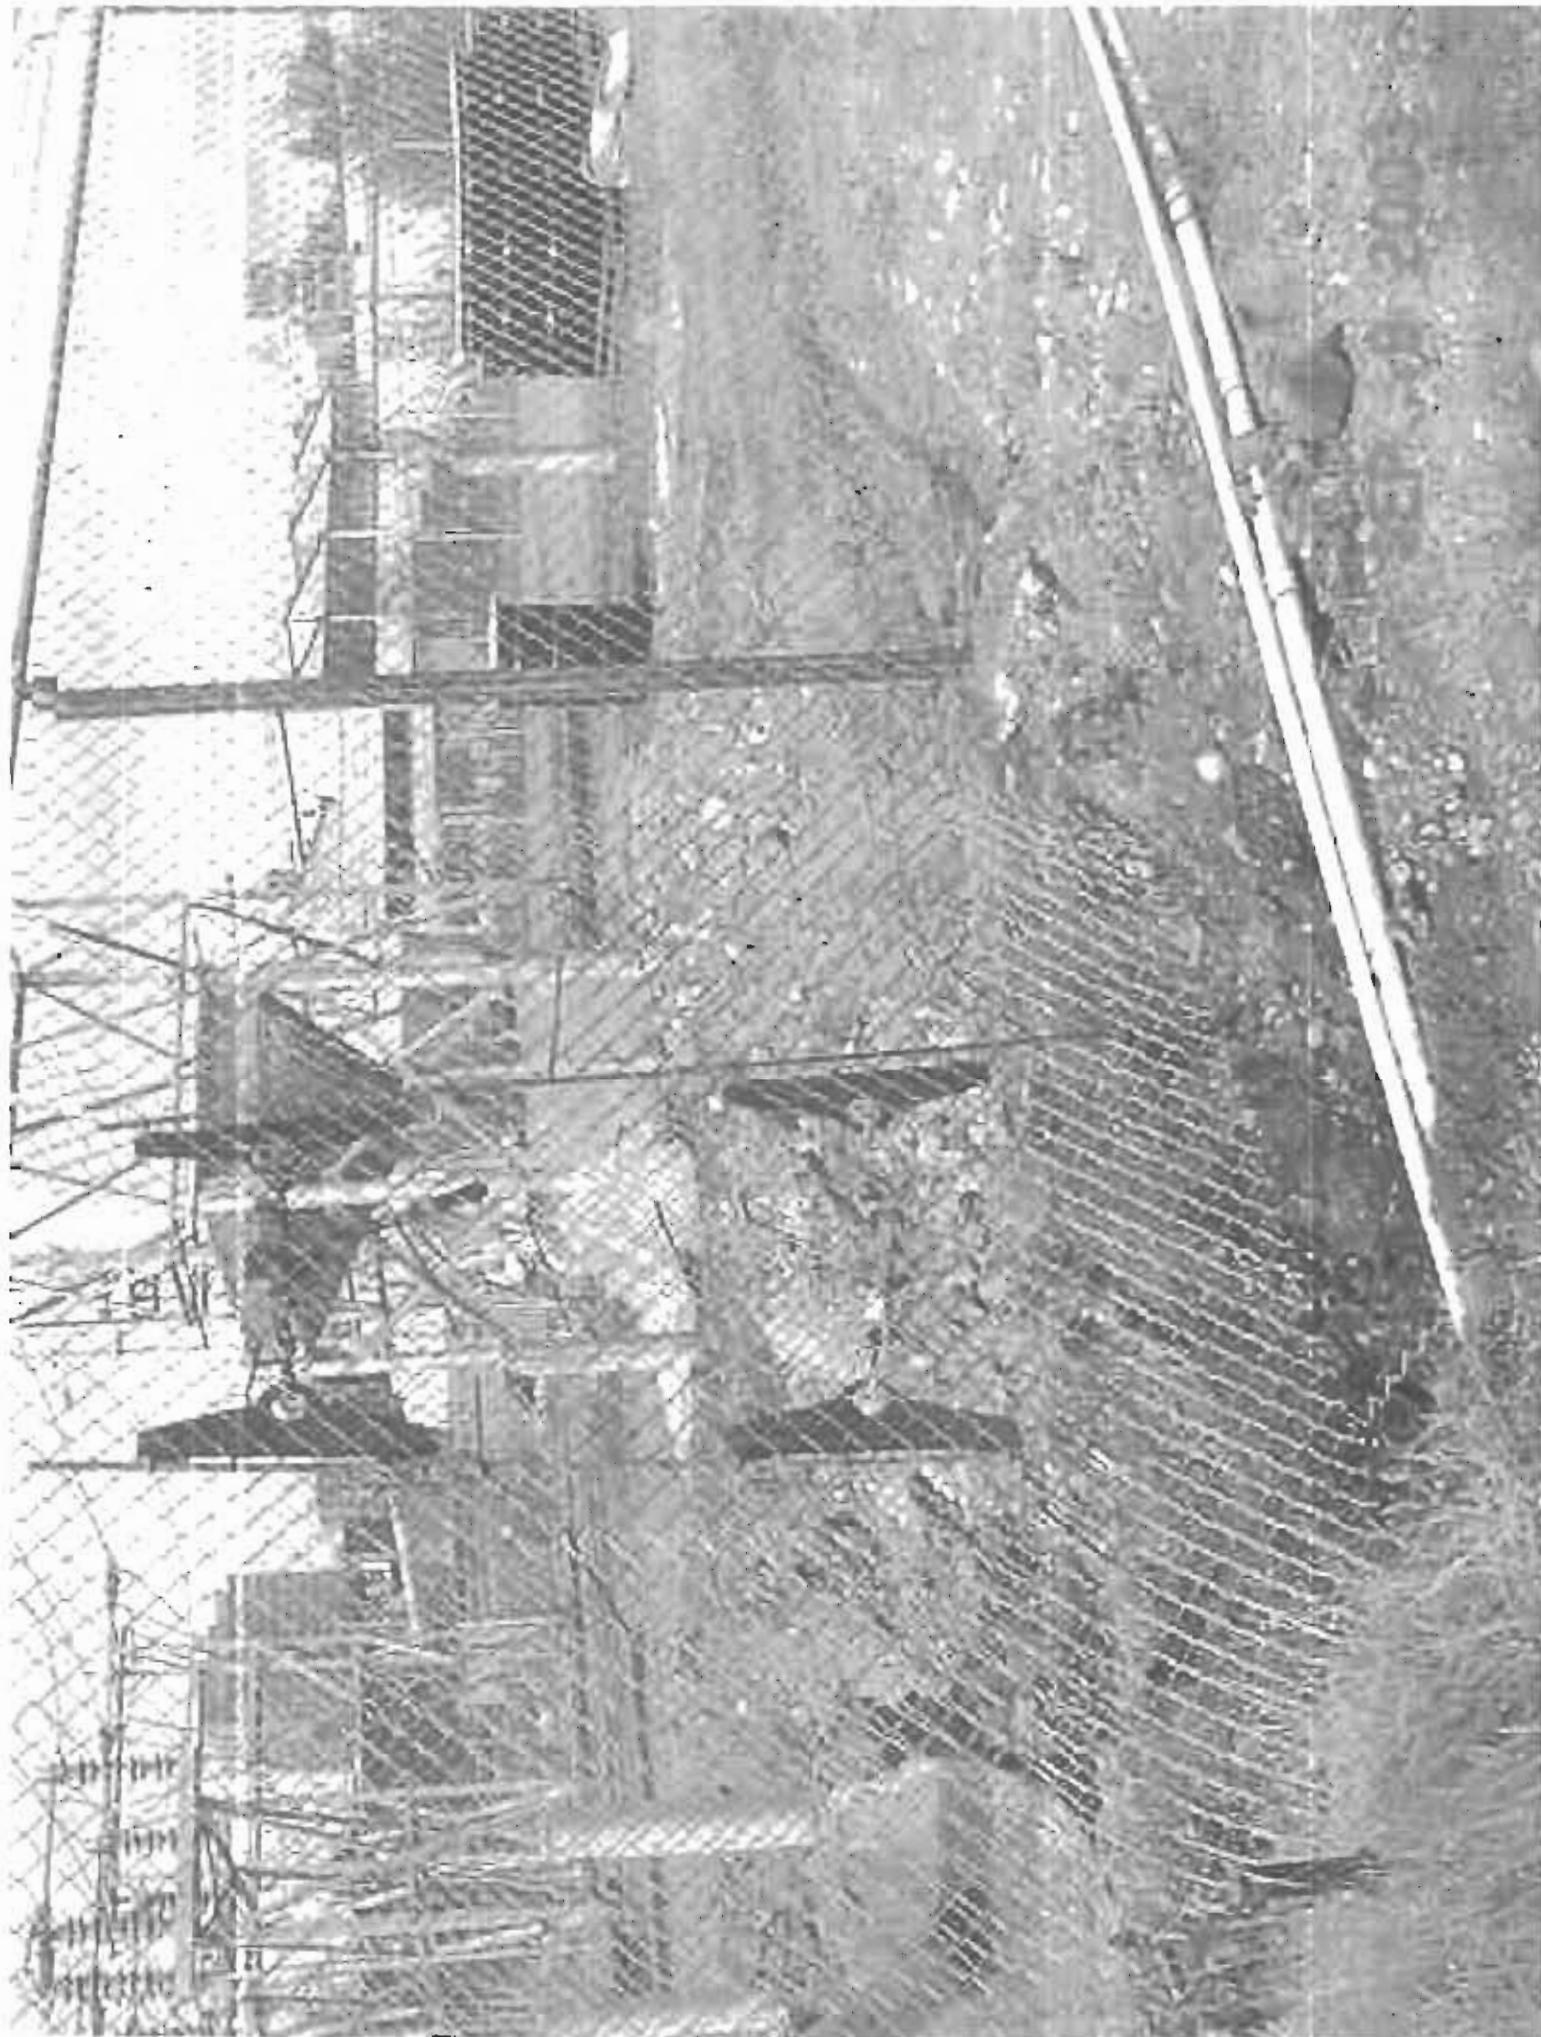
TPU Cleanup Pictures

In August 2003, Tacoma Public Utilities (TPU) performed a small cleanup that involved excavation of the top foot of material approximately 6 feet onto the site (See Appendix B for photos). Confirmation samples were taken post-excavation by TPU to ensure the completeness of the cleanup.
