TAHOMA SALT MARSH

YEAR 1 TO YEAR 3 MONITORING REPORT

City of Tacoma
December 20, 2006

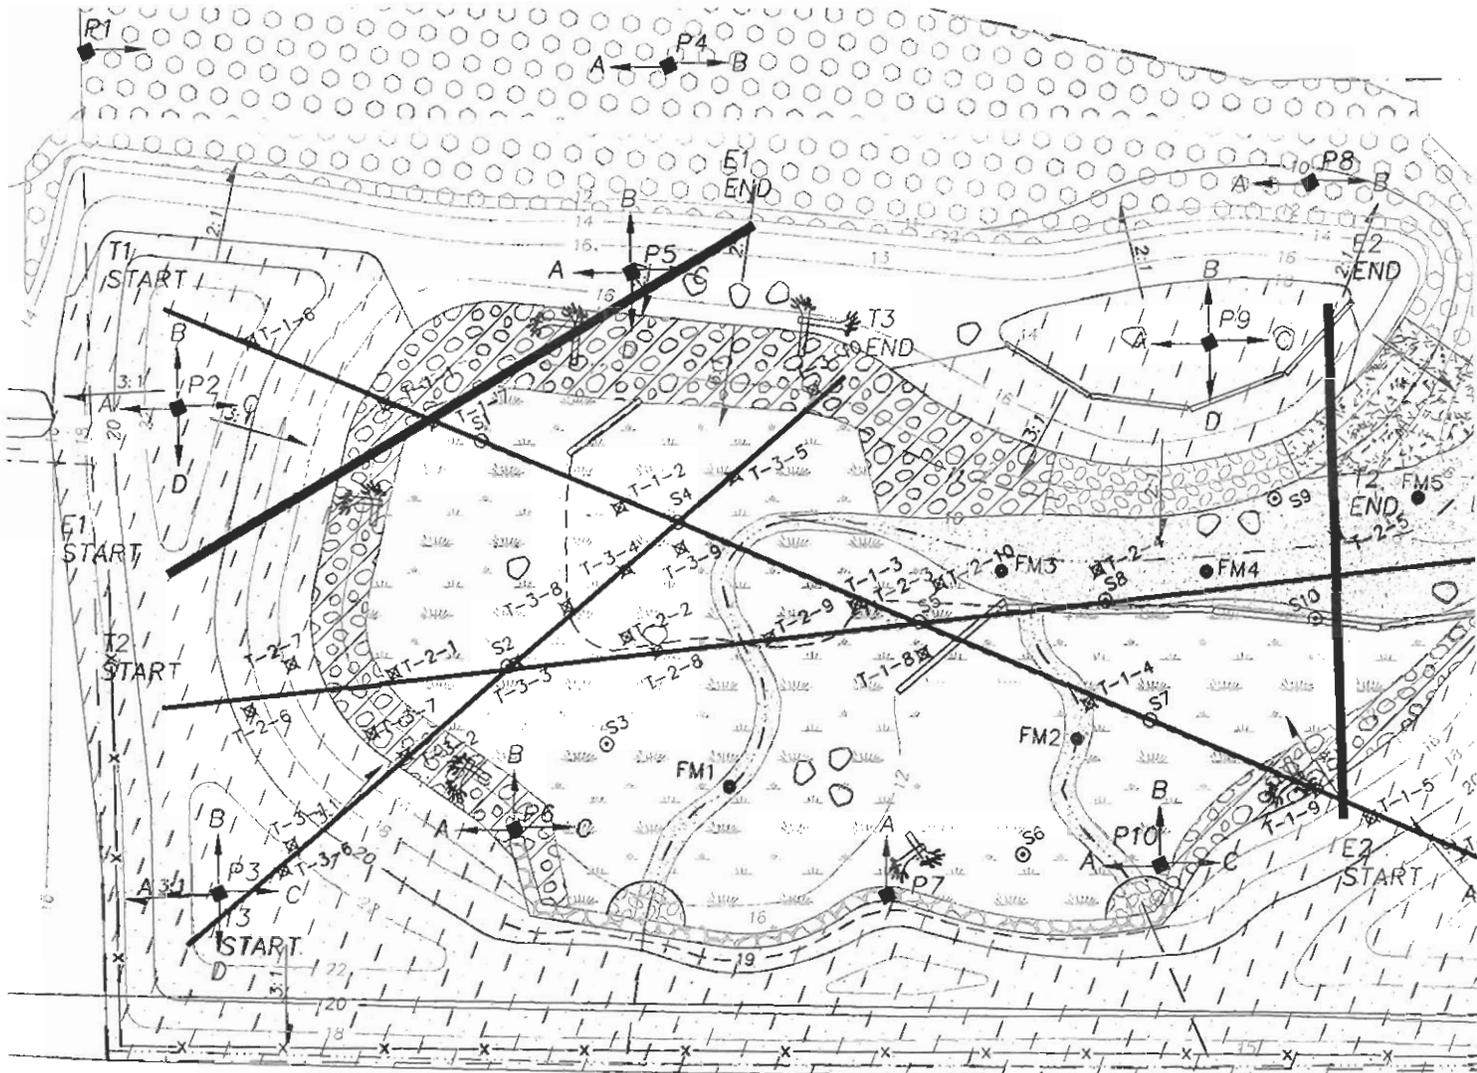
Photo points were established as described in the MAMP and depicted in Figure 2. Year 1 to Year 3 photos are presented in Appendix A. The following general trends were noted:

- Riparian Area: Plant growth and survival was much greater in irrigated areas than in non-irrigated areas.
- Salt Marsh Area: The low salt marsh region appears to be filling in with native vegetation, especially in regions with goose exclusion devices in place (Photo Point 6B). Plant survival in the high salt marsh region is limited.

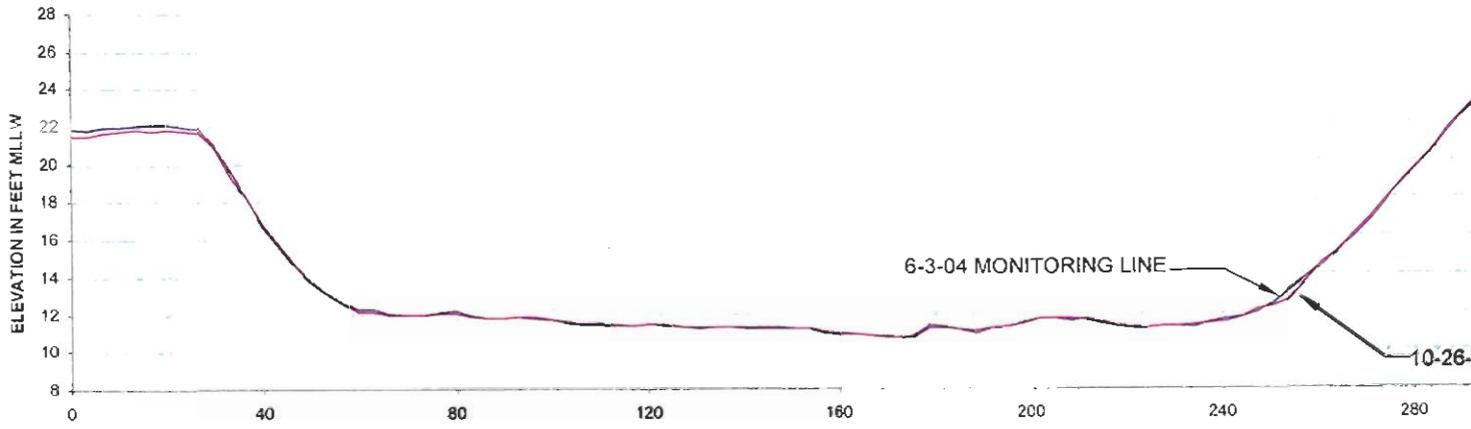
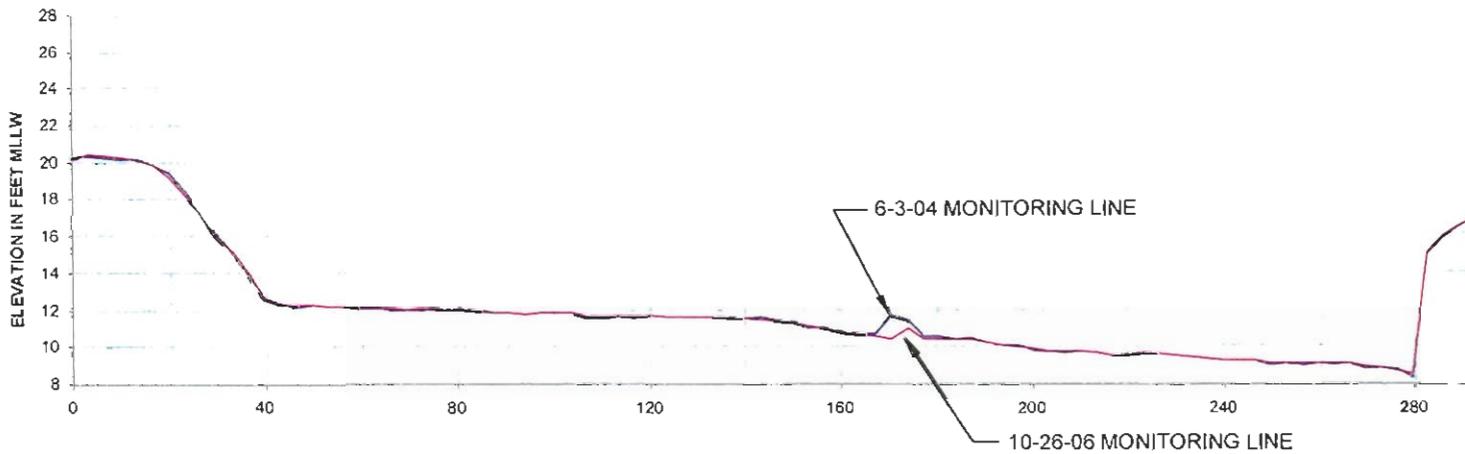
Figure 3 shows only slight changes in riparian area elevations occurred between 2004 and 2006. Sedimentation of approximately 8 inches was observed near the transition to the salt marsh on transect T3 (Table 5). This sedimentation does not appear to threaten the loss of vegetation in the area.

Transect T1 shows erosion slightly exceeding 6 inches near the edge of the salt marsh (Table 5). Based on field observations, this erosion does not appear to be threatening slope stability or vegetation.

Approximately 16 inches of erosion was noted during the 2006 survey in the middle of the salt marsh area on transect T2 (Table 5). Visual observation of this area noted no significant erosion. This location is very close to erosion marker S5, which has shown no change in elevation (Table 6) between 2004 and 2006. Initial measurements of this area may have been inaccurate either due to errors in measurement or due to a temporary high elevation (e.g. rock or log) following construction.

Performance goals for erosion were slightly exceeded in a few locations. These exceedances do not appear to be threatening vegetation or the stability of any slopes. No action to correct these changes is planned at this time; the points will continue to be monitored during visual inspections for conditions that threaten the stability of the slopes or the loss of vegetation.
