OLYMPIC VIEW RESOURCE AREA

**YEAR 1
ANNUAL MONITORING REPORT
2003**

CITY OF TACOMA
April 20, 2004

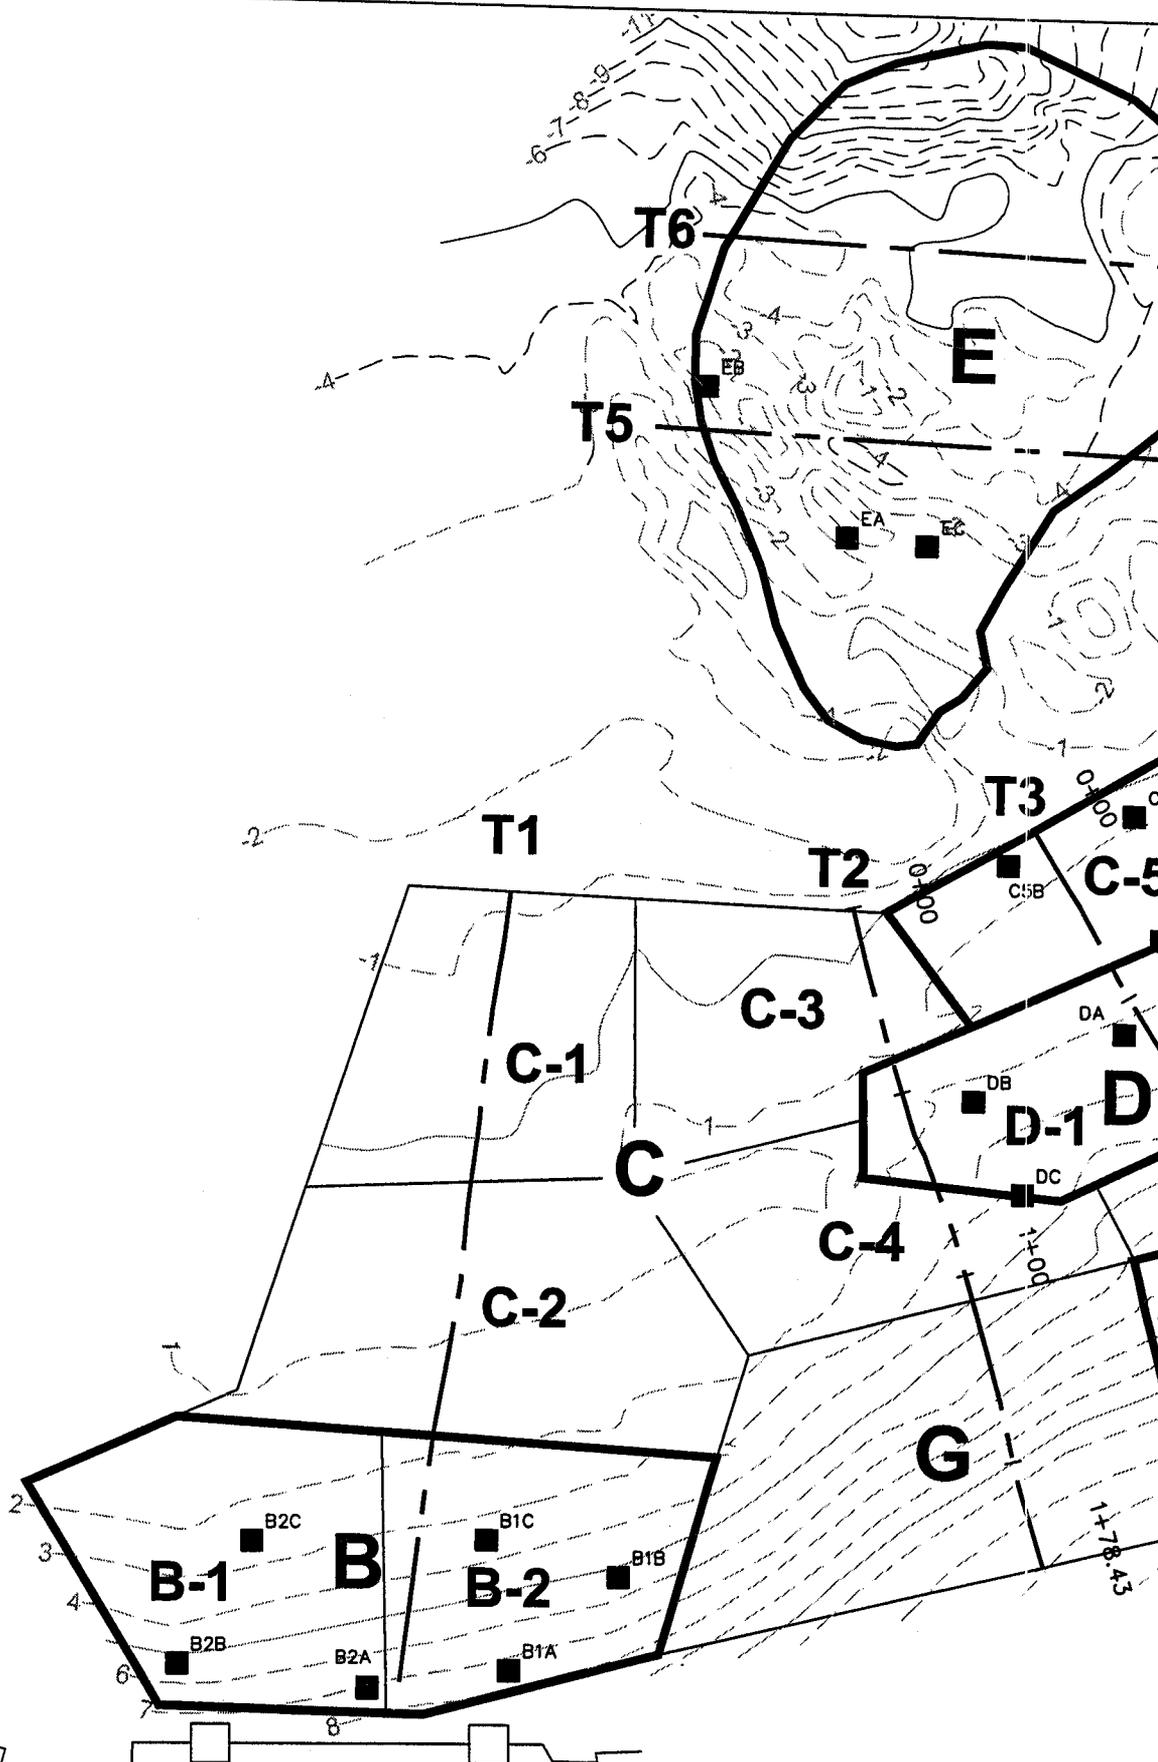
SHEET 1

Manson Construction Company conducted hydrographic survey transects (T5 and T6) over Area E under the direction of KPFF Consulting Engineers in November 2003. The locations of these transects are shown in Appendix A, Sheet 1 of 3 and the data are listed

CAPPED AREAS ARE A, B, C-5, D, AND E

GRAB SAMPLE LOCATION

TRANSECTS

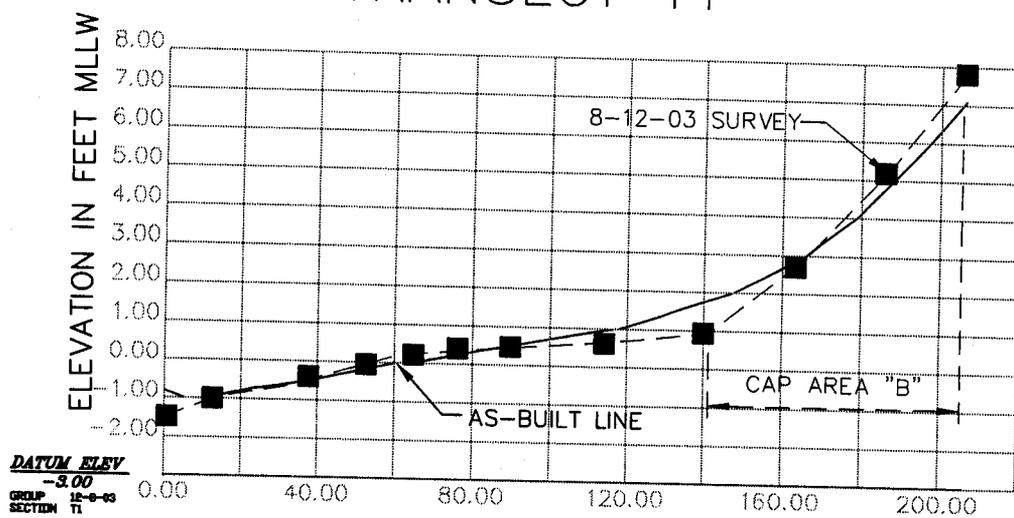
TRANSECT T1

At the northern edge of the Area B (near the boundary with Area C-2) along Transect 1 the surface elevation is lower by greater than 0.5 feet but less than 1.0 feet. The cap thickness in this area remains substantially greater than the 32 inch performance standard. The possible reasons for the change include:

- The as built elevation is based on contoured data that contains interpolations and is essentially an average value, while the monitoring data is a discrete survey point. Therefore, some of the difference may be ascribed to the comparison of a discrete elevation point to an average, contoured elevation. Future conventional survey monitoring events will re-establish the same discrete points for a direct comparison with Year 1 monitoring data.

- There may be some settling of the cap material or the under lying material. This is not likely given the fairly consistent elevations in other areas that received a similar loading of new material.

- There could be some erosion. If this is the case, it would appear to be an isolated occurrence and of limited extent. The visual inspections of this area did not note any evidence of rills, sloughing, or other indications of surface erosion.

Year 1 monitoring results have confirmed the success of the removal action at the OVRA. However, as a result of the exceedance of the early warning values in Transect 1, the City will, at the request of EPA, re-survey this transect in April, 2004 and establish a new transect (Transect 0) approximately 50 feet to the west of Transect 1. This new transect will be monitored in future years, consistent with the schedule for Physical Integrity monitoring set forth in the LMRP.

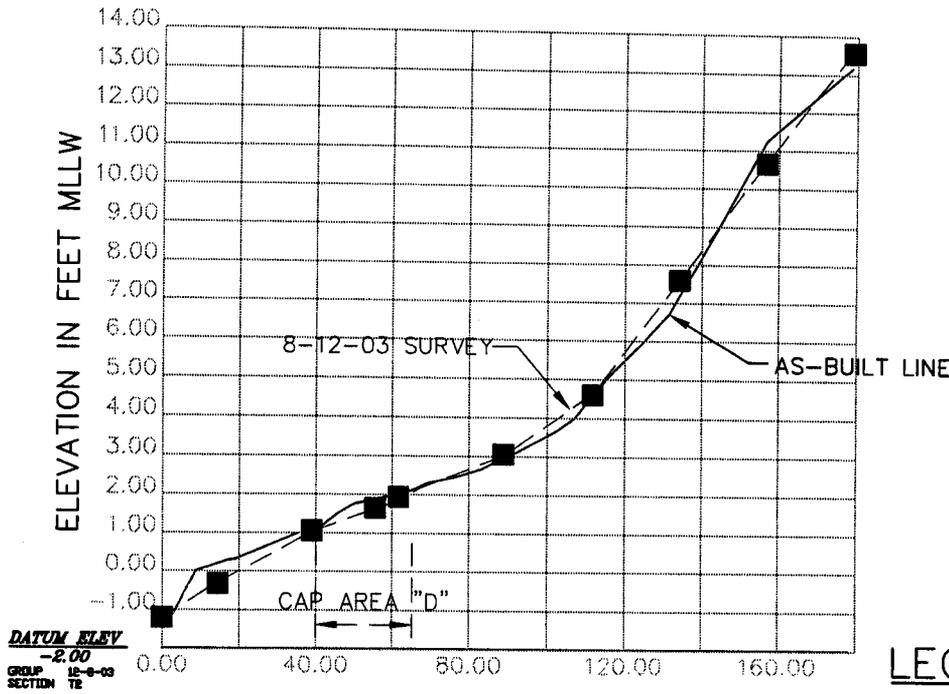
TRANSECT T2

- For Transect 2, the as-built and 2003 survey lines do not appear to be plotted correctly. For example, the as-built elevation of 11.3 ft does not appear to be plotted any differently than the 2003 survey elevation of 10.6 ft. A similar discrepancy is noted for other elevations in Transect 2.

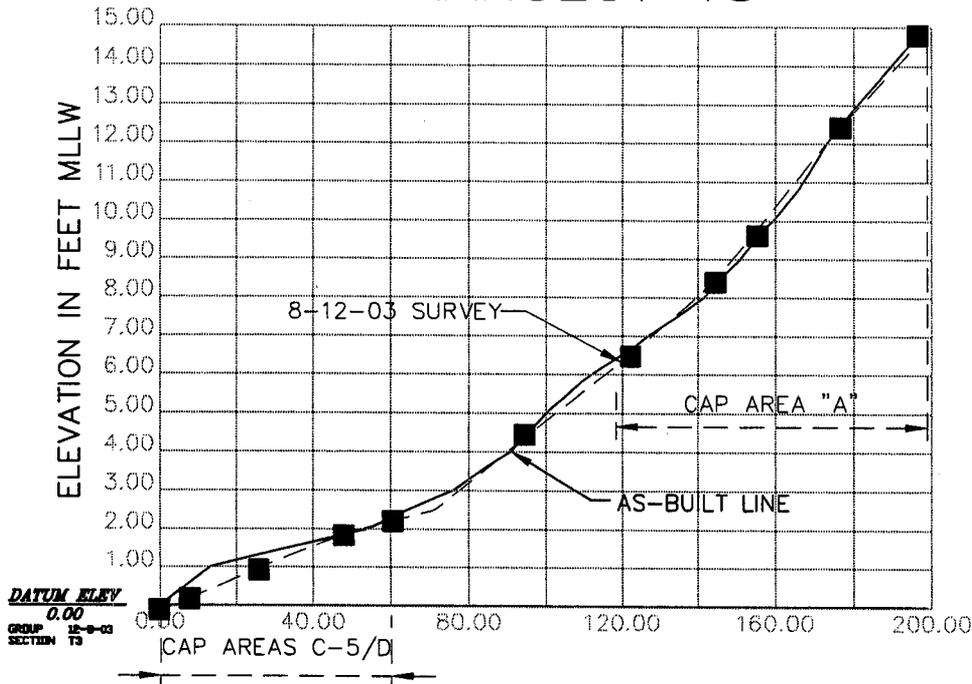
TRANSECT T3

Results of survey transects are presented in Table 1 and graphically depicted in Appendix A Sheets 2 and 3 of 3. Early warning levels are set at a loss of cap material of 0.5 feet between the as-built survey and the monitoring results in Areas A, B, and D and again at a loss of 1 foot of material in these areas. The early warning value is set at the loss of 1 foot of cap material in area E. Early warning levels are not performance standards, but are set at more stringent levels to assess whether performance standards could be exceeded in the future. The performance standards are set at minimum cap thickness in Table 1 of the LMRP. The performance standard is defined as a loss of 0.5 feet in Area C-5.

The survey monitoring results show that there has been no exceedance of the Performance Standards.

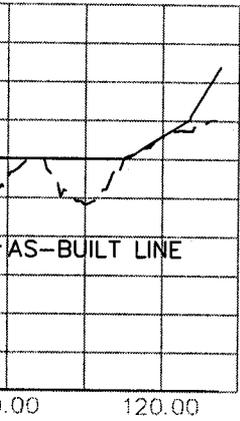
CT T5

In the two transects through Area E (Transects 5 & 6), the thicknesses were determined by overlay of the as-built drawing on top of the pre-existing contours and conducting a point wise comparison, as shown in Table 2. There are a couple of instances where the

mudline is lower by more than 1 foot from the as-built elevation. The cap thickness in these areas remains substantially greater than the performance standard of 33 inches. Cap thickness in these areas ranges from 48 to 60 inches (4 to 6 feet). The possible reasons for the change include:

- These areas have particularly thick caps and there could be some settling of the cap material or the underlying sediments.
- Transect 6 skirts the top of a steep subtidal slope and some of the cap material may have moved down the slope.
- Survey accuracy is +/- 3 feet in the horizontal and +/- 0.25 feet in the vertical.

- On Page 4, please clarify how the as-built cap thicknesses were determined for the two transects in Area E. Also, for Area E, incorporate additional bullets that describe how the accuracy standards of the survey equipment and the accuracy of relocating the exact points on a subtidal transect may also affect the observed changes in elevation.

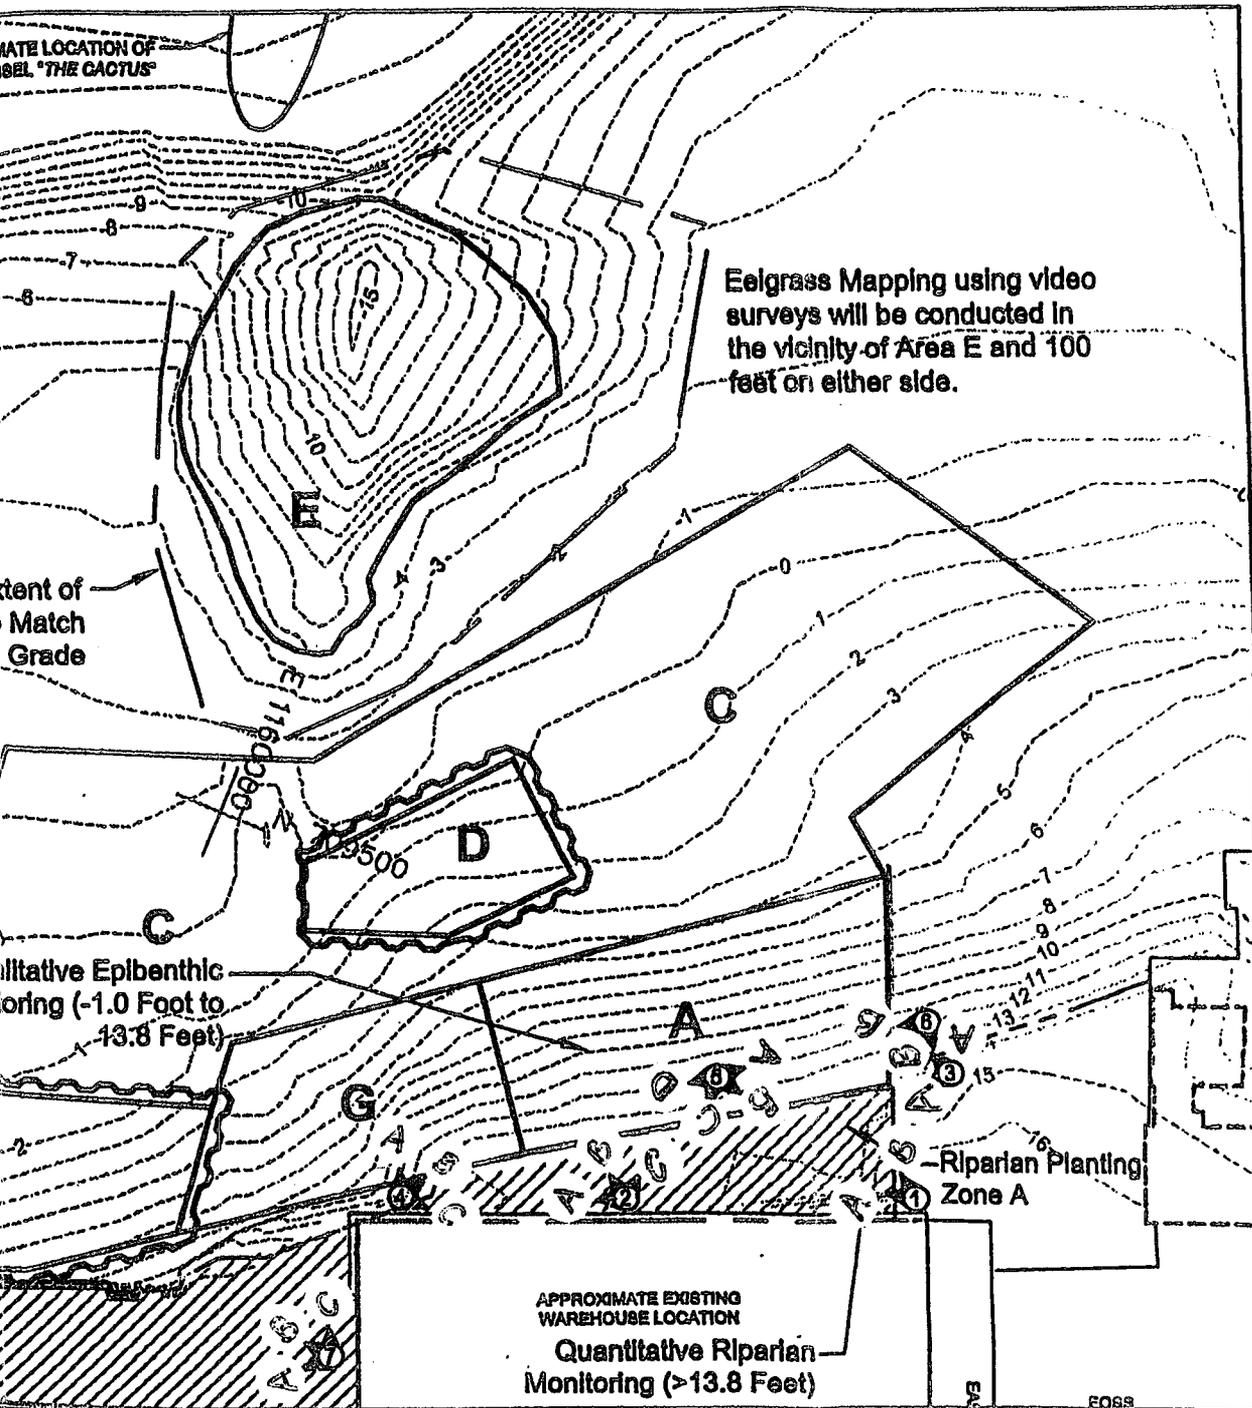
Monitoring Location Plan

Photos were taken from locations noted in attached Figure 1 from the Maintenance, Monitoring and Adaptive Management Plan (MAMP). Title indicates in which direction the photo is looking.

- ① Approximate Photo Point Location and Number
- A Site Area Boundary and Designation
- ▨ Riparian Planting Zones (See Plan Sheet 9)

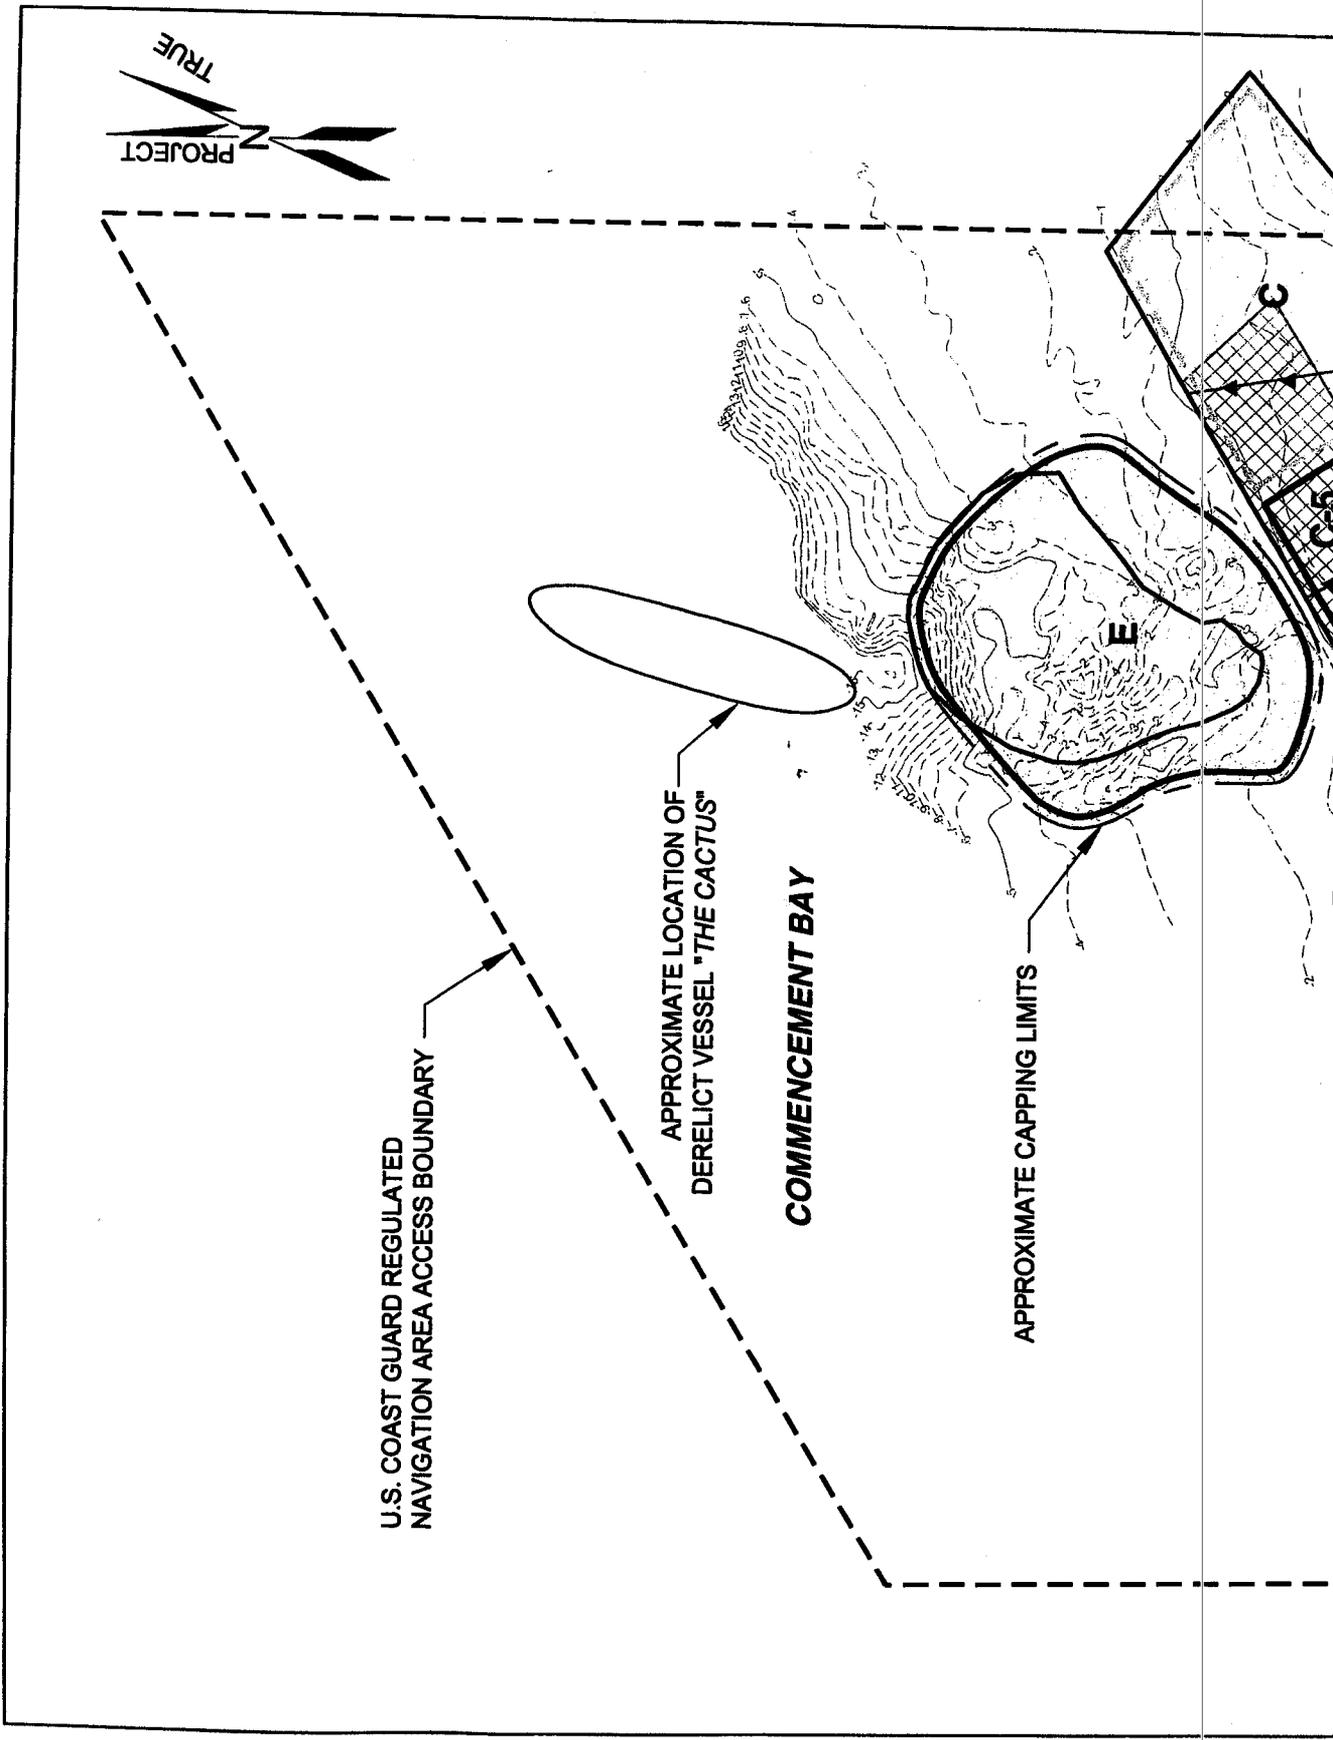
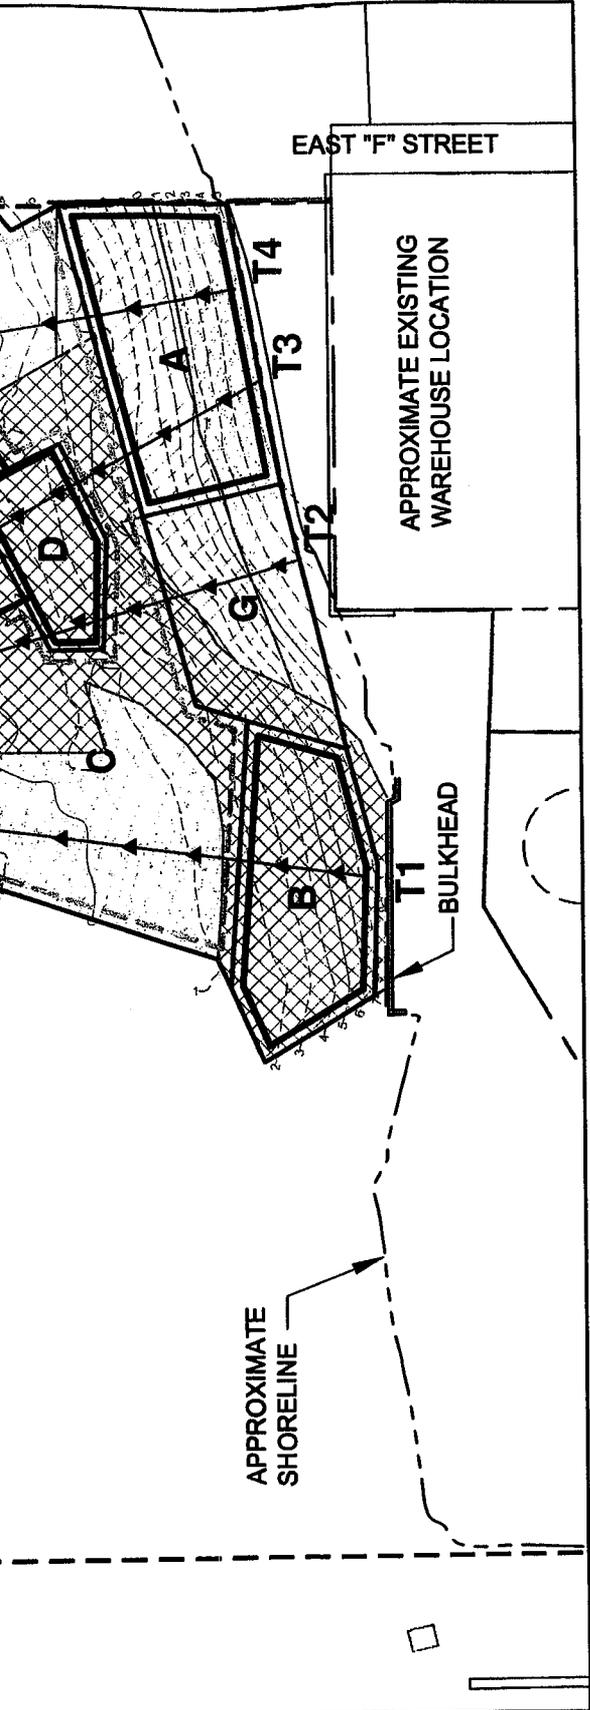
OVRA Site Areas and Survey Monitoring Transects

- UPPER BEACH EROSION PROTECTION-
EROSION PROTECTION MATERIAL B
PLACED OVER SAND MATERIAL
- LOWER BEACH EROSION PROTECTION-
EROSION PROTECTION MATERIAL A
PLACED OVER SAND MATERIAL
- SAND MATERIAL
- POST-CONSTRUCTION ELEVATION
CONTOUR IN FEET (CORPUS DATUM)
- C** OVRA SITE AREA DESIGNATION
- BACKFILLED AREA
- CAPPED AREA
- T1** ——— INTERTIDAL TRANSECT LOCATION AND NUMBER
- ▲ INTERTIDAL SURVEY POINT
