# **City of Tacoma Olympic View Resource Area**

## **Habitat Monitoring Report: Year 1**

**December 2004**

City of Tacoma  
Public Works Department

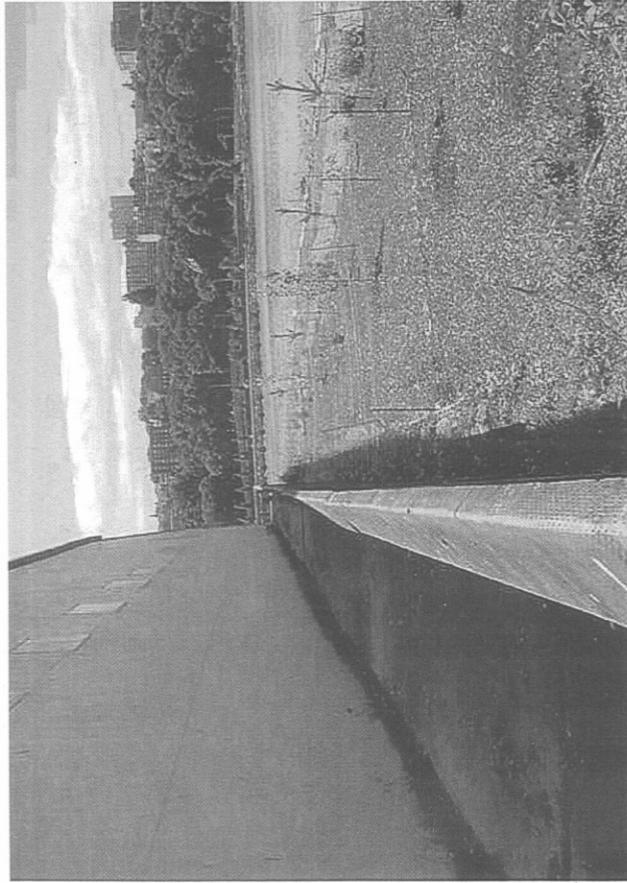
Photo Point P1A

Photos of the riparian areas show the general good health of the plantings. The meager showing of volunteer plants could be attributed to adjacent land use (industrial/commercial) and proximity of parental seed sources.
