POST-RESTORATION AND CLEANUP ACTION REPORT

OLYMPIC VIEW TRIANGLE RESTORATION PROJECT

COMMENCEMENT BAY, WASHINGTON

Prepared by
RIDOLFI Inc.

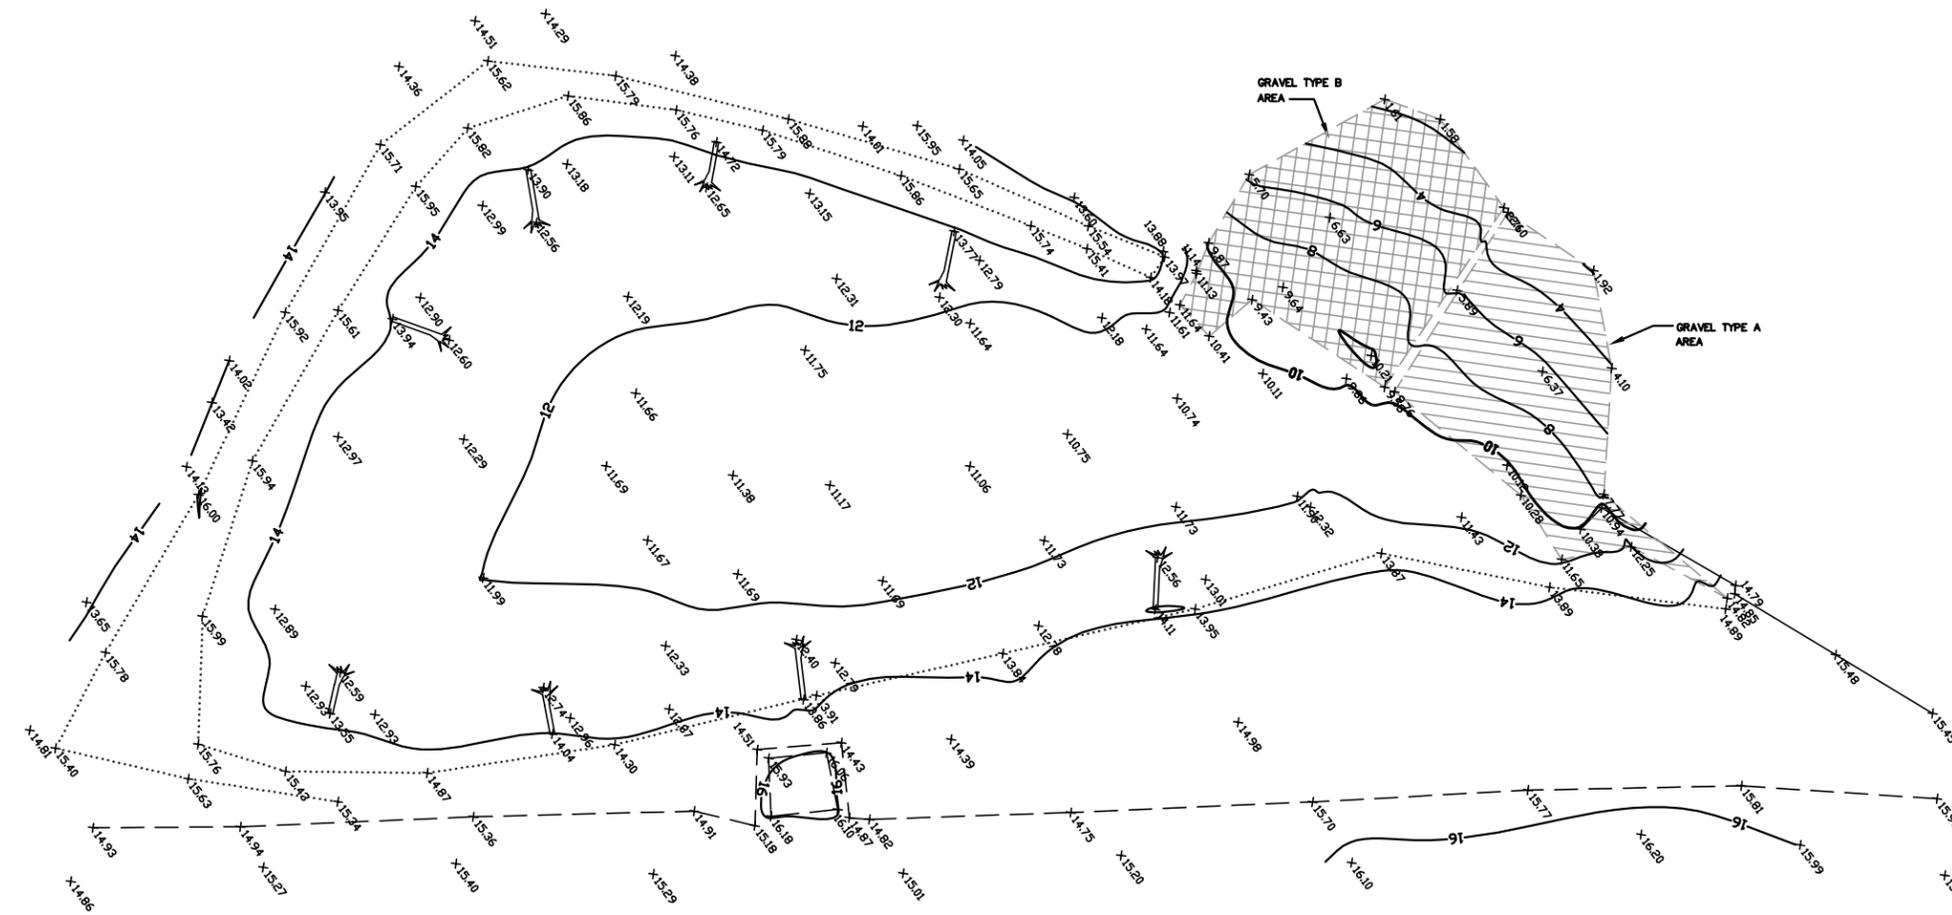
Figure 2

OLYMPIC VIEW TRIANGLE HABITAT RESTORATION PROJECT FINAL CONSTRUCTION SURVEY

Final Construction Survey

Prior to the project, most of the Site was at an elevation of 15 feet above MLLW. The Site is flat and mostly barren, with several grassy areas. Soil at the Site is fill material consisting of silty sand, gravel, and cobbles. A riprap bank and sheet pile retaining wall run along the Site's seaward perimeter, adjacent to the Thea Foss Waterway and Commencement Bay. The Site is approximately triangular in shape and occupies an area of about 1.2 acres (Figure 2).

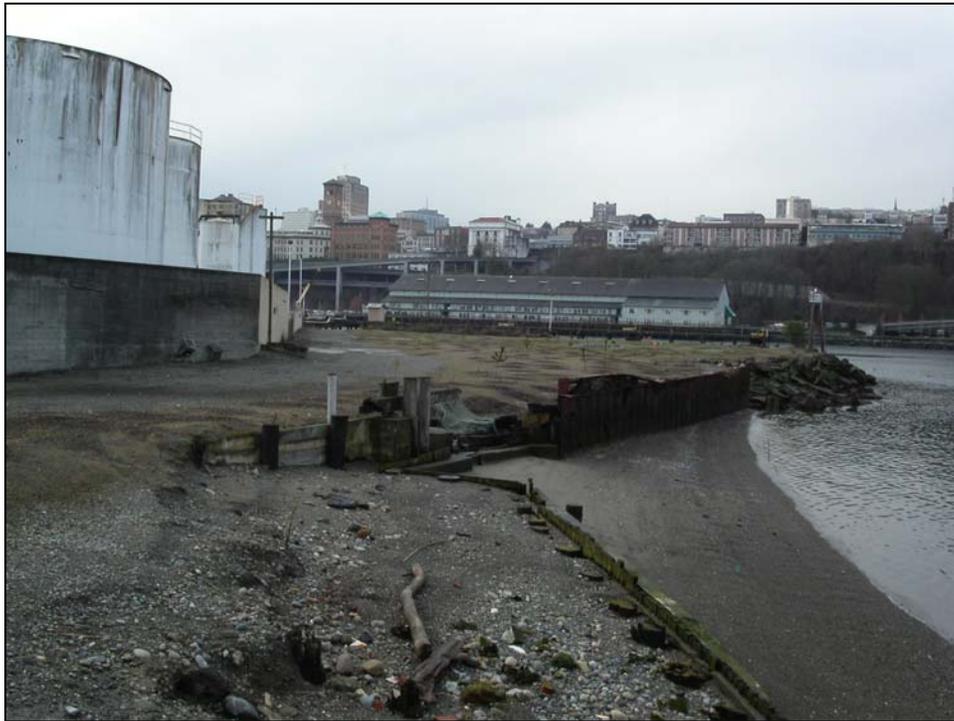
Figure 3. Existing Site Conditions

The Site, which is currently vacant, serves as a breakwater and buffer area to protect the adjacent fuel storage facility. The only structures on the Site are two ground water monitoring wells and the sheet pile retaining wall. Historical uses of the Site appear to have been limited to

the staging of logs and storage of milled timber. Figure 3 illustrates the conditions at the Site prior to the project.

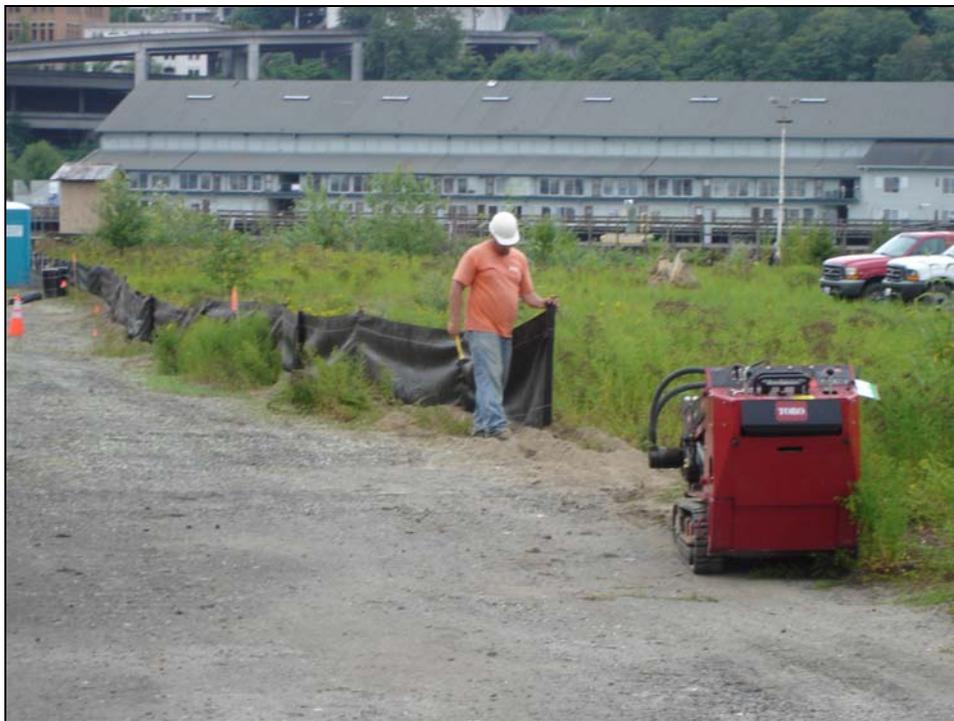
Figure 4. Setting Up Erosion Control Fencing to Protect Adjacent Waterbodies

- Silt fencing along the back perimeter of the Site (Figures 4);
- Floating silt curtains across the entrance of the Site (Figure 5);
- A rock driveway at the Site entrance; and
- Bank protection: geotextile fabric and Geoweb material backfilled with crushed rock and quarry spalls along the outside perimeter of the Site (Figure 6).

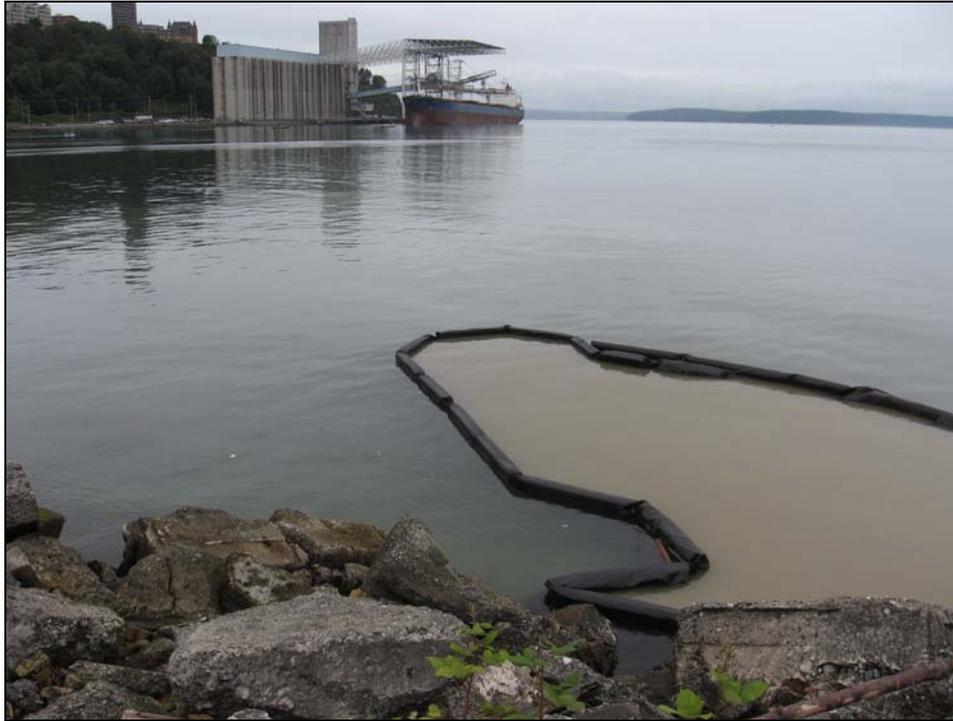
Figure 5. Floating Silt Curtain to Prevent Sedimentation of Commencement Bay

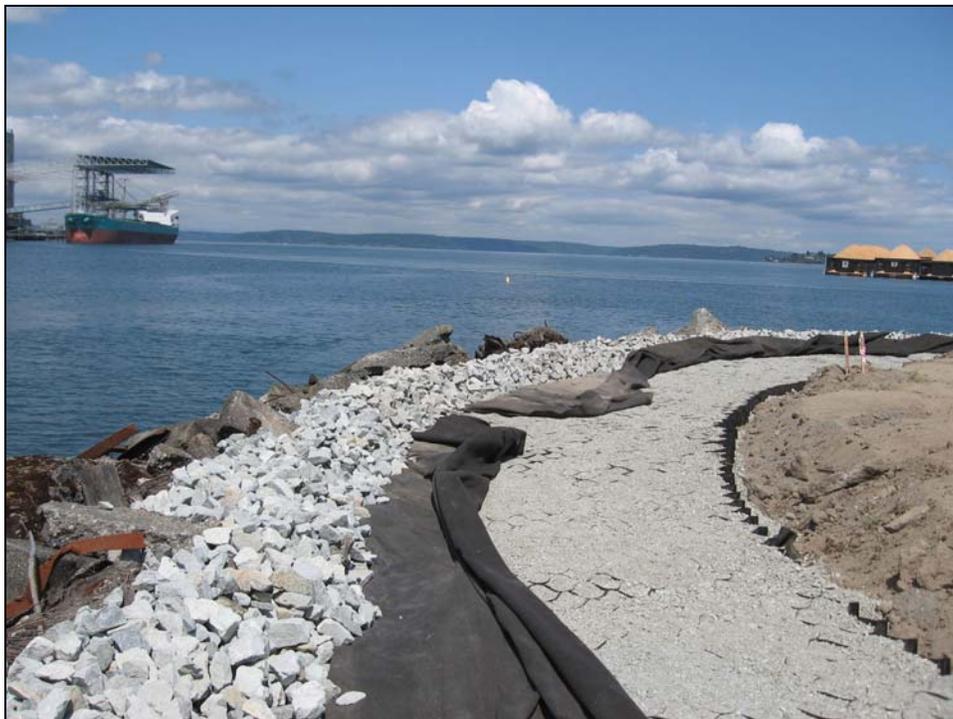
Figure 6. Bank Protection with Geotextile Fabric and Geoweb Material

A bank protection system was installed along the western corner of the Site on top of the existing rip rap bank, bordering the Thea Foss Waterway and Commencement Bay. The system consists of geotextile and Geoweb cell materials backfilled with gravel and bordered with quarry spalls. It is intended to provide bank protection and permanent erosion control for the Site (Figure 6). Topsoil was placed on top of the bank protection system to create the riparian habitat (Figure 9).

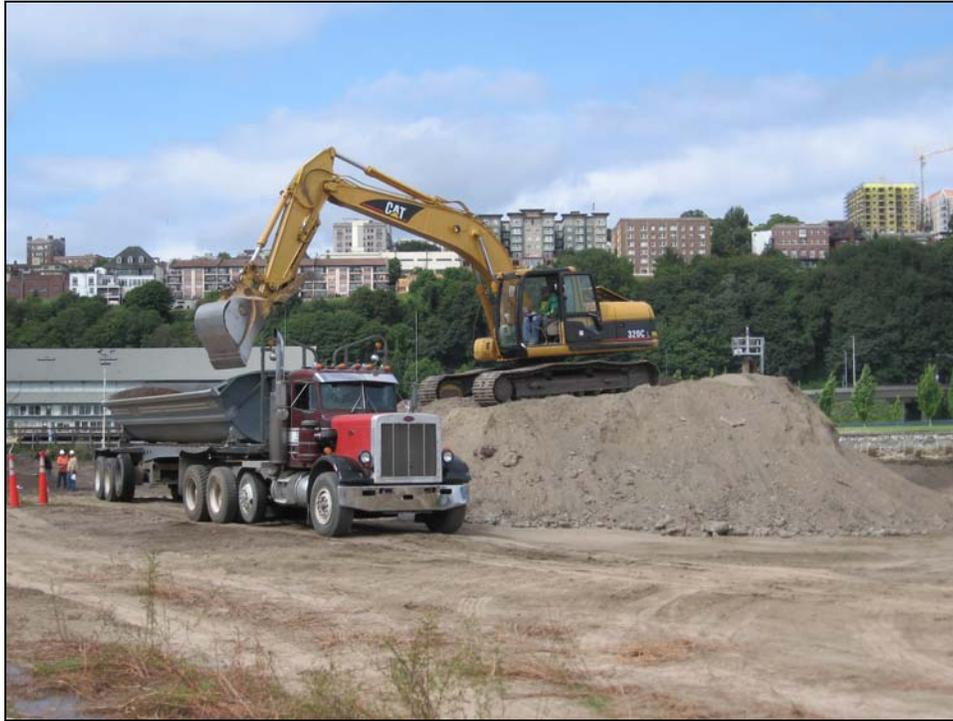
Figure 7. Stockpiles of Waste Materials and Waste Hauling Truck

Excavation began near the south corner of the Site along the Thea Foss Waterway and proceeded towards the north corner of the Site (south to north). Excavation was performed with trackhoes, and the materials were loaded directly from the stockpiles into dump trucks for transport the waste facility (Figure 7). Subsequently, 7,194 tons of materials were excavated to remove arsenic-contaminated soil and achieve design elevations. The materials included sand and gravel that had been placed at the ground surface and fill material consisting of arsenic-contaminated soil, concrete rubble, demolition wastes, bricks, scrap metal, and slag material. Approximately, 340 tons of concrete slabs and blocks were removed from the Site and rip rap bank. These materials were sorted and placed in onsite stockpiles. All materials were hauled offsite and legally disposed of. The arsenic-contaminated soil was hauled offsite to LRI's Landfill in Graham, Washington, a waste facility licensed to accept contaminated materials. All other waste

materials, including concrete, steel, vegetation, and general waste, were hauled offsite to a recycling facility or a municipal landfill.

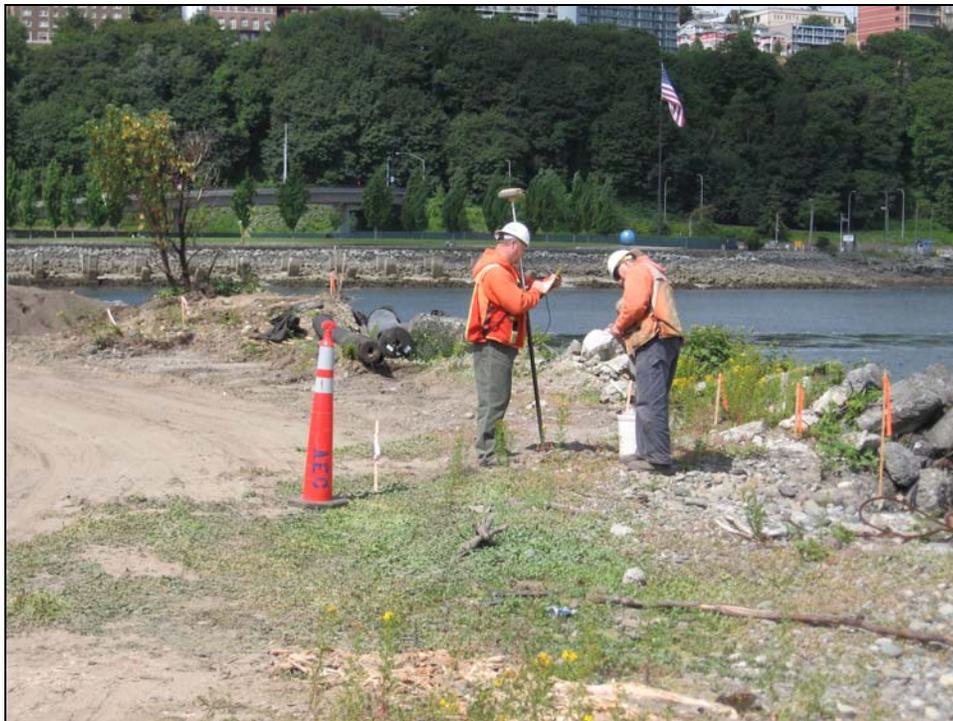
Figure 8. Survey Crew Planning Site Layout Staking

During construction, grade control was maintained using a laser level and construction staking. A survey crew, staffed by Baseline Engineering, Inc. (Baseline) working under contract to AEC, placed stakes indicating the required final grade and cut or fill prior to the initiation of earthwork (Figures 8). AEC's field personnel used the stakes for control and checked elevations provided in the construction plans to verify that the subgrade elevation had been achieved. The subgrade elevation was established to allow placement of materials (topsoil, bank protection systems, or marsh entrance rock) at the final design elevation; these materials were placed with a trackhoe and bull dozer (Figure 9).

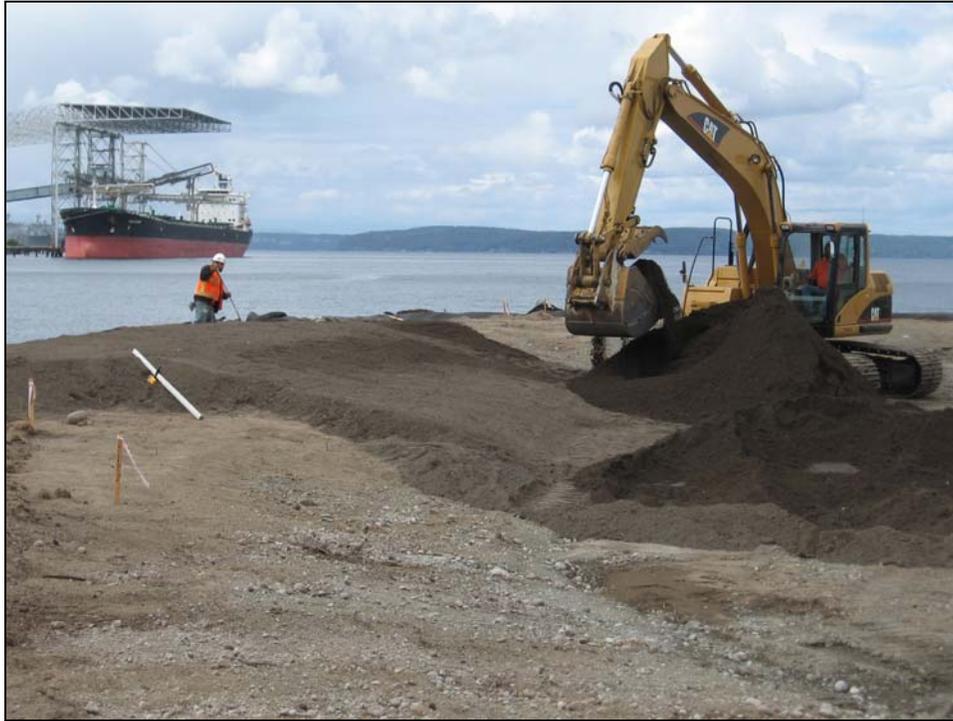
Figure 9. Placing Topsoil Using a Trackhoe

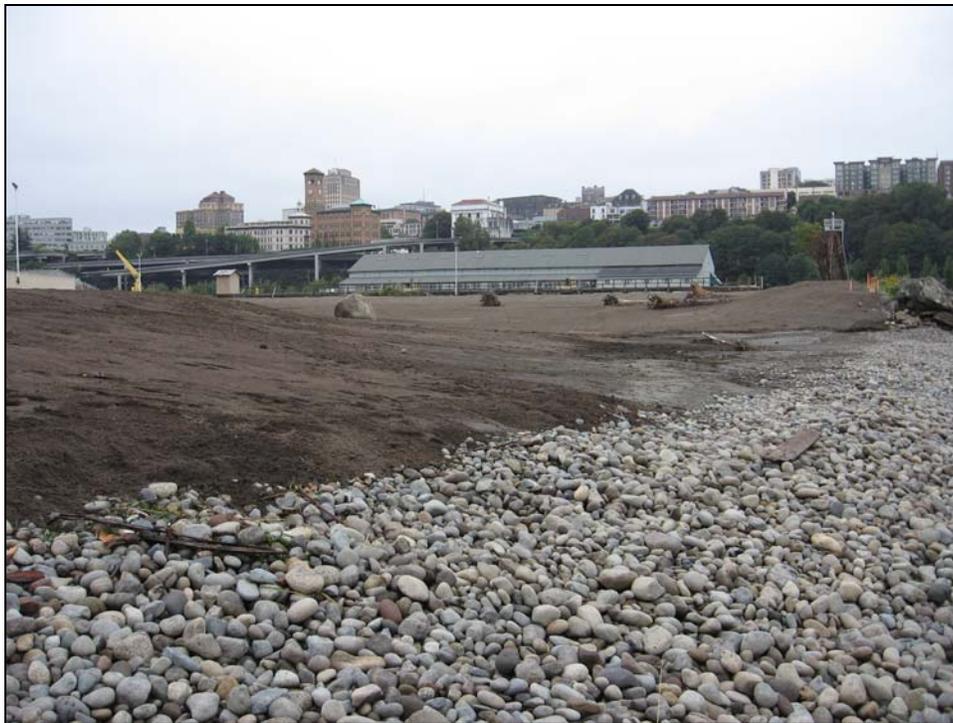
Figure 10. Final Site Features

A shallow embayment opening to Commencement Bay was constructed in the central portion of the Site at elevations intended to support salt marsh vegetation. An opening was constructed on the bayside of the embayment to allow tidal waters from Commencement Bay to enter and subsequently drain from the Site. A berm was constructed around the perimeter of the embayment at elevations intended to support riparian vegetation (Figure 10).

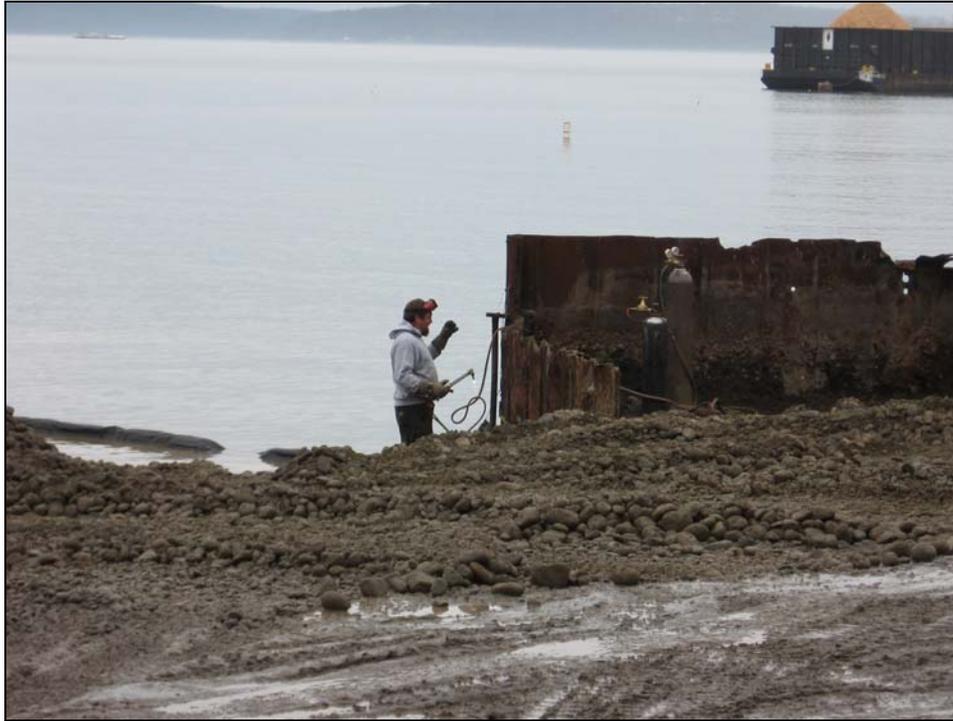
Figure 11. Sheet Pile Wall Being Cut with Acetylene Torch

The upper corner of the sheet pile retaining wall adjacent to the embayment was cut with an acetylene torch so that it would blend with the existing beach profile and transition into the newly created opening for the salt marsh (Figure 11). A portion of the sheet pile retaining wall remains in place, providing bank protection and permanent erosion control for the northern corner of the Site (Figure 3). The area behind the remaining wall was brought to grade with clean fill. An approximately 3 foot swath of rock mix was placed along the edge of the sheet pile

retaining wall and blended into the adjacent marsh opening. The rock swath or border is intended to provide erosion control and protection from wave action. The remaining area was covered with topsoil and will be planted with riparian vegetation.

- This is the final walk through. Everything looks great. Colin had Rod (AEC) wrap some Gravel A and Gravel B around the toe of the berm to blend it into the beach area and help protect the area from potential erosion. The sheet pile wall is out. It took 20 hrs to cut the wall due to the thickness and condition of the wall.

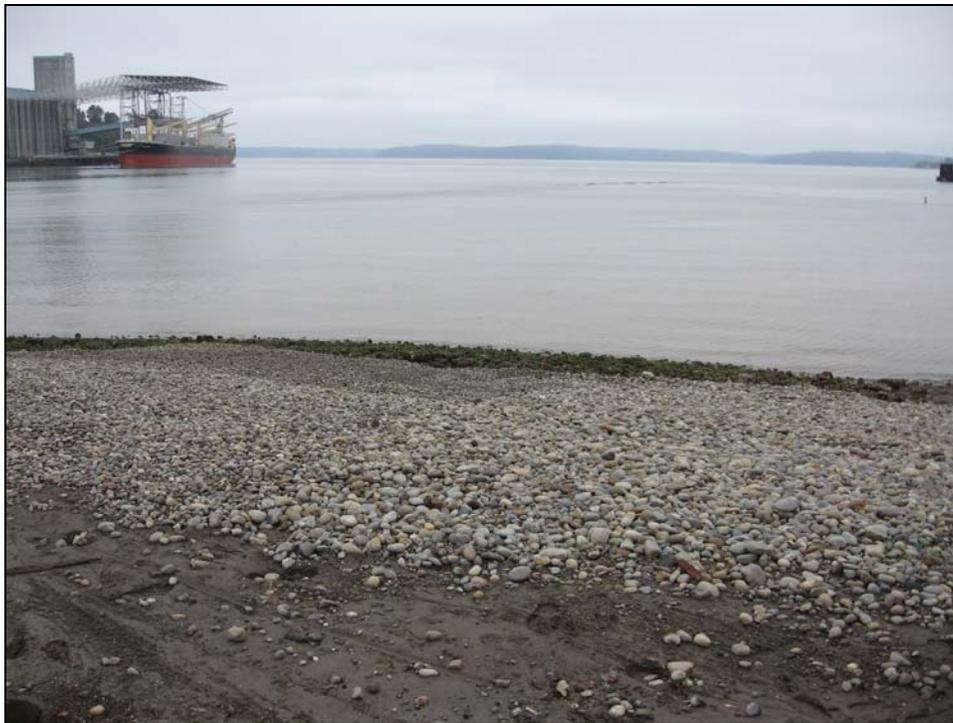
Figure 12. Marsh Opening Gravel Mixes

To fulfill the recommendations of the memorandum, two gravel mixes were placed at the entrance of the marsh, with the larger of the two mixes closer to the OVRA site. The gravel mixes were brought to a grade that matched the existing OVRA beach profile (Figure 12). The design is intended to minimize impacts to the adjacent sediment cap at the OVRA site as well as protect the existing embankment and adjacent fuel storage facility from erosion. Additionally, the gravel mixes will provide foraging habitat for salmonids and forage fish.

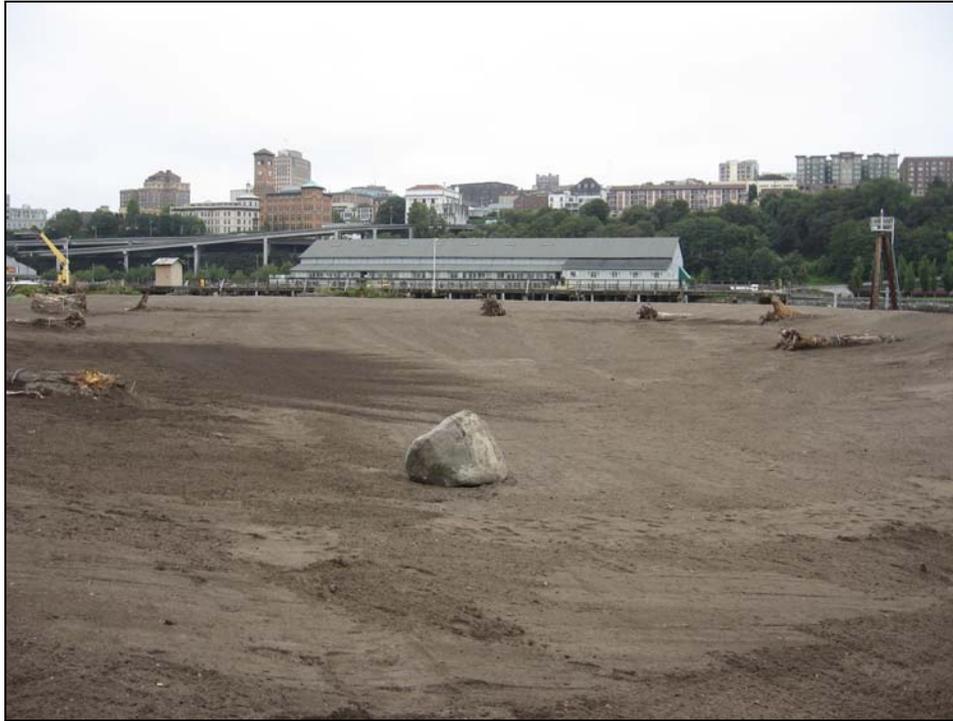
Figure 13. Large Woody Debris

Eight large stumps or LWD, were installed along the transition between the riparian berm and upper salt marsh. The purpose of these features is to provide habitat complexity and possible

refuge for juvenile salmonids that migrate through the area. Additionally, LWD provides habitat for insects; a critical food source for juvenile salmonids. The LWD was generally installed with the trunk end of the stump buried in the slope of the marsh and the root ball sitting at the edge of the marsh (Figure 13).

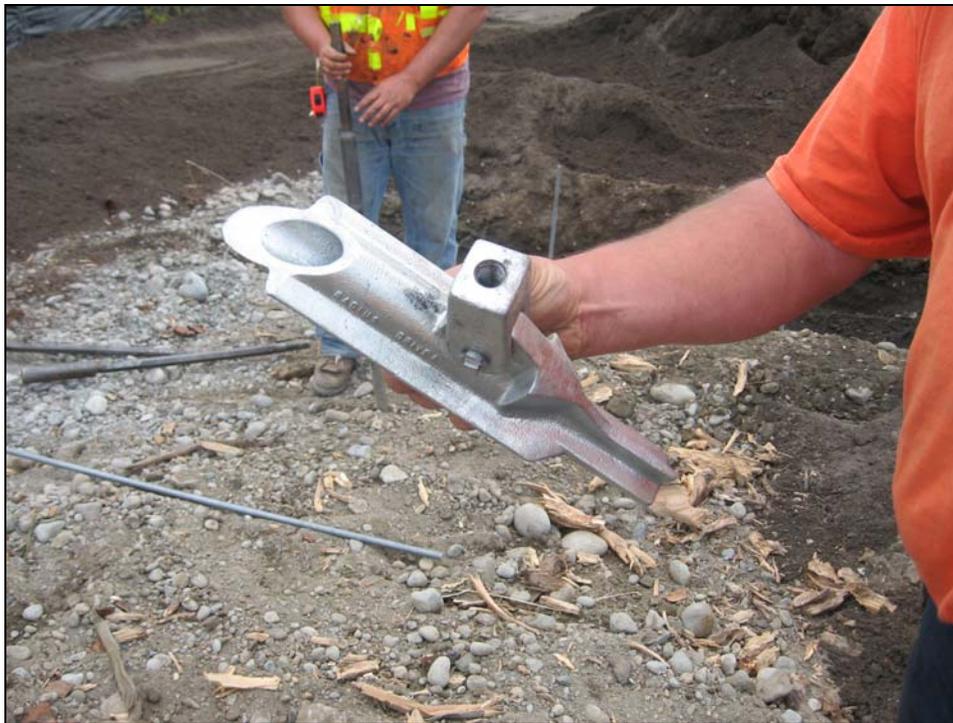
Figure 14. Manta Ray Mechanical Anchors for Large Woody Debris

Each piece of LWD was anchored with two Manta RayTM mechanical anchors; one placed on each side of the LWD (Figure 14). A long threaded bolt was attached to each anchor. The anchors were then driven into the ground using a hydraulically operated percussion hammer. The anchors were driven 6 to 12 feet below ground surface (bgs) and retracted to engage the folding arms of the anchor, much like drywall toggle bolts. The trackhoe bucket was used to pull up on the anchor so that it retracted. The remaining lengths of the threaded bolts were cut to just above ground surface and an eyebolt was screwed on the top of each bolt, so that it sat flush with the ground surface. A chain was then threaded through one eyebolt, wrapped over the top of the LWD, and threaded through the second eyebolt. The chain was cinched tight with the force of the trackhoe bucket before being connected with a shackle (Figure 15).

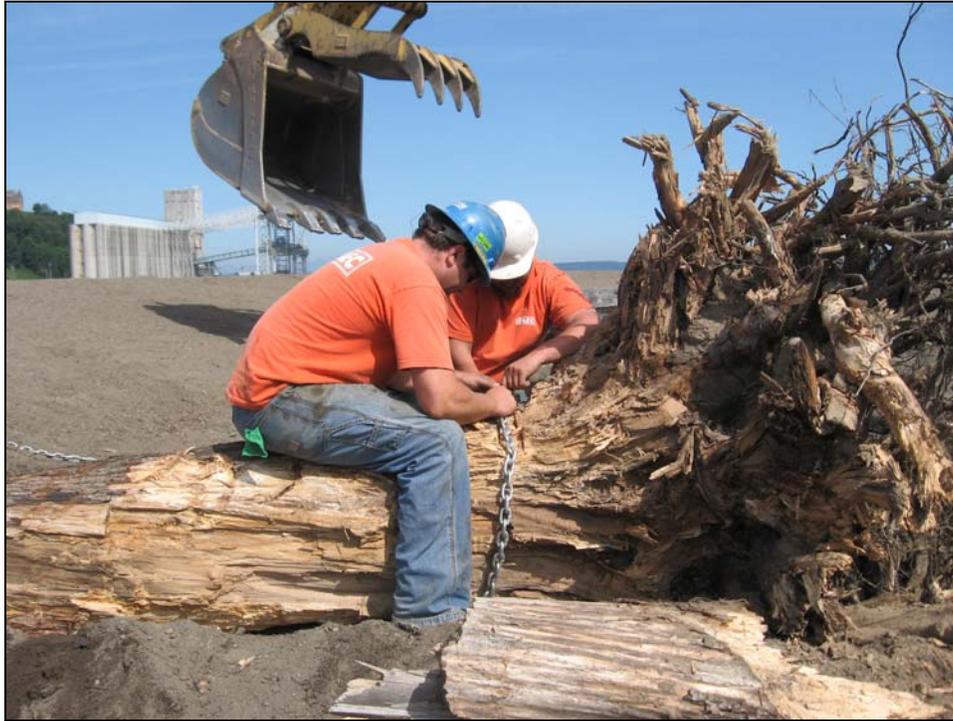
Figure 15. Chaining and Anchoring Large Woody Debris

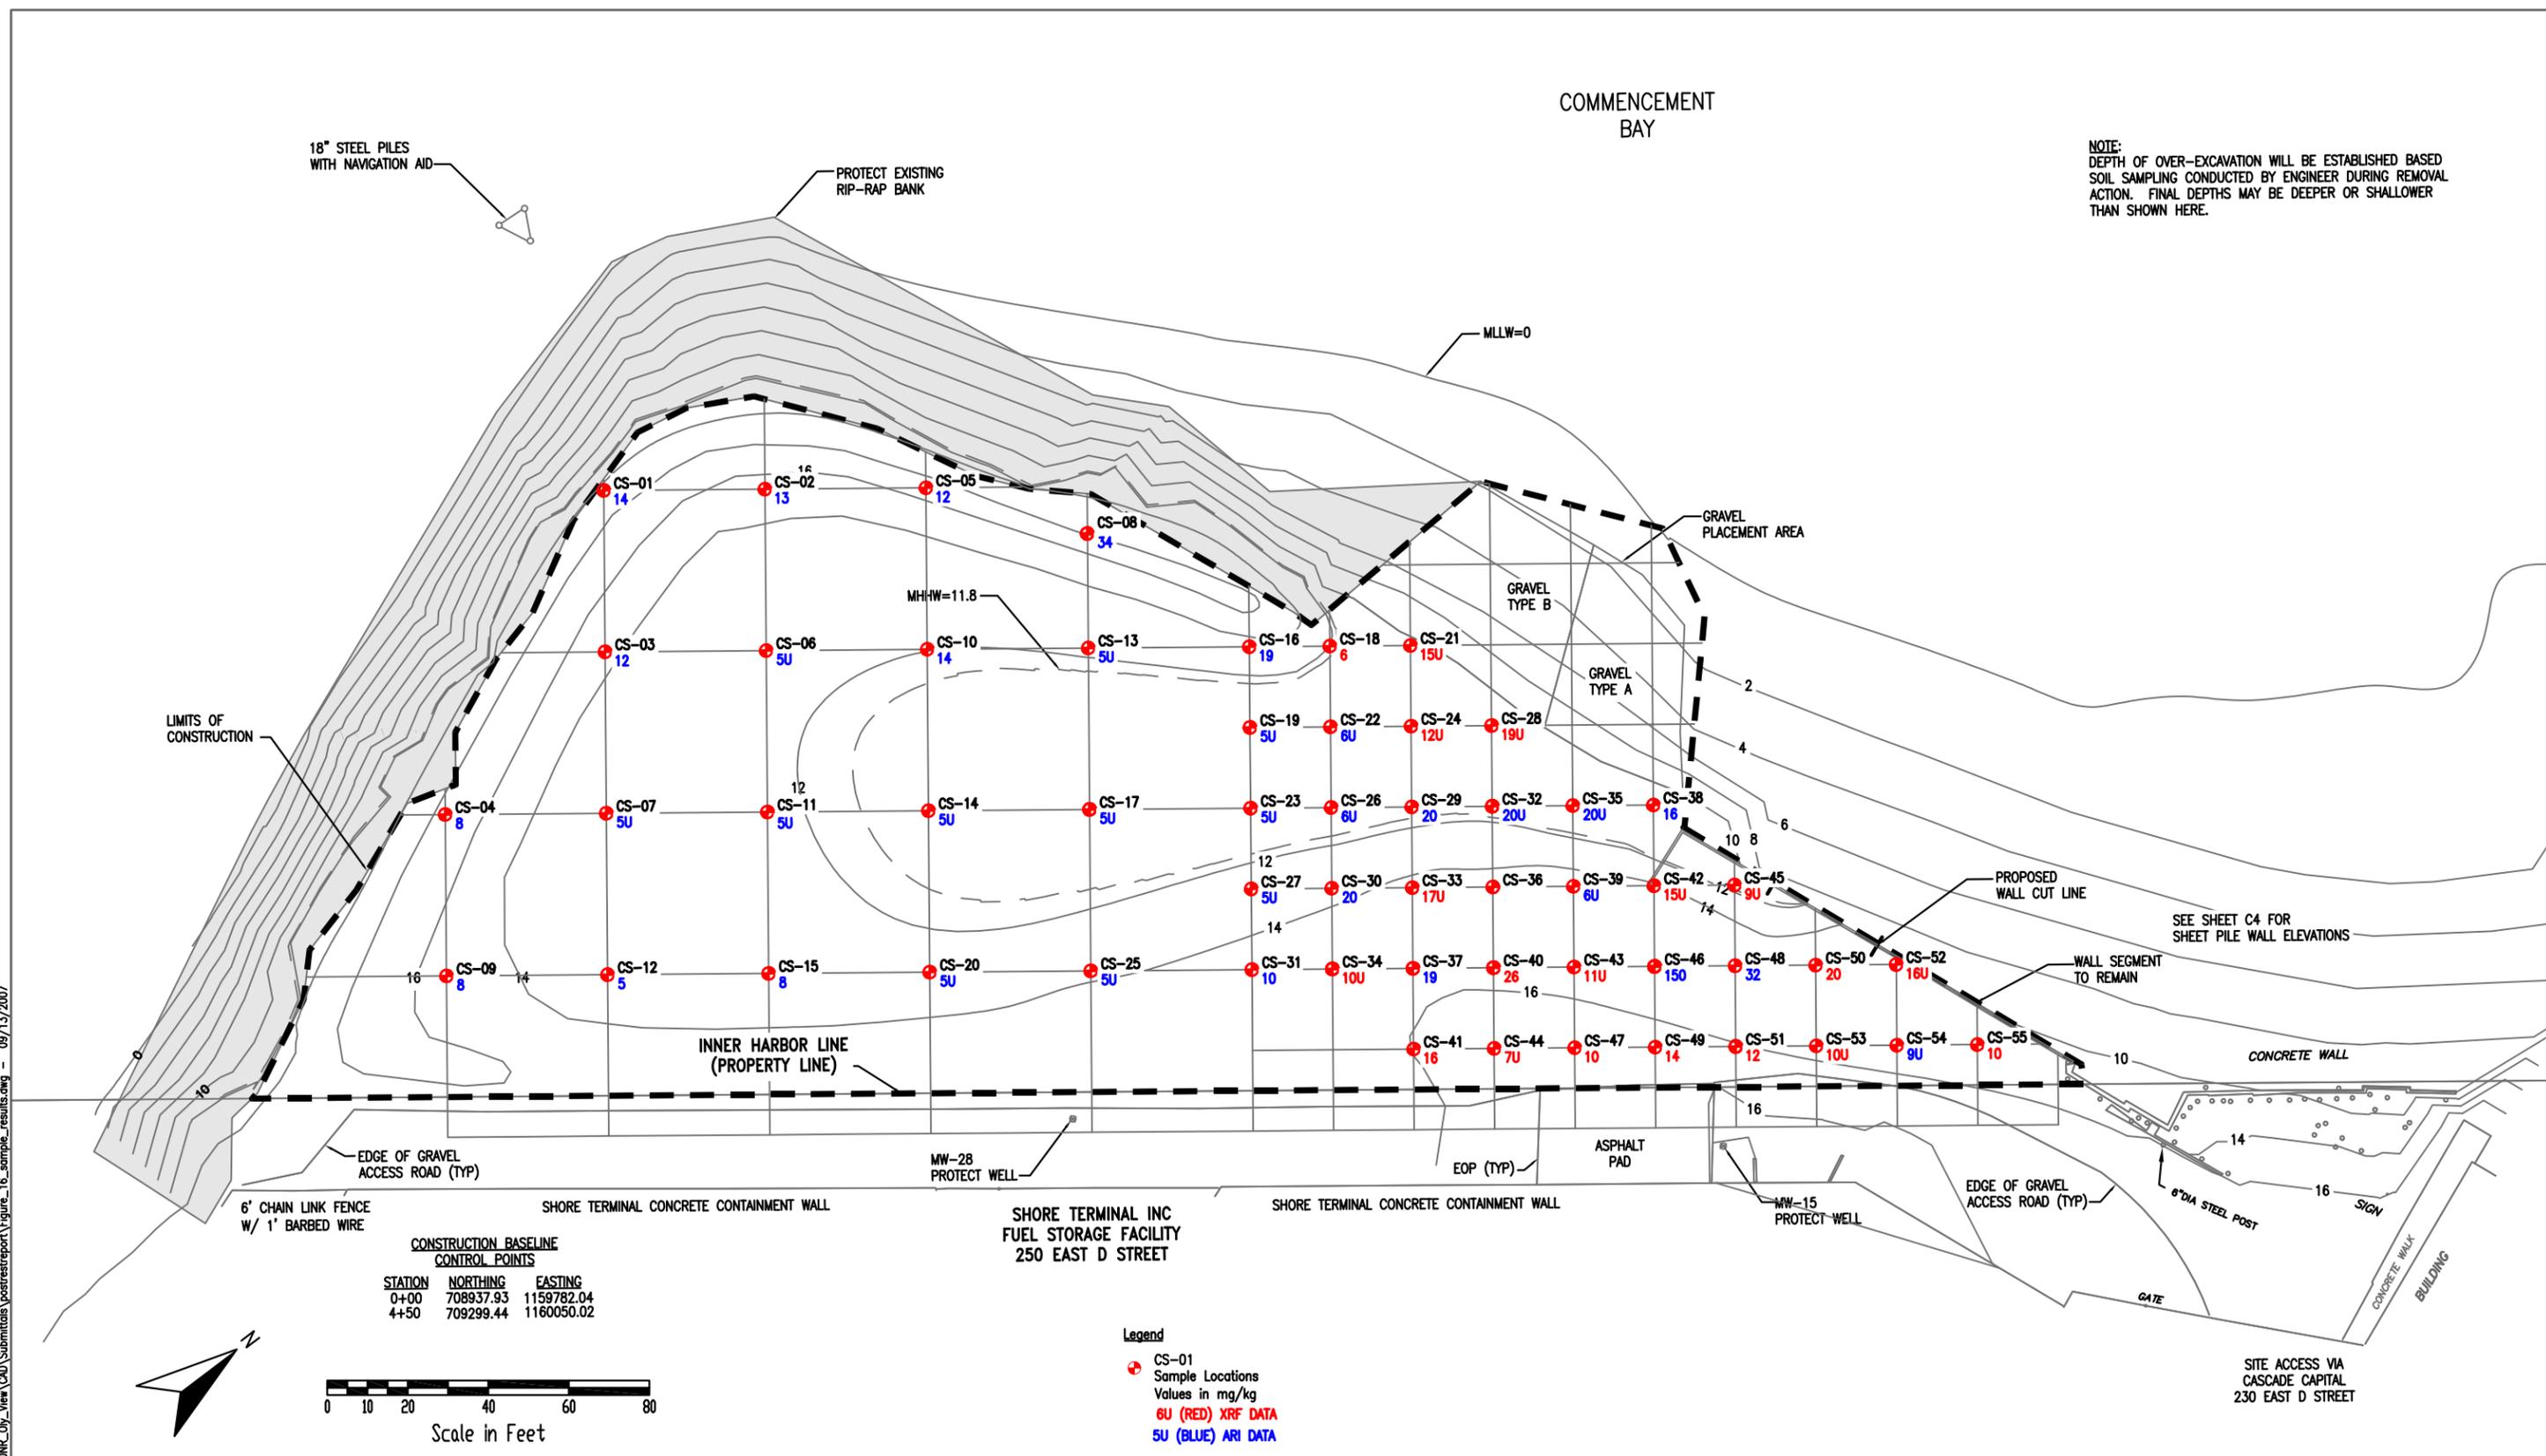
September 2007	Figure 16
Confirmation Soil Sample Locations and Results

Sampling was conducted according to the Olympic View Triangle Restoration Project Confirmation Soil Sampling and Analysis Plan (Ridolfi, 2007b). Surface samples were collected using new plastic spoons and new plastic disposable bags. Before filling the sample containers, each soil sample was thoroughly homogenized and all large organic debris and material such as leaves, twigs, roots, and rock was removed. In the “hot spot” area of the Site, one sample was collected approximately every 20 feet. For the remainder of the Site one sample was collected every 40 feet. A vertical composite of soil, from 0 to 12 inches bgs, was collected from each sample point. The sample locations and results are shown on Figure 16.

The confirmation soil samples were analyzed for inorganic arsenic by U.S. EPA method 6010B and by an XRF instrument. The results of the arsenic analysis were compared to the Washington State Model Toxics Control Act (MTCA) ecological indicator soil concentration of 10 mg/kg (Ecology, 2001) and the MTCA value for residential land use of 20 mg/kg (Ecology, 2005) depending on where at the Site the sample was collected. Samples that were collected in areas that were excavated below the final project elevation by at least 1 foot and backfilled with clean fill material were considered in compliance if detected arsenic concentrations were less than 20 mg/kg. The contractor was required to provide clean fill material with a concentration of arsenic less than 10 mg/kg. All other areas were considered in compliance with cleanup levels if concentrations of arsenic were less than 10 mg/kg. A sufficiently sensitive analytical method was chosen to insure that the laboratory target reporting limit was below the cleanup level. A summary of the arsenic concentrations detected in the soil samples is presented in Table 2. Figure 16 provides the confirmation soil sampling locations and results.

Arsenic was detected in 29 soil samples collected at the Site with concentrations ranging from 6 to 150 mg/kg. Arsenic was detected at concentrations above the screening level of 20 mg/kg in four of the soil samples: sample 07061501Lab at sample point CS-08 (34 mg/kg); 07061921XRF at sample point CS-40 (26 mg/kg); sample 07071602Lab at sample point CS-46 (150 mg/kg); and sample 07071702Lab at sample point CS-48 (32 mg/kg). These sample points were over-excavated to depths of over 3 to 7 feet below final grade of the Site. After consultation with DNR and Ecology, a decision was made to halt further over-excavation at these sample points and backfill the areas with clean fill. The rationale for this decision was based on the possibility of “chasing” the arsenic off property and the fact that groundwater was present in the excavation at the deepest sampling locations.

In the “hot spot” area, an approximately 8 foot diameter 7 foot deep test pit was dug around sample point CS-46 in an attempt to reach arsenic levels under the MTCA level of 20 mg/kg. A composite sample was collected from the bottom of the pit and sent to ARI for arsenic analysis. Arsenic was detected in the composite sample 07071602Lab at a concentration of 150 mg/kg, which exceeds the cleanup level by a factor of 7.5. Arsenic concentrations at the sampling points surrounding CS-46 or the pit were below the cleanup level of 20 mg/kg, with the exception of sample point CS-48 (07071702Lab) which had an arsenic concentration of 32 mg/kg. Based on these results and the fact that the bottom of the pit was approximately 7 feet below grade and the surrounding area was 3 to 5 feet below grade a decision was made to stop further over-excavation in the area and cap it with clean fill. The decision was made after DNR consulted with Ecology.

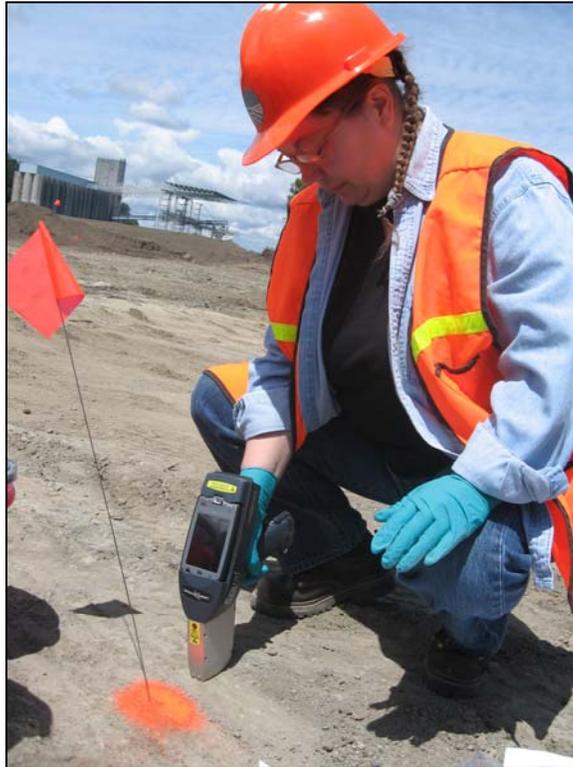
Figure 17. Testing a Soil Sample with the Portable XRF

For the first round of sampling, 55 samples were collected from excavated areas of the Site and analyzed on-site with a rented portable x-ray fluorescence (XRF) device (Figure 17). The on-site XRF analysis was conducted according to U.S. EPA Method 6200 Field Portable X-Ray Fluorescence Spectrometry for the Determination of Elemental Concentrations in Soil and Sediment (U.S. EPA, 1998). The instrument was operated by personnel trained and knowledgeable in the operation of an XRF instrument. All radiation safety measures in the operating manual were followed.

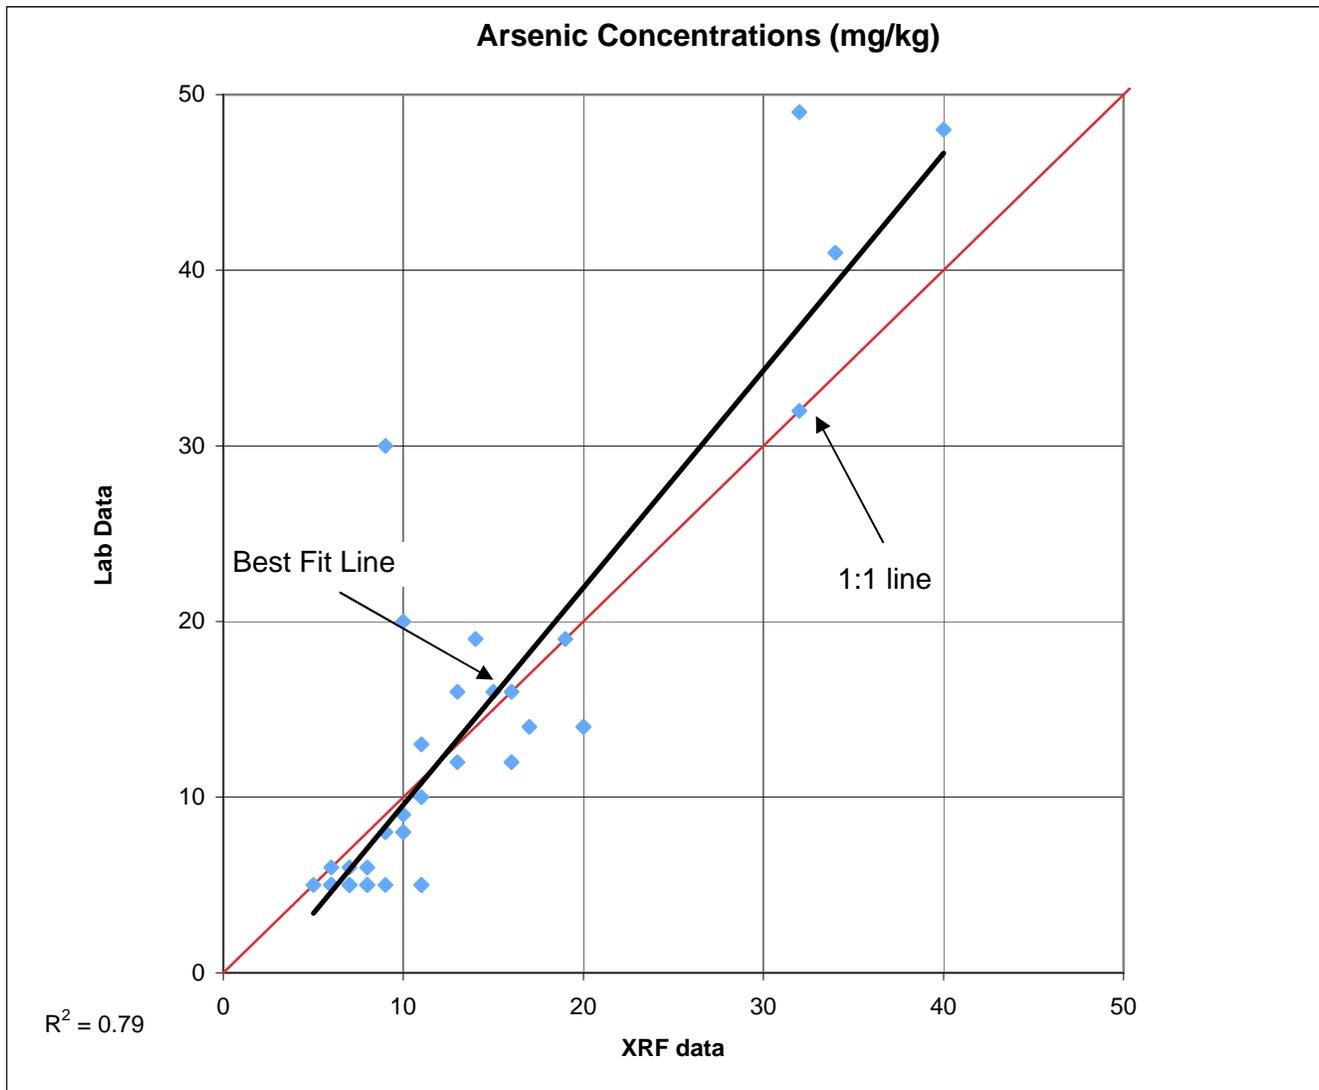
Figure 18. XRF and Laboratory Correlation

After approximately 20 sample pairs were obtained, a correlation analysis between the XRF and analytical results was conducted. The XRF and laboratory data were correlated as shown in Figure 18. The correlation was calculated to evaluate the agreement between the two methods.

When the correlation coefficient was equal to or greater than 0.75, the XRF method was considered to be sufficiently accurate and was used for cleanup decisions at the Site. During the last two weeks of the project, the number of samples submitted to the laboratory decreased to 20 percent.
