ENGINEER'S POST-RESTORATION REPORT
MOWITCH AND SQUALLY BEACH PROJECTS
COMMENCEMENT BAY

COMMENCEMENT BAY
NATURAL RESOURCE DAMAGE ASSESSMENT
AND RESTORATION TRUSTEES

RIDOLFI ENGINEERS Inc.

December 2000

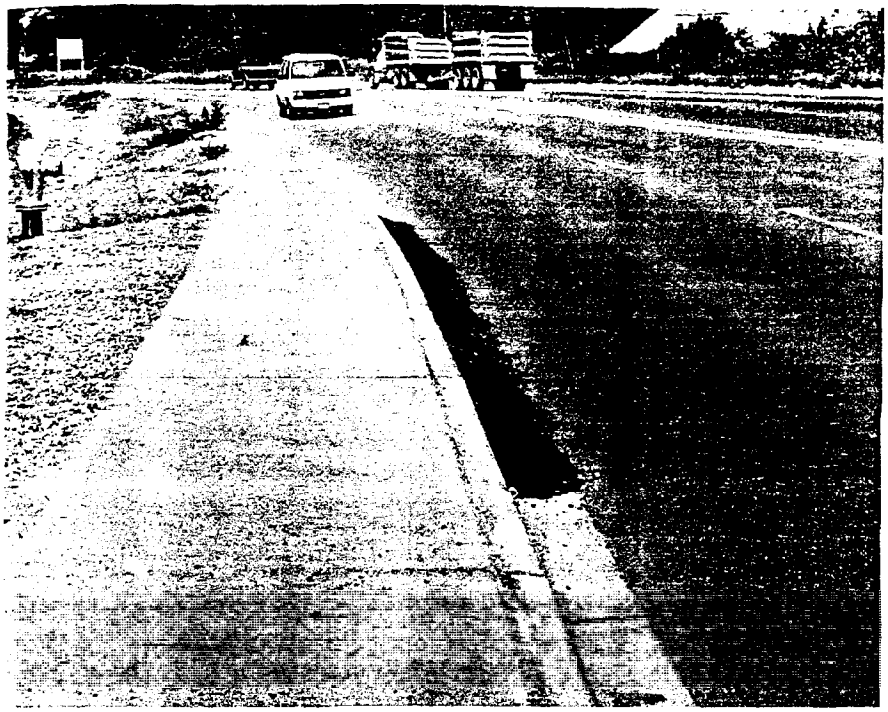
- Silt fencing along the bank of the Hylebos Creek (Figure 8),
- A floating silt curtain between the site and the Hylebos Waterway,
- Filter fabric in catch basins in Marine View Drive,
- A rock driveway at the site entrance, and
- A ramp to protect the curb (Figure 9).

Figure 9. Ramp to Protect the Curb at the Mowitch Site

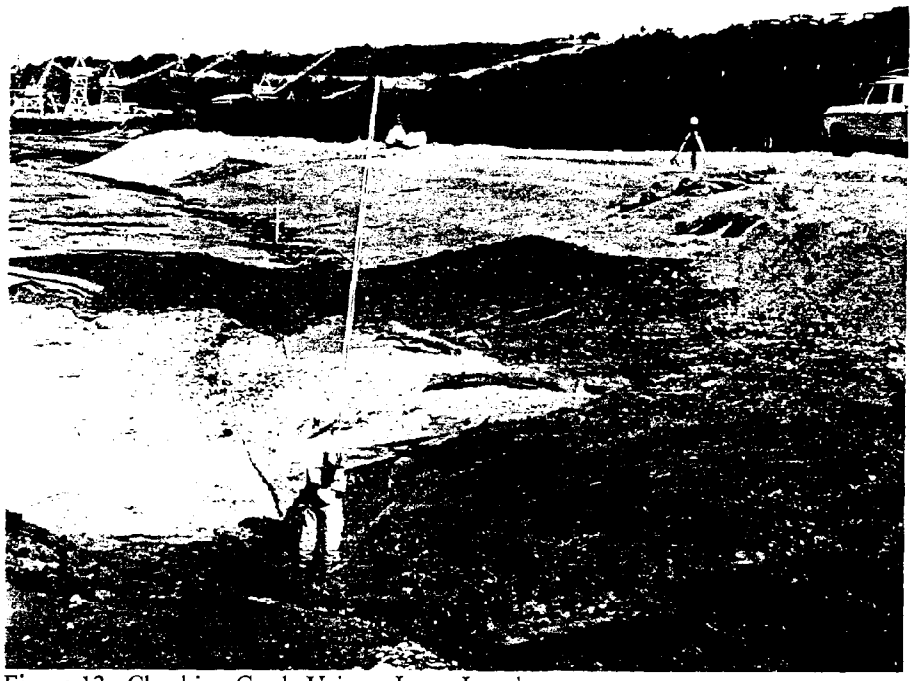
Figure 13. Checking Grade Using a Laser Level

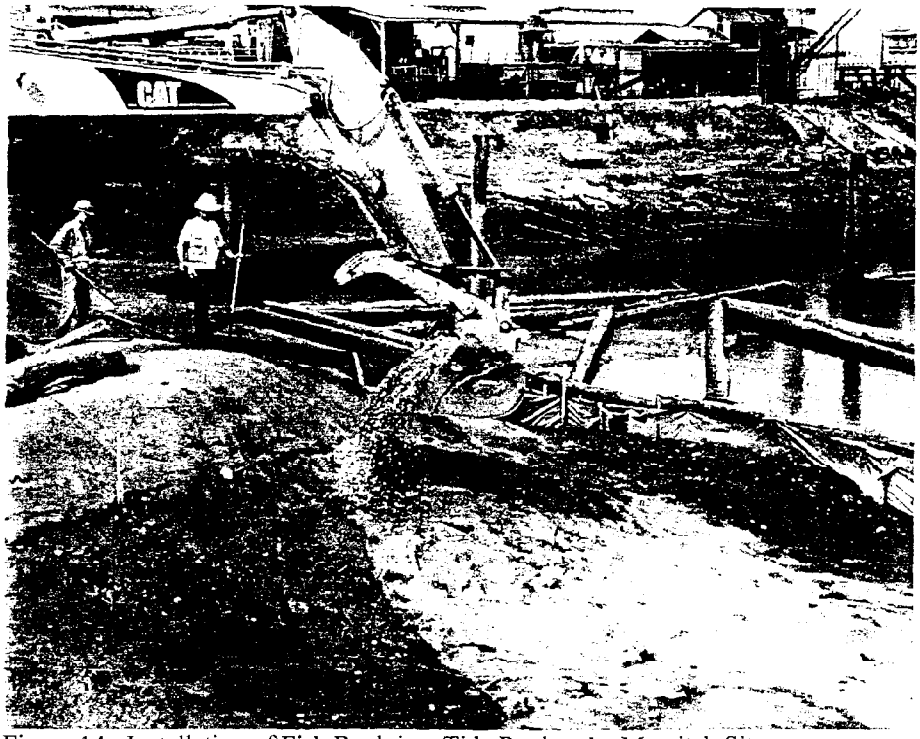
coir (coconut fiber) based mat to reduce the loss of fish rock into the underlying substrate (Figure 14). Fish rock at the toe of the slopes also provides a measure of slope stabilization. Topsoil was placed on the pool slopes at elevations above +6.3 feet MLLW and covered with the same coir matting, used in this context as an erosion control material. The sides of the pool were generally sloped between 2.5:1 and 3:1 horizontal to vertical. These relatively steep slopes were dictated by the site geometry, which is relatively long and quite narrow.

Figure 14. Installation of Fish Rock in a Tide Pool at the Mowitch Site

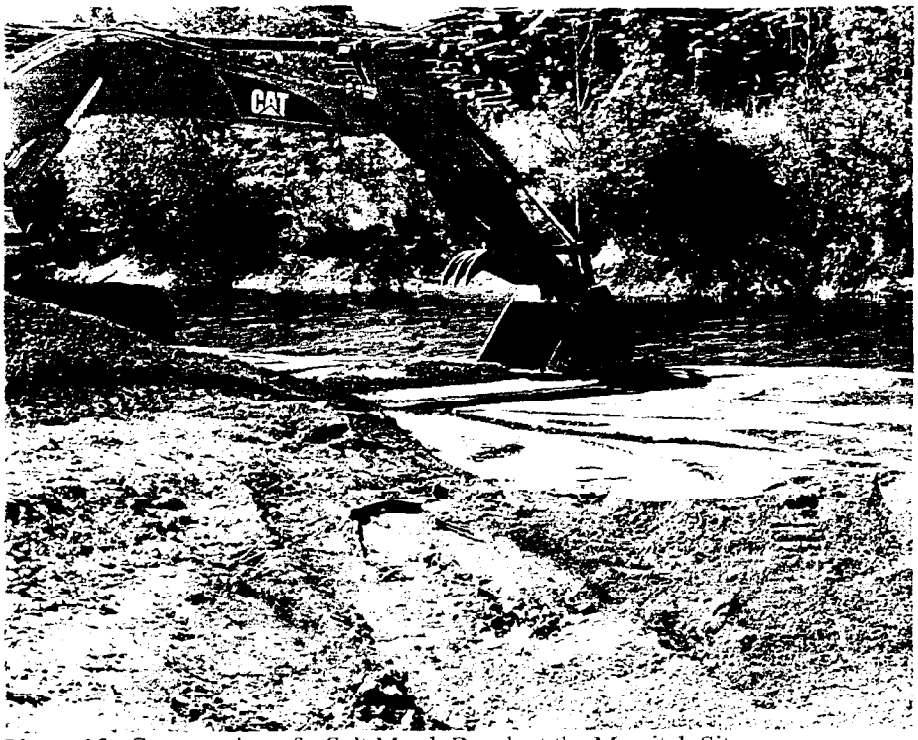
Islands or peninsulas were constructed between the tidal pools and Hylebos Creek. The tops of these features are relatively flat and are at an elevation between +10 and +12 feet MLLW. These flat areas are intended to support development of salt marsh vegetation (Figure 15). Broad flat areas between the pools are at a similar elevation and are intended to support similar vegetation. Grading in these connective areas was designed to allow water to enter the site at the upstream portion of the site and flow downstream toward the Hylebos Waterway.

Figure 15. Construction of a Salt Marsh Bench at the Mowitch Site

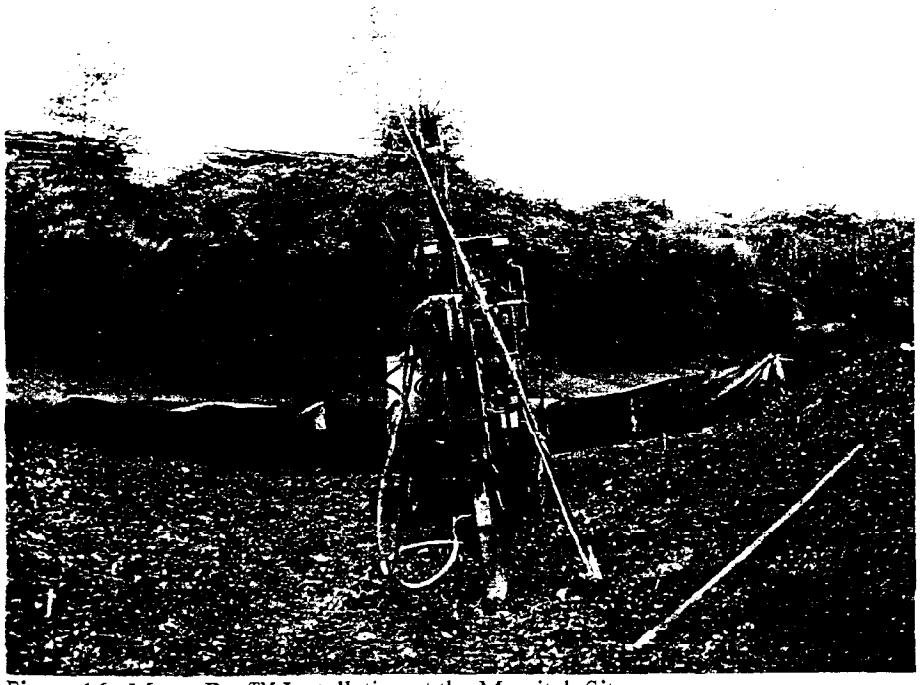
Numerous boulders and large stumps, known as large woody debris or LWD in restoration jargon, were installed in the tidal pools. The purpose of these features is to provide refuge for juvenile salmon that may migrate through the area and to provide habitat diversity. The LWD was generally installed with the trunk end of the stump buried in the slope of the pool and the root ball sitting in the bottom of the pool. One Manta Ray™ anchor was driven at each location prior to installing the LWD as a means of fastening and anchoring the LWD. The anchors were driven using a small tracked vehicle with a hydraulically operated percussion hammer (Figure 16). The anchors were driven 6 to 12 feet into the ground and retracted to engage the folding arms of the anchor. The anchors work like drywall toggle bolts that are commonly used in homes (Figure 17).

Figure 16. Manta Ray™ Installation at the Mowitch Site

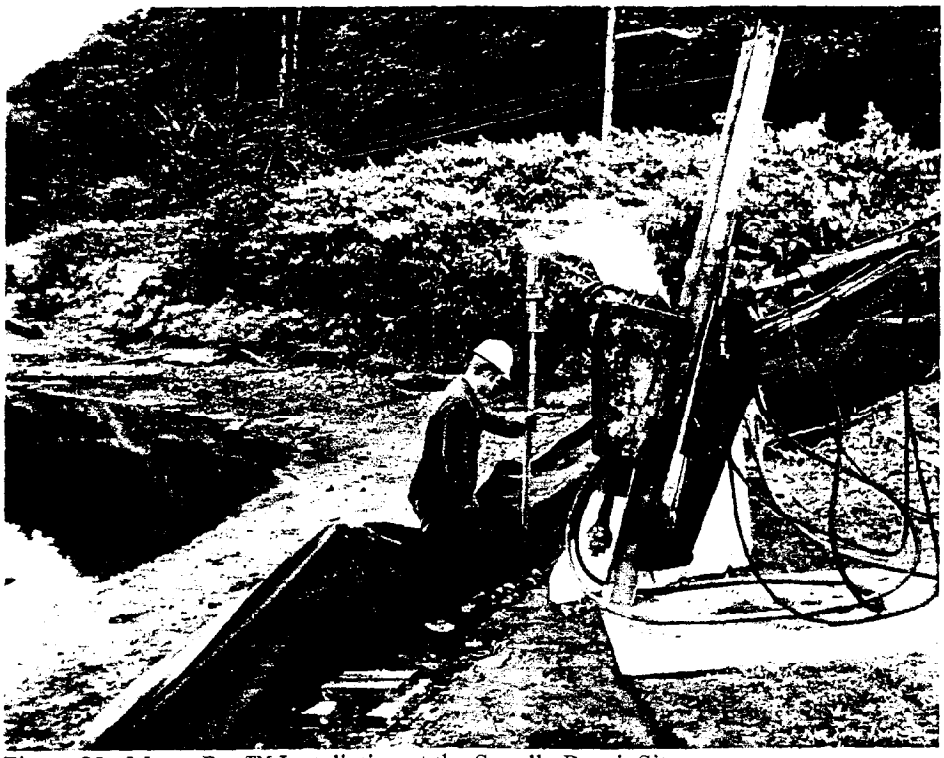
Toe logs were installed parallel to the shoreline at the Squally Beach site to reduce the potential for erosion in areas with cut banks. The toe logs were 10 to 30 feet in length with diameters in the one- to two-foot range. The end of each toe log was secured with two Manta Ray™ anchors (Figure 22). Ten toe logs were installed at the site.

Figure 22. Manta Ray™ Installation at the Squally Beach Site

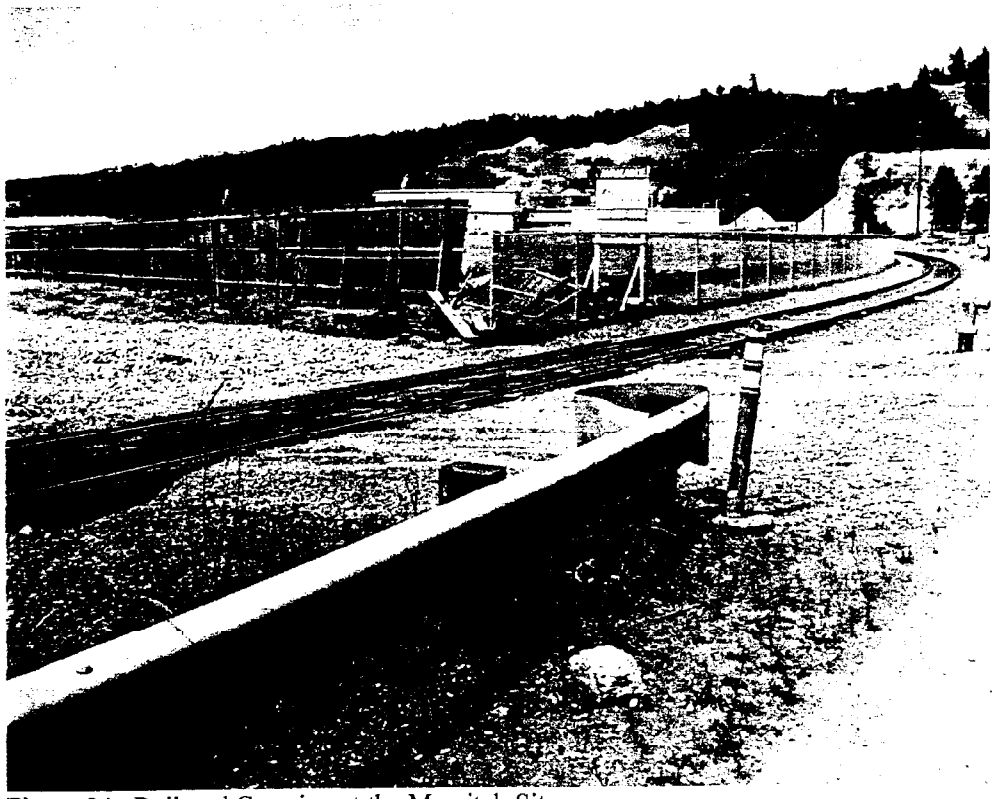
Figure 24. Railroad Crossing at the Mowitch Site

NOAA issued a contract modification to Remtech to obtain a permit from Tacoma Rail to construct and use a temporary rail crossing (Figure 24). The requirement for a permit was recognized several months prior to beginning construction but several of the permit conditions were not identified in time to be included in the contract. For example, Tacoma Rail required insurance and specific materials for the crossing and indicated a strong preference for using a specialized subcontractor to install the crossing. Additionally, there was a daily notification requirement in the permit. This issue resulted in a three-day delay and a cost increase of $15,223.

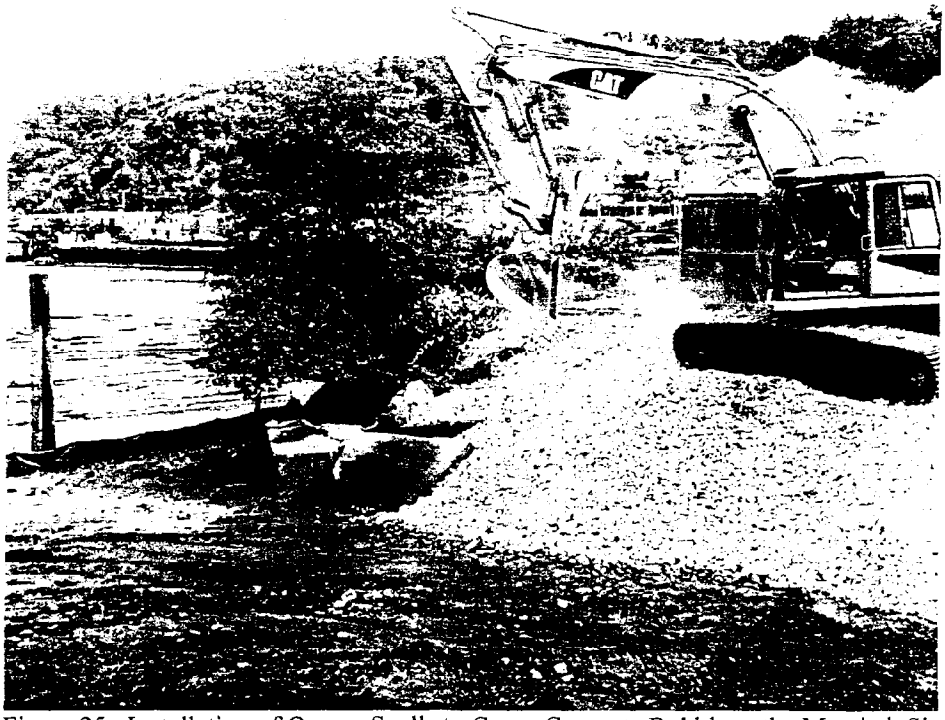
Figure 25. Installation of Quarry Spalls to Cover Concrete Rubble at the Mowitch Site

Quarry spalls were used in three instances at the Mowitch site. First, quarry spalls were placed in a veneer over concrete rubble at the corner of the site (Figure 25). Subsequently, quarry spalls were placed in two areas where the soil was particularly unstable because of groundwater seepage (Figure 11). The quarry spalls cost $12,766 and resulted in a one day time extension.

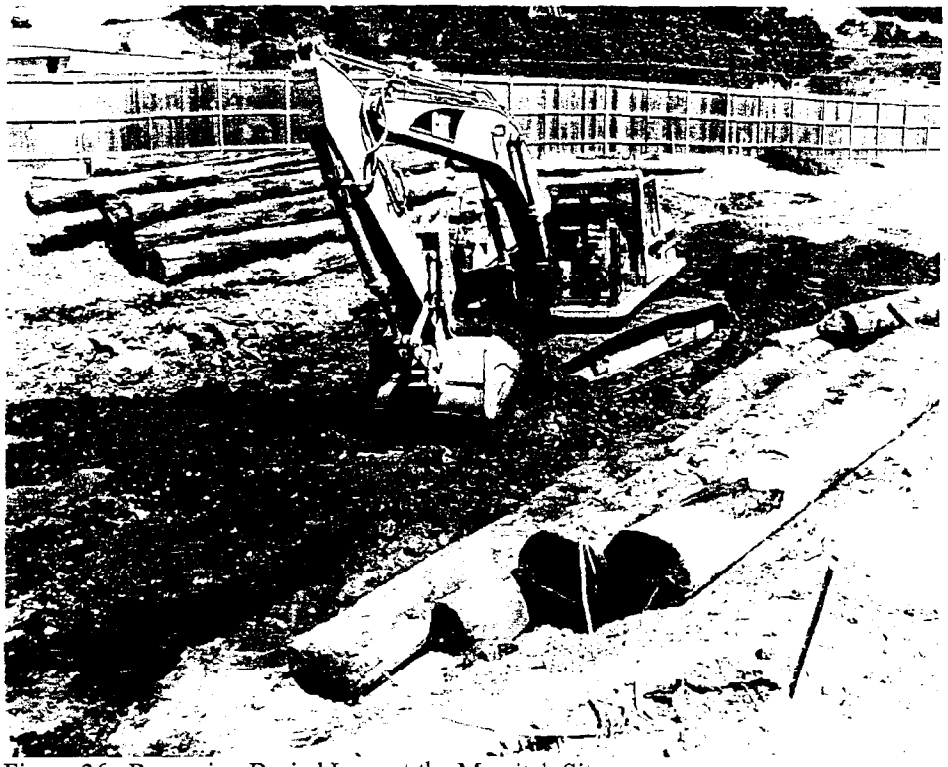
Figure 26. Removing Buried Logs at the Mowitch Site

Approximately 60 logs were discovered buried just below ground surface under the log ramp at the Mowitch site (Figure 26). It appeared that the logs had historically been used to stabilize the ground surface to allow the use of heavy equipment in the area. The logs were removed and most were transported to a nearly log sorting yard. Six logs were transported to the Squally Beach site for use as toe logs. Disposal of 55.91 tons of logs was paid under the debris disposal pay item at a cost of $2,516. A deduction was made for the volume of soil displaced by the logs, which was estimated to be 120 cy. This resulted in a credit of $660, for a net cost of $1,856. There was no time impact associated with this changed condition.
